The on-site example of influence of selected factors on the quality of monolithic reinforced concrete elements

Abstract. The subject of the article is the analysis of the influence of factors related to the course of concreting on the quality of the reinforced concrete element. The problem was discussed on the example of columns with an unusual narrow cross-section (18x80 cm). The characteristics of the surface defects of tested columns are presented and their causes are discussed. The basis of discussion were observations and in-situ tests of concrete mix performed during concreting similar elements in similar conditions. The potential effects of defects in terms of component durability were also considered.

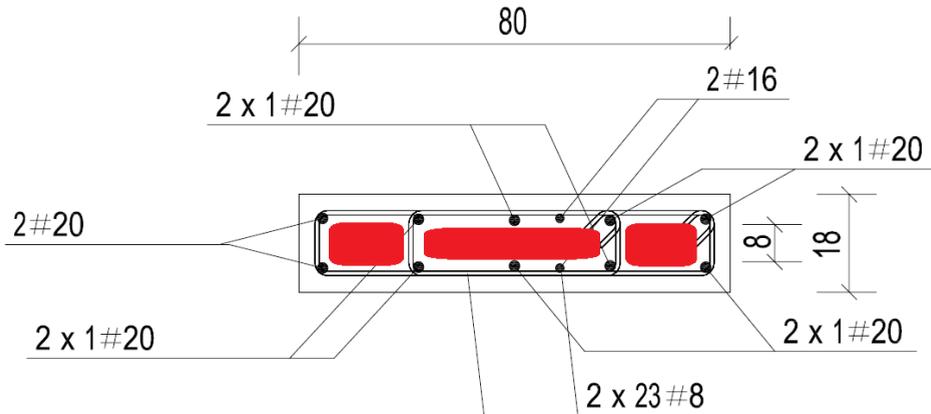
Fig. 2. Cross-section of a reinforced concrete column with space marked by the authors, remaining after taking into account reinforcement, for filling with a concrete mix and compaction.

According to the recipe, an admixture significantly reducing water (polycarboxylic superplasticizer) was used, in an amount of 1.40% relative to the cement mass, which is in accordance with the manufacturer's recommendations. The technical sheet of the admixture contains a statement that "the product can be used at temperatures down to -15°C". Because there were no lower temperatures during concreting, the admixture could be used. Table 1 shows that aggregate with a $D_{max} = 16$ mm was used to make the mix. This value of aggregate grain diameter, in relation to the cross-section geometry and column reinforcement, could significantly hinder filling of the formwork by the concrete mix (see Fig. 1 and 2).

During the analyzes, doubts appeared as to the correctness of the course of laying and compacting the concrete mix. As given in Chapter 1 of the paper, the smaller dimension of the column cross-section was 18 cm, and the thickness of the designed concrete cover was 2.5 cm. Taking into account the thickness of the cover and the diameters of the reinforcing bars, very little space remains, i.e. around 80 mm, for introducing the tip of the vibrating tool (see Fig. 2). During the observation of the concreting process of the subsequent elements, it was found that a vibrator with a 60 mm diameter tip was used to compact the concrete mix. The vibrating tip hit the reinforcing rods, which made it impossible to properly compact the mixture in its entire volume. Narrow mixing space in combination with too large, in this case, dimension of the vibrating tip could hinder proper compaction of this mixture. This was important especially in critical places, such as the concrete and reinforcement contact zone, and the cover zone. It could also contribute to the formation of vibrated spaces filled with water at the surface of the concrete. An additional difficulty was, as demonstrated in the work, too dry consistence of the concrete mix.

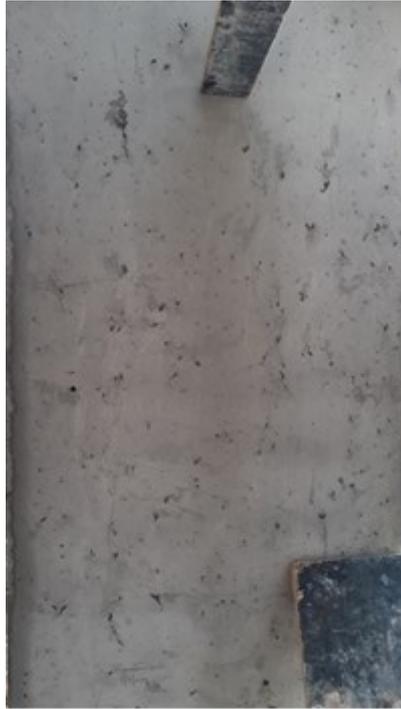
Fig. 3. A view of a reinforced concrete column - visible concrete defects: numerous pores and blisters located on the entire surface of the column and crushed and discolored corner (left edge).

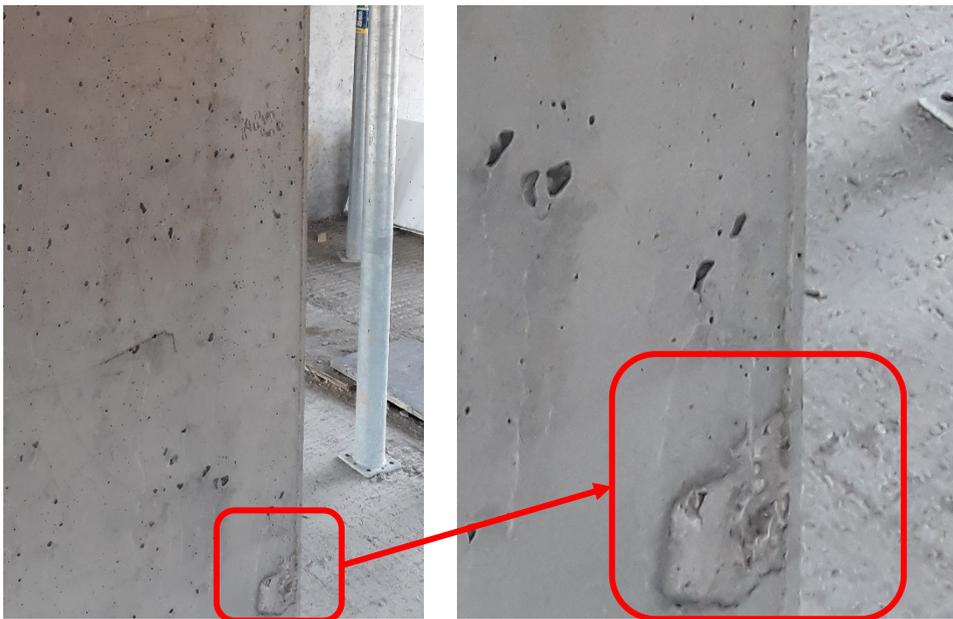
The local inspection were done, including an analysis of the surface state of reinforced concrete columns, in the case of which the most irregularities regarding the concrete surface were found. It should be emphasized that the surface defects described below revealed only on vertical support elements, with the largest changes occurring on elements with a cross-sectional size of 18 x 80 cm and therefore these elements were analyzed. The scale of the issue was high, because the observed defects related to the majority of made columns. In all cases, the presence of very numerous defects on the concrete surface as well as discoloration and cracks at the edges of the columns were found. A large number of open pores and blisters were found, located at the entire height of the columns. The distribution of pores was relatively uniform, there is no reason suggesting the local nature of the cause (Fig. 3). Pore diameters have values ranging from a few to a dozen or so millimeters. Blisters and honeycomb, which are usually the result of leaking water/mortar from formwork in the corners of columns and improper laying and compacting of the concrete mix, occurred less often and their distribution was of a less regular nature. Diameters of blisters had values from a few to several tens of millimeters, and their depth reached even a few millimeters (Fig. 4).

Fig. 4. Blisters in concrete at the edge of a reinforced concrete column (located in its lower part).

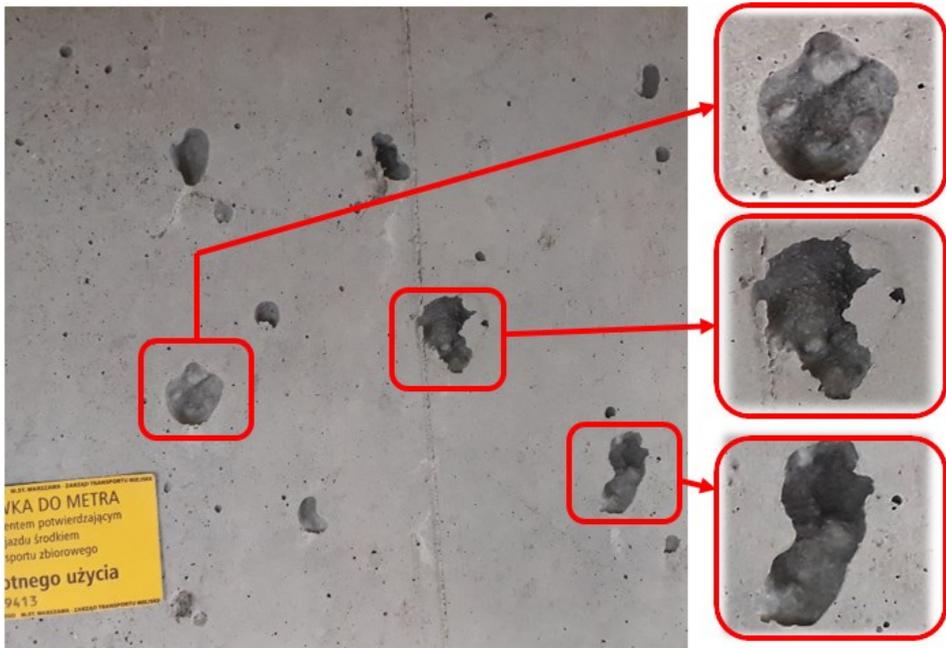
Observed surface texture inside many blisters indicates that these were places where water accumulated during binding and hardening of concrete (so-called bleeding; Fig. 5).

Fig. 5. Blisters on the concrete surface; the scale of their dimensions is indicated by the reference to the dimensions of a typical pass.

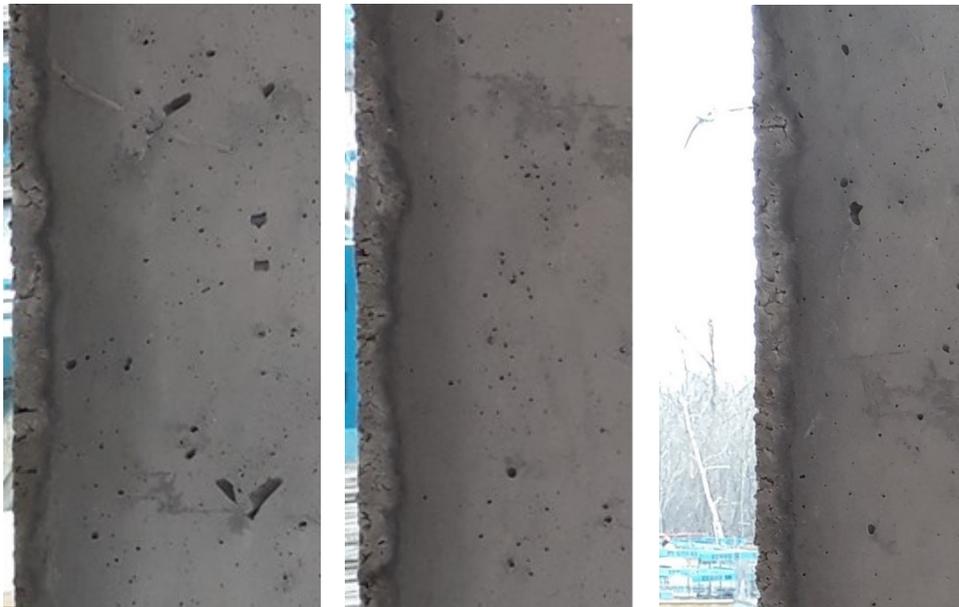
The separation of water from the concrete mix is also confirmed by defects on the edges of the columns. A darker color of edges was observed, suggesting a much greater moisture content of the cement matrix (Fig. 6). The structure of the material within the defect was very porous, and the aggregate was partially exposed (honeycomb effect), which could be the result of washing out a part of the mortar from the mix. The fact that during the dismantling of the columns, water leaks appeared on the floor around them is the confirmation of the mixture segregation and bleeding phenomenon.

Fig 6. Honeycomb effect and discoloration of concrete at the edges of reinforced concrete columns (occurring at the entire height of the element).

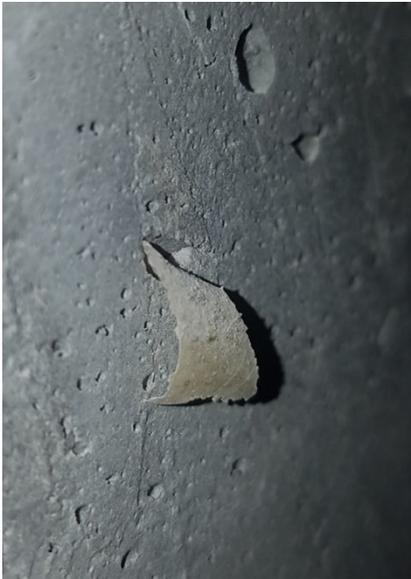
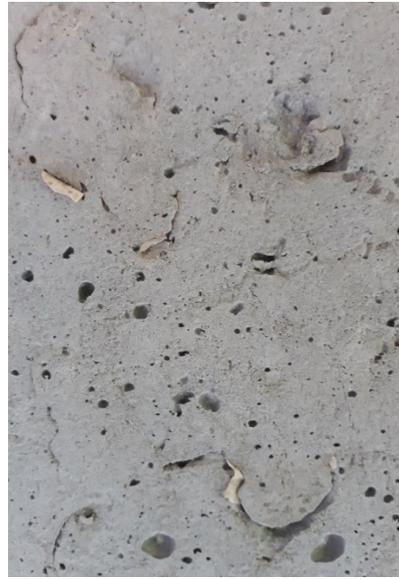
Another defect observed during the inspection was the occurrence of "flakes" resembling fragments of plastic (Fig. 7). They were very brittle and easily destroyed. According to the authors, it could have been a residue of the anti-adhesive agent, which was used for moulds, and which could react with the concrete components. This effect could also come from the outer layer of formwork panels, especially in the case of panels with high degree of use.

As stated, a anti-adhesive agent used to coat the formwork, according to the manufacturer is suitable for various types of formwork. It should be noted that the manufacturer does not provide information on the suitability of the agent for use during the winter in the technical datasheet.

Fig. 7. „Flakes” on the surface of concrete.

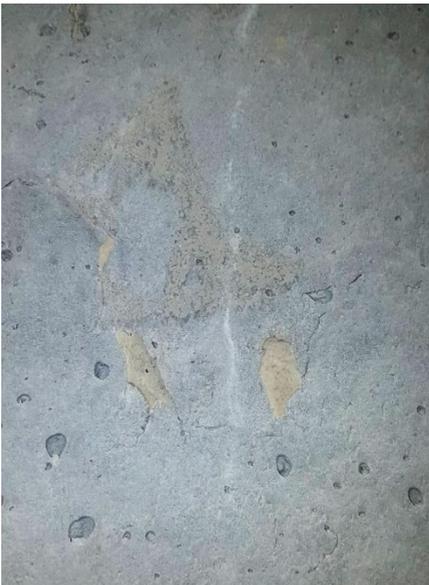
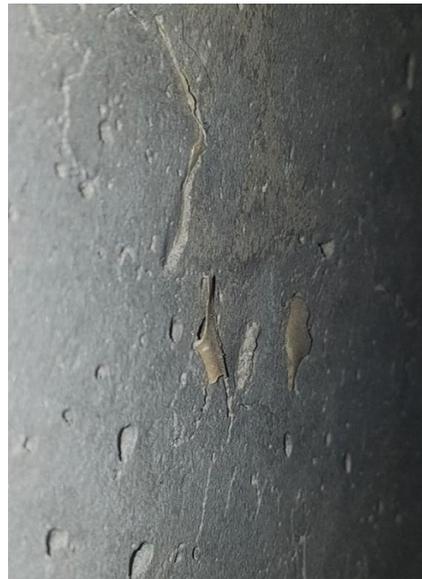
Noteworthy is the fact, that the flakes often covered pores and voids, the edges of which correspond to the shape of the flakes (Fig. 8).

Fig. 8. Pores and blisters visible after removing „flakes”.
