# Chemical corrosion of concrete tank in sewage treatment plant as the cause of failure

**Abstract.** The organoleptic examination proves a significant degree of structural disintegration of concrete - some loosely embedded aggregate grains easily fall out when touched. The vertical range of the above changes includes a zone up to approx. 60 cm above the wastewater level, i.e. the zone of fluctuations in the level of wastewater and a spray-gas zone. In the case of the tank 01/1 this means the full usable height of the tank, which may mean in the longer term the propagation of damage to the lower surface of the roof.

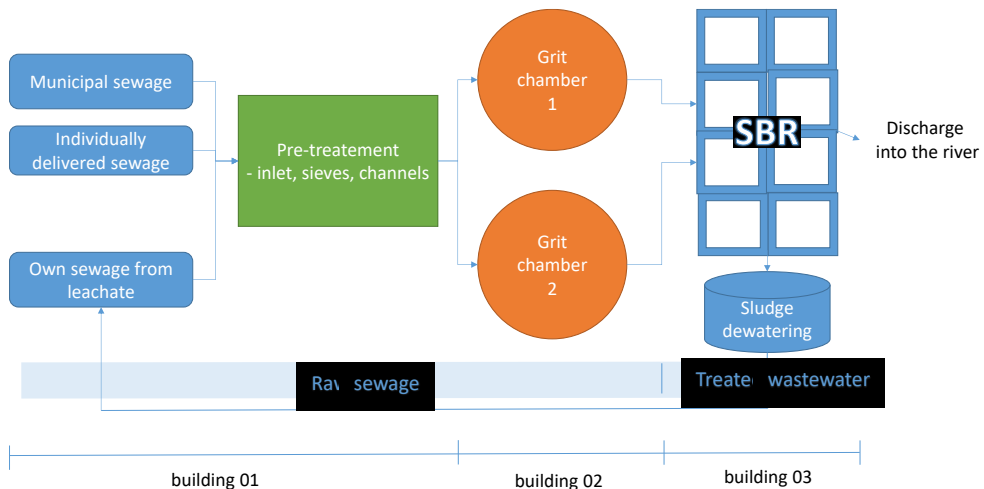
**Fig. 1.** Technological scheme of treatment process.

The treatment plant consists of three main objects (Figure 1), the first and second of which include pre-treatment devices (technical building - building 01 and grit chambers - building 02), and the third is a biological reactor (SBR) with accompanying facilities (building 03).

Raw sewage, which flows into the building 01, are subject to subsequent stages of mechanical cleaning in the building 02. In the building 03, pre-treated sewage is subject to a further treatment - biological process - with the use of the activated sludge. This means that the walls of the subsequent tanks in the technological line are in contact with the gradually changing environment. This influences the assessment of the environmental aggressiveness in subsequent tanks and may lead to the determination of different concrete exposure classes, presumably towards less aggressive environment at the final stage of the treatment [2].

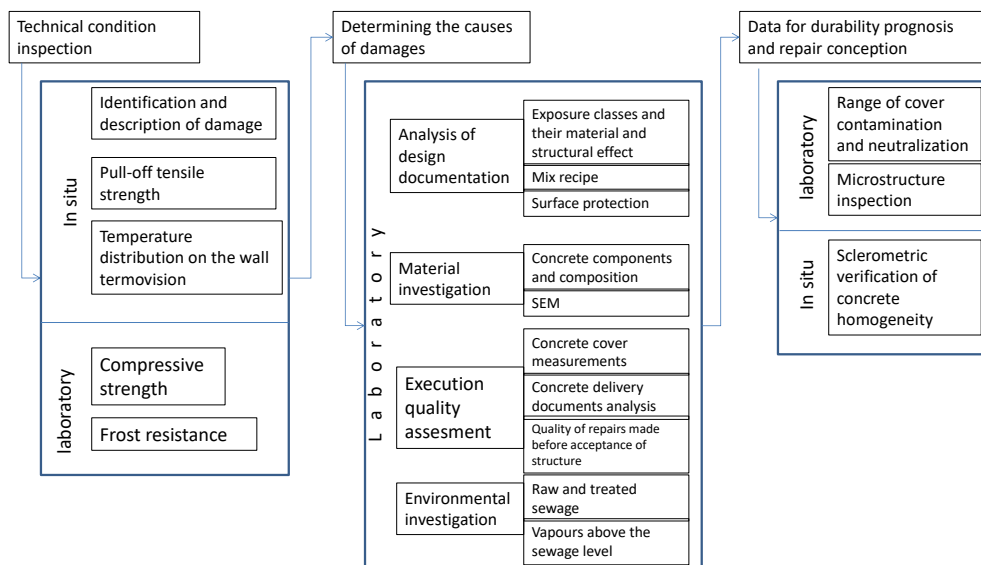
**Fig. 3.** Diagram of diagnostic procedure.

The initial visual inspection and initial review of the documentation made it possible to specify the following main research and analysis objectives (Figure 3):

- determination and documentation of the condition of the tank walls,
- determination of the causes of damages found,
- collecting of the data for the durability prognosis and for developing of a repair concept.

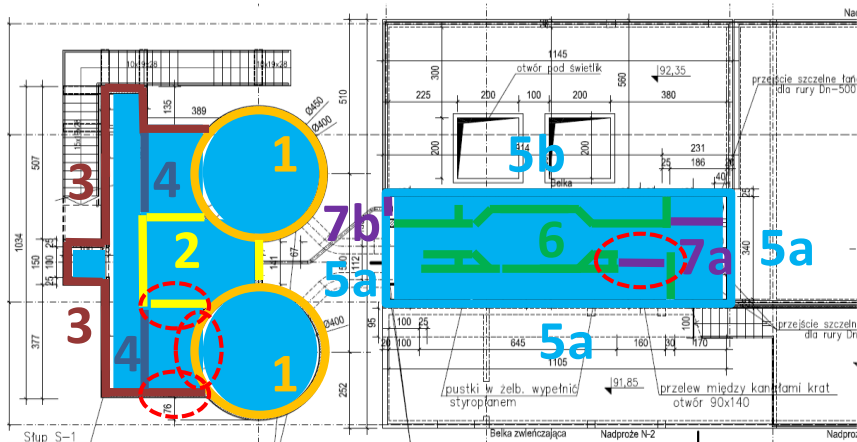
**Fig. 4.** Different types (different thickness) of walls in the tanks 01/1 and 02/2; elements subject to a detailed inspection and tests - red dotted line.

The tank 01/1 is the closest to the raw sewage inlet. The subject of detailed research in this part was the wall marked as No. 7 (dashed line in the Fig. 4).

The walls of the tank 02/2 are in contact with mechanically pre-treated sewage. The subject of detailed research in this part were fragments of the walls marked as No. 1, 2 and 3 (according to the Fig. 4). The internal surfaces of the tank are characterized by numerous

The subject of the inspection were accessible internal surfaces of tank walls, having contact with the sewage and their vapours (Fig. 4).

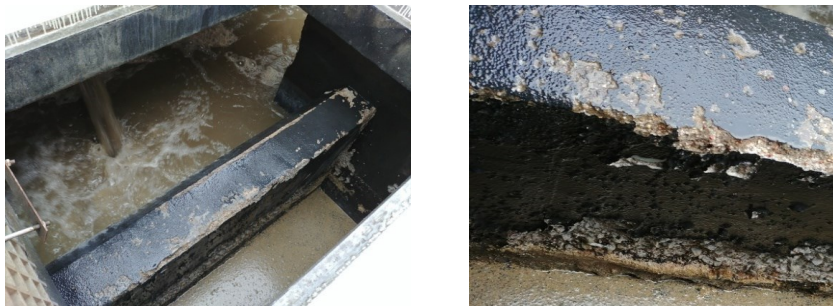
In the places of detailed inspection of walls, but also in many other areas visible through inspection openings in the roof, signs of advanced surface corrosion of tank walls 01/1 and 02/2 were found. On the other hand, there were no signs of corrosion of the tanks in the building 03. No corrosion symptoms were found in the lower tank in the building 01, but it should be noted that the access to this tank was difficult and only fragmentary. The technological scheme of the wastewater treatment indicates that in the above mentioned tanks there are wastewater at various stages of the treatment process, which can cause their different aggressiveness for concrete.

**Fig. 5.** Damaged surfaces of walls of the tank 01/1.

losses of the bituminous coating and extensive crumbling of the concrete (surface and linear shape) along the edge (Fig. 5 and 7), with an approximate range in the zone above the water level (Fig. 6 and 8). The symptoms found in the tanks 01/1 and 02/2 are similar, although the aggressive environment in both reservoirs could be somewhat different. In both cases the concrete cover damages depth exceeds 2 cm (Fig. 7).

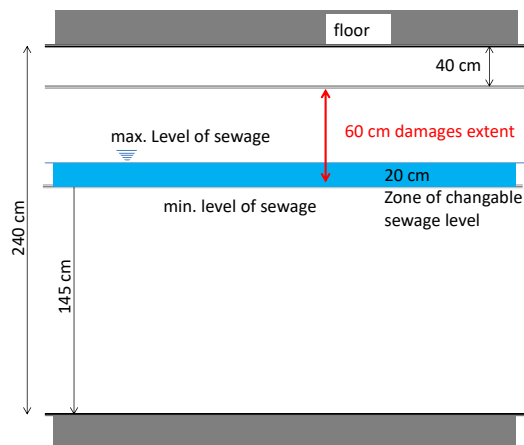
**Fig. 6.** Estimated extent of damages on the wall height in the tank 01/1.

The organoleptic examination proves a significant degree of structural disintegration of concrete - some loosely embedded aggregate grains easily fall out when touched. The vertical range of the above changes includes a zone up to approx. 60 cm above the wastewater level, i.e. the zone of fluctuations in the level of wastewater and a spray-gas zone. In the case of the tank 01/1 this means the full usable height of the tank, which may mean in the longer term the propagation of damage to the lower surface of the roof.

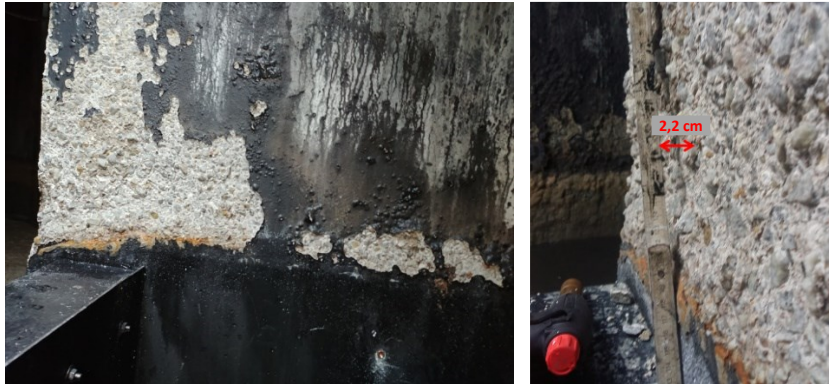
**Fig. 7.** Damaged surfaces of walls in tank 02/2.

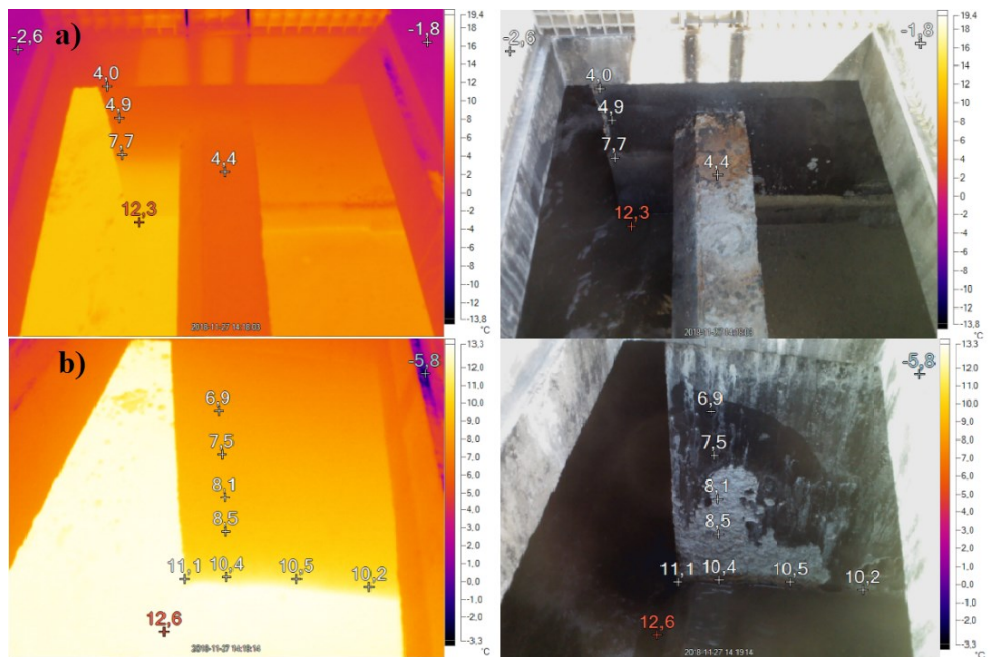
Infrared photos of the interior of the tanks (Figure 9) were used to estimate the temperature distribution on the walls in the zone above the sewage level. During measurements, the temperature of the atmospheric air was -2°C to -3°C. It was found that the surface temperature of the concrete wall of the tank 02/2 at the level of the sewage level (about 1 m below the top of the tank) under these conditions was approx. 12°C and decreased towards the top of the tank by approx. 5°C/m. This means that - assuming a constant temperature of sewage - already at a drop in air temperature to the level of -9°C, the temperature of the wall surface can be expected to fall below zero, even in a deeper water tank 02/2, in the zone of observed concrete damage.

**Fig. 9.** Infrared photos: a) tank 01/1; b) tank 02/2

The analysis of thermovision measurements of the internal surfaces of tanks allows to assess that there is a real threat of negative temperature impact in the tank's splash-gas zone. It is estimated that in the case of lowering the outside temperature down to -9°C, there is possibility of freezing the surface of the tank 02/2 slightly above the wastewater level. The cyclical occurrence of this phenomenon together with high humidity of concrete leads to the classification of the environment aggressiveness as XF3 exposure class. In the case of tank 01/1, in which the distance from the bottom of the tank to the sewage level is smaller, the risk of freezing occurs at a relatively higher temperature.
