Case study of a derecho wind storm on August 11-12, 2017 in Poland: part one

Abstract. Windstorms belong to the most costly natural threats in Poland. On August 11-12, 2017, a strong thunderstorm happened which resulted in a catastrophic damage in three provinces: Wielkopolskie, Kujawsko-Pomorskie, and Pomorskie. This disaster has resulted in the death of 6 people, injuries to several dozen people, and enormous property losses including approximately 16,000 residential, utility and public buildings, 80,000 hectares of forest area, 67,000 hectares of agricultural crops, in excess of 300 overhead power line poles, and over 200 cables were downed. The trees felled by the wind blocked and partially damaged local and municipal roads over a length of about 1100 km. Over 500,000 consumers were deprived of electricity at the peak of the disaster. The purpose of this paper is to describe, analyse, and learn from such a dangerous extreme weather event. In order to achieve this, a cause of the thunderstorm, its important meteorological data, the severity of damage to buildings, civil infrastructure and environment, processes of damage surveys, ideas for reconstruction and removing of all dam

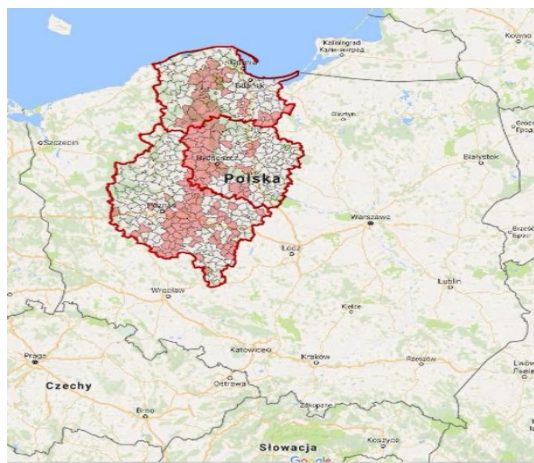
Fig. 1. The thunderstorm path (red colour) in Poland in August 11/12, 2017 over three provinces: Wielkopolskie, Kujawsko-Pomorskie, and Pomorskie [3].

In Poland, the first days of August 2017 were sunny. From August 9, 2017 hot tropical air began to flow into Poland, carrying a huge amount of energy. At 00:00 (02:00 official time) on August 11, 2017, a wavy, almost stationary, cool polar-maritime atmospheric front approached western Poland, preceded by a line of convergence. The front was arranged parallel to the flow at the central troposphere, so it moved slowly deep into the country only departing on the morning of August 13, 2017. The meeting of these two different air masses - hot tropical and cold polar - generated a dangerous weather phenomenon. There was a strong thermal gradient, the difference between the temperature in the north-west and the temperature in the south-east, both near the surface of the Earth and at a level of 850 hPa (at a height of about 1500 m), was about 13°C. Amongst the hot and unstable mass of air, a squall line formed along the front. One of these lines was created on Friday (August 11, 2017). This thunderstorm line was extremely violent because it appeared at the junction of two extreme masses of air: a hot and damp air mass, which for several days laid over a much colder polar air mass over Poland. The cold denser air forced the warm moist air aloft, which resulted in the accelerated development of storm clouds. The whole storm covered a vast area about 540 km from Wrocław, through Poznan, Bydgoszcz, along Gdynia and Gdansk and part of the coast. Late in the evening of August 11, 2017, and at night from August 11/12, 2017, a squall line crossed the area from Wielkopolskie through Kujawsko-Pomorskie to Eastern Pomorskie (see Fig.1) [1, 2].

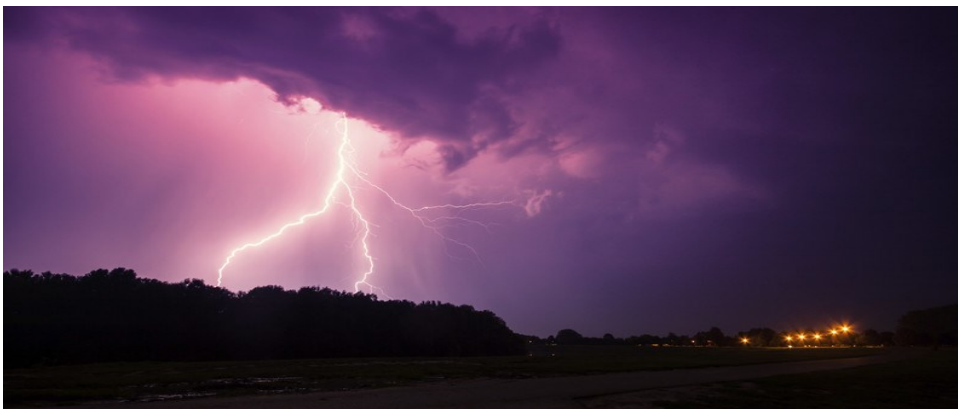
Fig. 3. Dark clouds in contact with the surface of the ground with strong atmospheric discharges – August 11/12, 2017, [3].

The sky was crisscrossed by lightning every few seconds as shown in Fig. 3. The thunderstorm caused much fear and despair for residents in its path. Based on the data collected in the European Severe Weather Database (ESWD) [1] and by authors of the paper [2], it appears that the storm meets the derecho criteria.

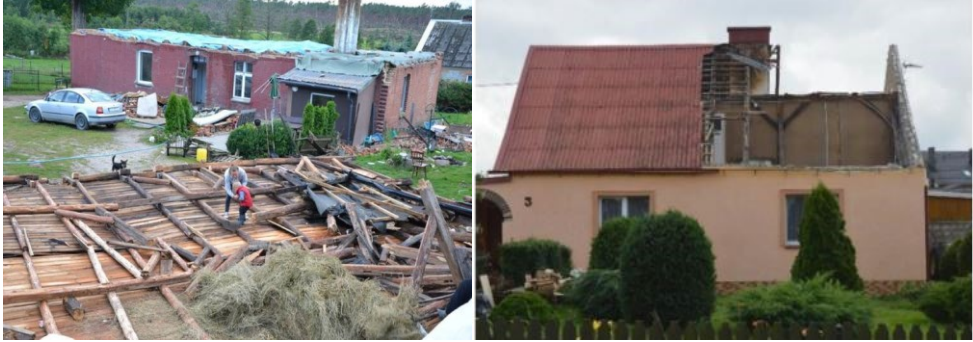
Fig. 5. Damage to buildings: entire roof blew off and part roof blew off from residential building.

Damage to roofs were found in all damage buildings. The majority of damage buildings, above 90 %, were low-rise structures, i.e. less than 14m in height. The degree of damage to the buildings was different. It was in the range from light damage, i.e. damage to gutters, several exposed tiles, through medium- including loss of roofing, battens, rafters, to total damage, i.e. loss of roof and loss of some walls. On the base of conducted control, 1116 buildings (i.e. 11.5 % of assessed), including 235 residential buildings, have been excluded from further use. Generally, buildings constructed in the early 2000s performed better than the buildings which were constructed earlier, e.g. in the years 1945-1990. Several of them have been built according to lower building codes, suffered a lack of maintenance, and some by an economic system that can be treated as non-engineering

Some cases of damage to buildings, agricultural crops, forests, and power line poles are shown in Figs. 5 – 7. The details of enormous damage which are presented above have been the basis for the estimation of all costs for the reconstruction and repair of buildings, infrastructure, forests, natural, and tourist values on the communes, districts, provinces, and government level.

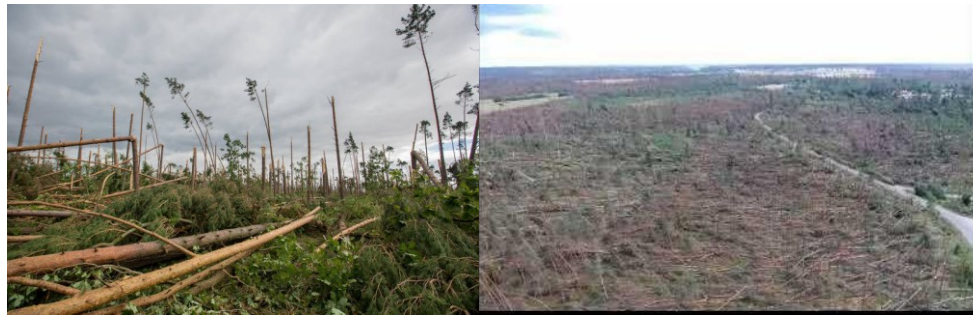
Fig. 6. Damage to forests.

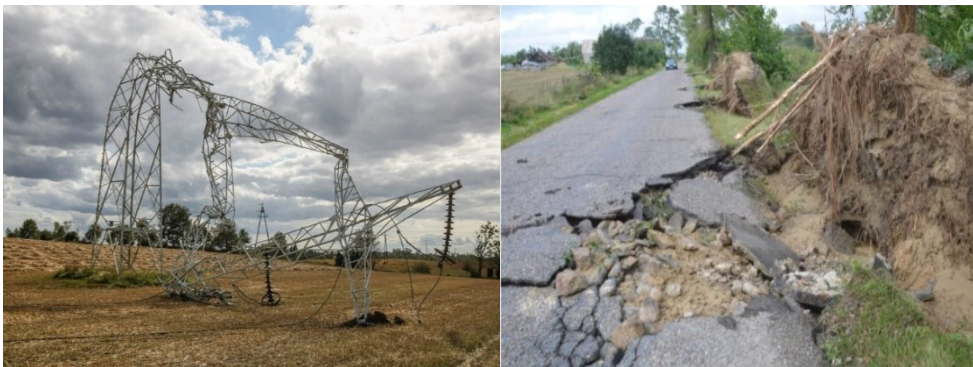
Fig. 7. Damage to a overhead power line pole and a commune road.

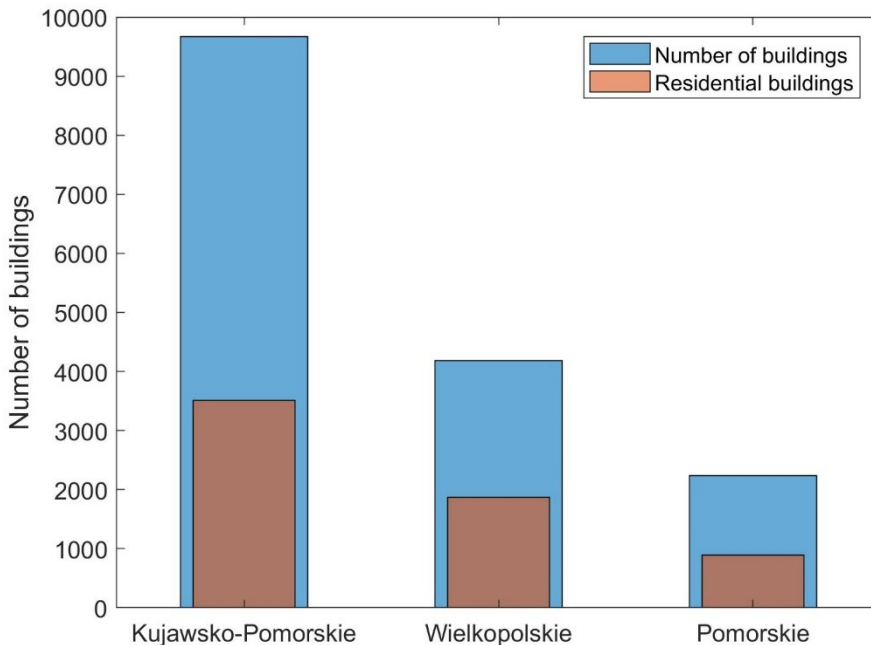
Table 3 shows that the majority of damage to buildings was in Kujawsko – Pomorskie, less in Wielkopolskie, and the least in Pomorskie province. This is shown in Fig. 8.

Fig. 8. Histogram of damage to buildings in in three provinces: Wielkopolskie, Kujawsko-Pomorskie, and Pomorskie.

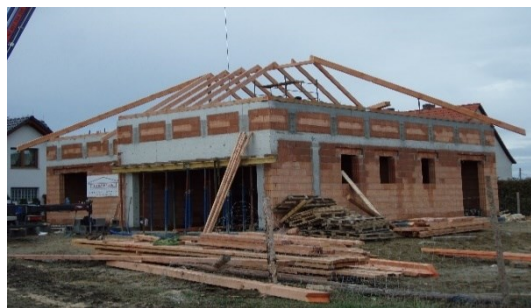
Fig. 9. An example of a residential building with improved stiffness, i.e. with two concrete rim and selected concrete columns.

The authors of the paper [5] with co-author of this paper have proposed three pieces of advice on how to construct low-rise buildings to be resistant for tornadoes. They may be recommended to any extreme wind. They are as follows:

- a) to increase the stiffness of a part of all residential building against drag and uplift wind forces,
- b) a stronger anchorage of roof elements down to the top of the building walls,
- c) to apply stronger connections between construction elements.

Recently many people have been convinced to apply these proposals. Several victims of the described extreme weather event on August 11-12, 2017, whose buildings were totally damaged, applied above suggestions for rebuilding their residential, farm, and utility buildings as shown in Fig. 9.
