Analysis of Exploitation Damages of the Frame Scaffolding

Abstract. The analyzes and classifications presented in the article were based on the research carried out in the years 2016 to 2018 on a group of over one hundred scaffoldings assembled and used on construction sites in different parts of Poland. During scaffolding selection process efforts were made to maintain diversification in terms of parameters such as scaffolding size, investment size, type of investment, location and nature of conducted works. This resulted in the research being carried out on scaffoldings used for church renovation in a small town or attached to the facades of classic apartment blocks, as well as on scaffoldings used during construction of skyscrapers or facilities of the largest power plants. This variety allows to formulate general conclusions about the technical condition of used frame scaffoldings. Exploitation damages of the frame scaffolding elements were divided into three groups. The first group includes damages to the main structural components, which reduce the strength of the scaffolding elements and hence the whole structure. The qualitative analysis of these damages was made based on

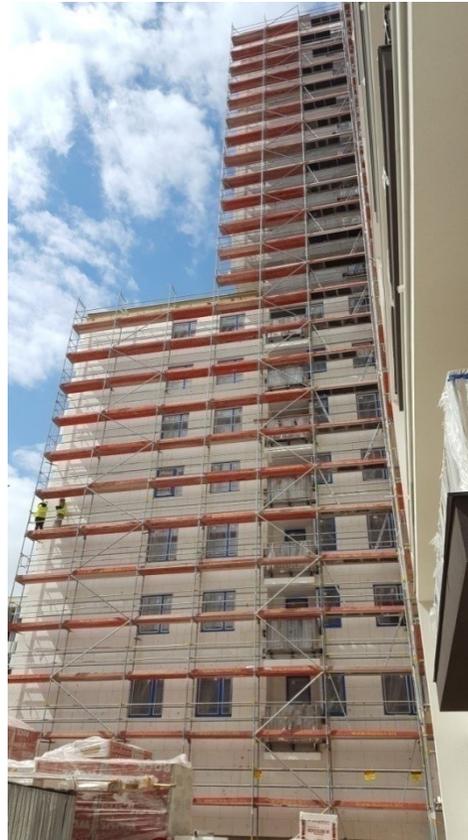
Of all types of scaffoldings, one can identify those that play a leading role. In Poland, such are certainly frame scaffoldings that owe their popularity and widespread use to simplicity and speed of assembly and other economic factors. Fig. 1 shows an exemplary structure made of elements of a scaffolding framework system in a classic application, i.e. used as working scaffolding during the finishing of the outer facade of a residential building.

Fig. 1. Frame scaffolding.

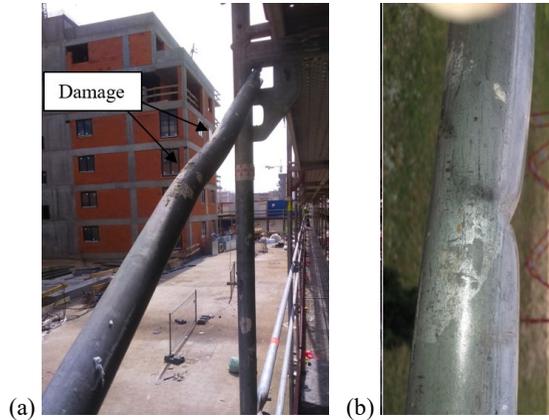
The damage to the frame standards in the form of deformation of the pipe cross-section as a result of dynamic external action (point indentation) shown in Fig. 4 (a) was included in the first discussed group. Another damage of this type is the curvature of the pipe axis which is shown in Fig. 4 (b). It is worth mention that if the first type of damage occurs far from the nodal point then the second type occurs simultaneously. A similar phenomenon is described in [5]. In this situation, the adverse effects affecting the load-bearing capacity of the structure are reinforced. Another basic element in which damage can be extremely dangerous is vertical bracing. Vertical braces are made of smooth pipes and between the various systems differ only in the shape and type of mountings located at their ends. The defects classified in the first group identified in bracings are in most cases identical to those observed on the frame standards. Mainly we deal with the deflection of the axis of the bracing tube as well as with spot deformations. Frame standards have a fixed length of 2 m. The connections in the frame between vertical and horizontal elements are very often shaped with use of large gusset plates, which reduces the buckling length. In contrast, bracing pipes in the most commonly used modules typically have a length of approx. 3.5 m and are not reinforced in any way. Moreover, in many systems, the bracings are made of pipes of smaller diameter than the frames standards. All this causes that these elements are slenderer and more due to it are much more exposed to mechanical damage, e.g. during transport. Fig. 5 (a) shows the bracing at which two bends in one plane are seen in two opposite directions.

This is most likely caused by an attempt to “straighten” the element which had a very large damage obstructing assembly.

Fig. 5. Damage of vertical bracing: (a) deflection of pipe axis, (b) point indentation.

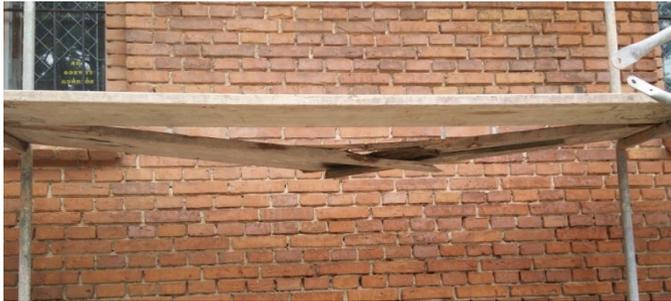
Fig. 9. Broken timber deck.

During the tests, aside from the elements with damage, broken decks such as the timber one shown in Fig. 9 were found. Such a failure unfortunately is very difficult to remove because a bridge from the central scaffolding field cannot be easily removed and replaced. For this purpose, it would be necessary to dismantle all the frames above this platform, which in the case of the scaffolding with the damaged deck shown here meant that it would be necessary to dismantle almost the whole scaffolding. In such a situation, it is most often possible to exclude the danger zone from the use if it is possible. In practice, unfortunately, it turned out that in this case, it was limited to drawing the attention of employees to this place. Damage to timber decks resulting in such events is mainly caused by timber corrosion, for example shown in Fig 10 (b) and splitting of glued timber Fig. 10 (a).

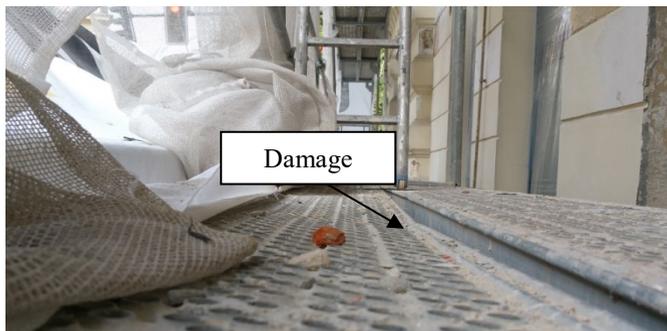
Fig. 11. Damaged steel deck.

In the case of steel decks, a very large number of permanent plastic strains was observed causing deflections along and across the bridge. Such were the ones shown in Fig. 11, most likely due to the fall of a large mass from a height. However, in the case of these bridges, damages in the area where the platform is attached to the frame appear much more dangerous. In particular, damages such as weld crack shown in Fig 12, and deformations of the elements causing the disconnection of the elements.

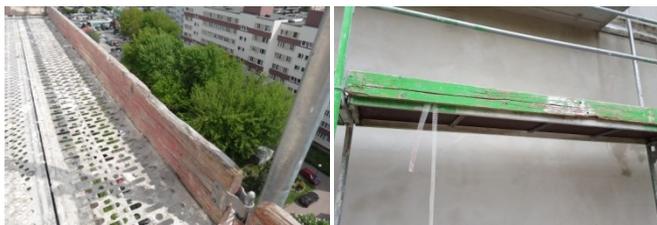
Fig. 15. Damage of toe boards.

Such defects certainly include damages on the edges and longitudinal cracks in safety toe boards (Fig 15). These elements prevent falling of tools or materials left at the edge of the platforms. They do not carry almost any loads. Therefore, the occurrence of these defects even in all elements does not reduce their performance values. However, these are quite large elements, which is why their poor condition may lead to an unjustified understated assessment of the technical condition of the entire structure.

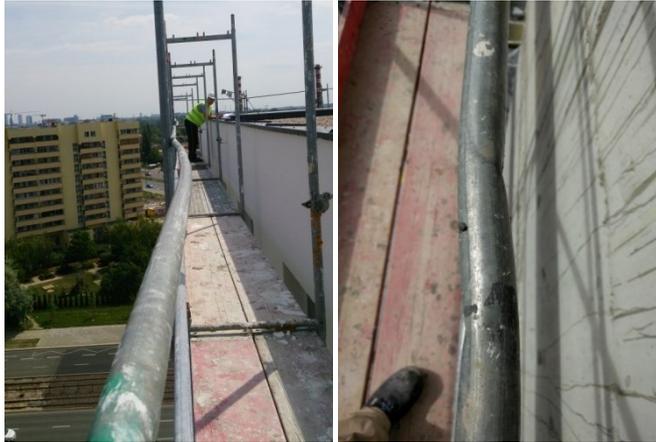
Fig. 16. Handrails damage.

Like in the case of toe boards, a large amount of damage in the handrails may give the impression of poor technical condition of the scaffolding, more so that here we deal here with steel elements that are considered to be much more durable than timber ones. During the inventory, a very large number of damages in these elements were found, consisting mainly in bending (deflection of the pipe axis) and indentation (point deformation) shown in Fig. 16. In many cases, there were several such damages on one element. Nevertheless, if the handrail is properly fixed, damage of this type does not affect its performance. The last damage included in this group is surface corrosion with a small coverage. Corrosion was already included in the first group, but only in main structural elements that during usage have a high degree of cross-section effort. An example of corrosion which does not affect the scaffolding capacity and safety of use is shown in Fig. 17 (a) and (b) where surface corrosion with very small extent occurs on the horizontal element of the front frame and the fixing bolt of the handrail. However, as previously stated, corrosion is a progressive phenomenon and over time these damages can turn into a dangerous hazard, especially in the case of a handrail fixing.
