Causes of hot and cold water system failure

Abstract. The paper presents causes of the failures of hot and cold water systems. Most often they occur in the case of installations built with metal pipes and result from the use of improper materials and the adoption of wrong solutions. Failures are caused by chemical and electrochemical corrosion resulting from design and manufacturing errors. Further on, the corrosion process is briefly described. The most common causes of corrosion of hot water installations are discussed and examples of them are presented. On the basis of observations it can be stated that despite the knowledge about corrosion of hot and cold water installations, some of the them are improperly designed and constructed and exhibit high failure rates. The summary discusses the most common errors for different installation solutions.

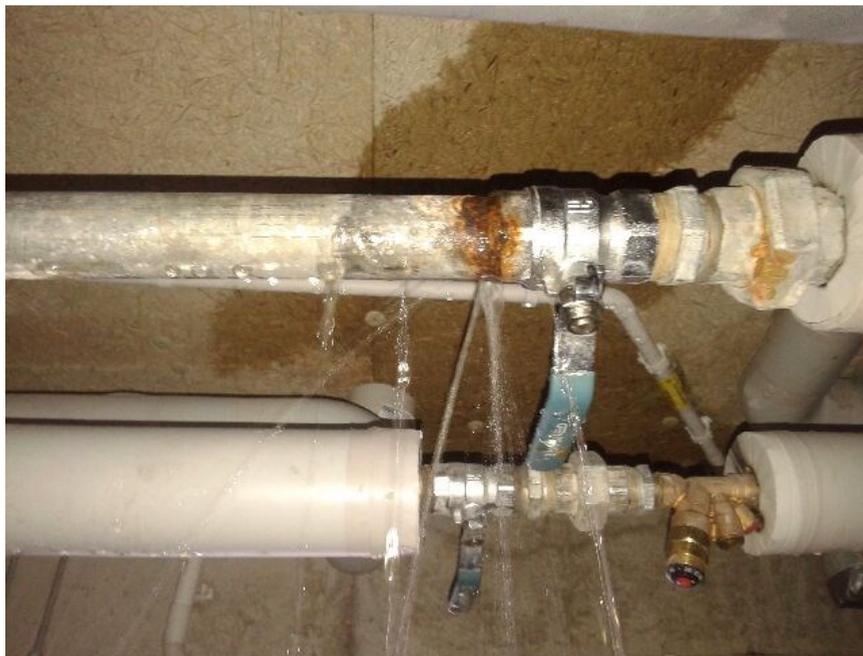
The cold and hot water systems failures, resulting in more or less intense water leaks are common for all buildings in use. Most often the leakage in the installation are not dangerous for people, but can be a nuisance especially when repairs require total or partial shutting off water in the facility. At the same time, they can cause significant damages. An example of a typical water leakage is shown in Figure 1.

Fig. 1. Water leakage in a hot water system.

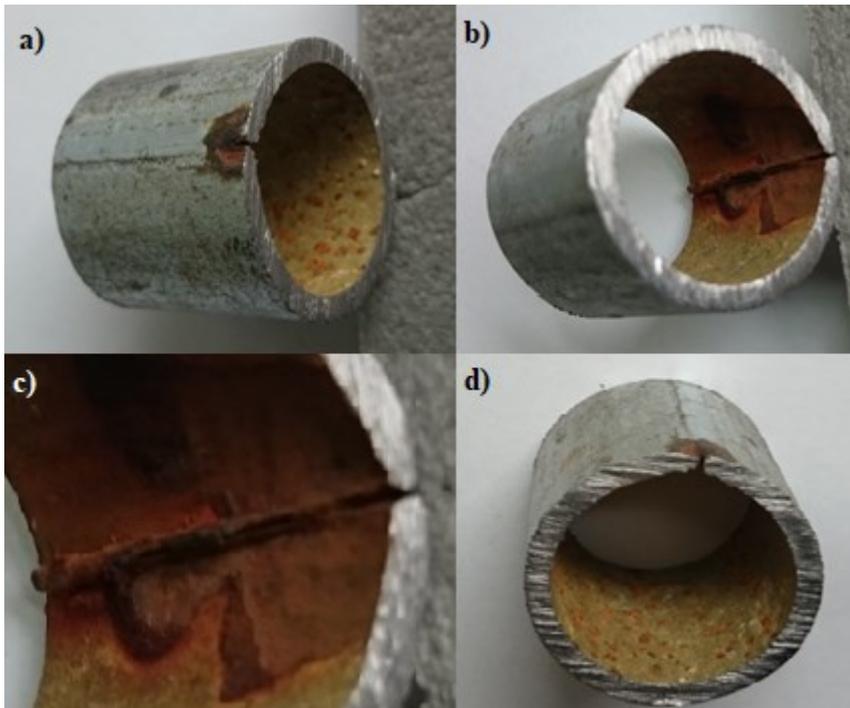
Cold and hot water systems used to be made of galvanized steel pipes with thick zinc layer. The frequent occurrence of plastic pipes in water systems allow to reduce the leakage caused by material defects. The author has several years of evidence of improper quality of galvanized steel pipes. An exemplary cross-section of a pipe of improper quality, found at the place of leakage, is shown in Figure 1.

Fig. 2. Cross-section of improperly welded pipe a) view from the outside b) from the inside, c) close up, d) from the front.

In the analysed case, the leakages started to occur frequently after four years of operation. Leaks occurred on the pipe weld. The cross-sections show that there is a point and sectional lack of weld due to lack of material in the leakage areas. As it was concluded above, it is most likely that in the places where the leaks occur there was metallurgical scale, in the initial period it sealed the pipe. During operation, flowing water caused its leaching and after some time leaks started to appear in places where scale was present.

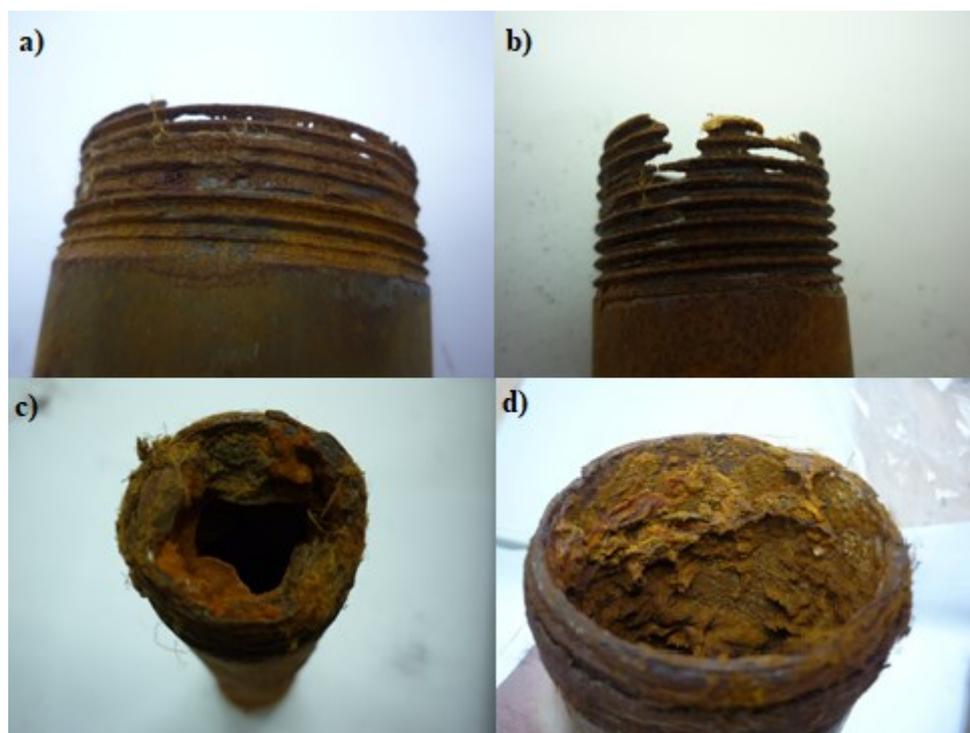
The hot water systems for preparation and distribution of tap water are primarily susceptible to corrosion. Particularly due to various interactions and corrosion deposition that is insoluble in water. The corrosion intensity in those systems is hard to evaluate. Different pipe damages caused by corrosion and corrosion deposition are shown in Figure 2. Probable cause lies in the temperature of water that results in the production of zinc oxide residue. The oxide acts as an anode, while under the elevated temperatures inverts the polarity towards iron, causing extensive corrosive damages.

Fig. 3. Corroded hot water system pipes a), b) corroded pipe ruffling, c), d) corrosion deposition on the inner surface.

People needs regarding quality and comfort of using hot water systems increase periodically. For proper durability of hot water systems, they should operate on 45 to 50°C water. Such temperatures are suitable for showers and baths. For all modern laundry detergents, high water temperature is also unnecessary. The extend of the corrosion increases with temperature in all hot water systems.

The regulations [3] require that the temperature of hot water at the point of consumption is not less than 55°C and not more than 60°C. The process of corrosion is relatively slow at 45-50°C, whereas it has been observed that the rate of corrosion increases drastically between 60 to 65°C. When the temperature is further increased to 70°C and above, additional complex

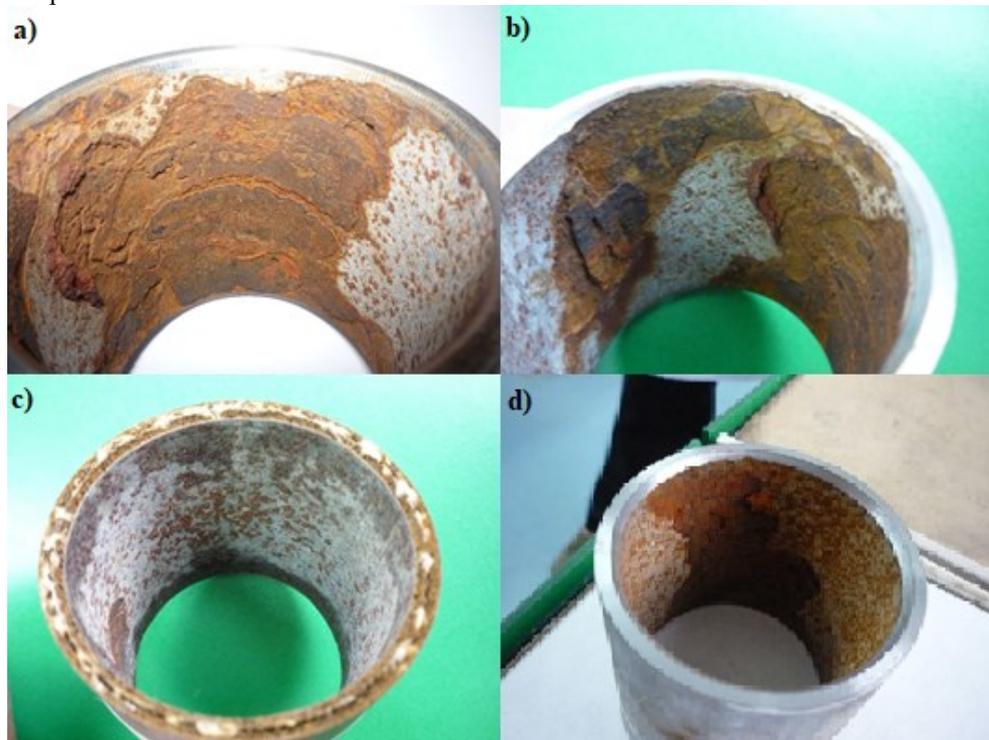
Raising the temperature to 70°C results in an predictable increase in the intensity of corrosion in iron and copper pipes. However, for galvanized steel pipes and tanks things are different and less unequivocal. The behaviour of galvanized iron at these temperatures depends on the type of water. In the literature much is written about the change in the potential of zinc at temperatures from 60°C to 70°C. This phenomenon is treated as the main cause of increased corrosion. However, the change of the zinc potential can only take place in the presence of iron, i.e. only after the damage of the zinc coating. It should be added that zinc at higher water temperatures, especially in the range of 60 to 70°C corrodes much faster than at lower temperatures. This is due to the fact that the oxide deposits formed at lower temperatures are compact and protect the zinc against further corrosion, while at higher temperatures they have a loose structure and are washed out by water [4]. The progress of dissolving the zinc layer inside the pipes that takes place during the operation of the hot water installation was determined. Figure 3 shows the condition of zinc on pipes after nine years of operation.

Fig. 4. Condition of zinc coating and pipe inside pipes after eight years of operation a) surface corrosion of the pipe - deep corrosion, b) surface corrosion of the pipe - deep corrosion, c) several small corrosion centres d) surface corrosion of the pipe - shallow corrosion.

Based on the presented photos, it can be noticed that the zinc coating defects can either be on a surface as a whole or have several centres. In accordance with PN-EN 10240: 2001 pt. "Internal and/or external protective coatings for steel tubes - Requirements for hot dip galvanizing coatings in automated galvanizing plants"[5] for pipes with water intended for human consumption, the thickness of the zinc layer on the inner surface of the pipe should be at least 55 µm. Following condition is certainly not met by the presented pipe sections.

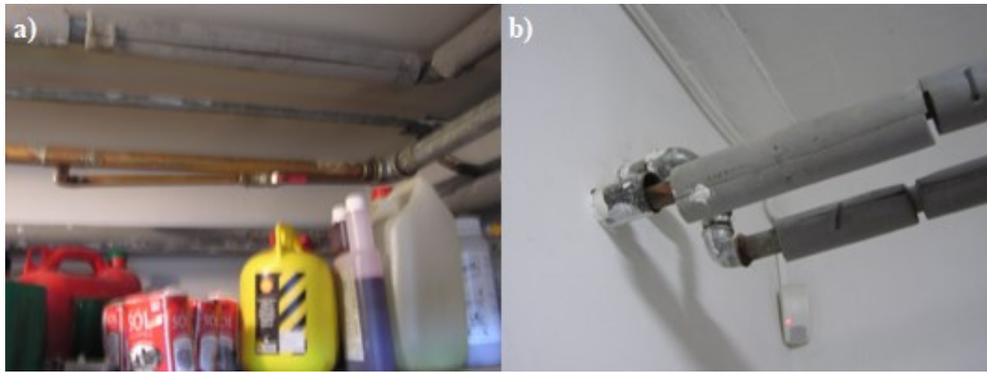
A different problem occurs in systems which combine copper, steel, galvanized steel (or aluminum). As a result of direct interaction of these metals, electrochemical centres are formed and cause a rapid dissolvment of iron and zinc. This phenomenon is prevented by the use of insulating spacers between different metal sections. Iron and zinc corrosion also occurs when copper ions are present in the water (derived from the corrosion of copper sections). The ions stick to the surfaces of these metals causing an intense corrosion build-up. Therefore, steel and copper pipes must not be connected in closed water circuits (circulatory) of domestic hot water systems. Hot water plate heat exchangers soldered with copper [8] should not be used either. Interaction of those metals in an operating hot water system requires a proper section order. The copper sections must always be installed behind the steel sections according to the direction of water flow [9].

In some cases the corrosion products of steel pipes may break away from their surface and mechanically damage the copper oxide layer protecting it against corrosion, increasing the corrosion rate. For this reason, it is preferable to use a single metal installation, which protects it against corrosion in the most effective way.

Figure 5 shows fragments of the installation in which corroded fragments of galvanized steel pipes were replaced with copper pipes causing further corrosion.

Fig. 5. Replacement of corroded steel pipes with copper pipes.
