Instant performance verification after electrochemical chloride extraction by enhanced corrosion testing

Ulrich Schneck^{1,*}

¹CITec Concrete Improvement Technologies GmbH, 01156 Dresden, Germany

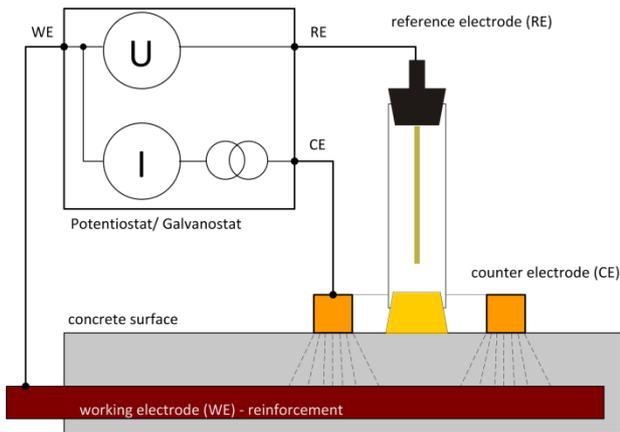
Fig. 1. Corrosion measurement setup with a potentiostat

For the enhanced electrochemical measurements a potentiostat/ galvanostat is needed, which is a standard testing device in electrochemistry [1]. In addition to the voltmeter and the reference electrode which are used for potential measurements on the reinforcement, it has a current source and a counter electrode for triggering changes to the working electrode/ reinforcement (fig. 1). The following electrochemical test methods have been applied at different stages of the ECE:

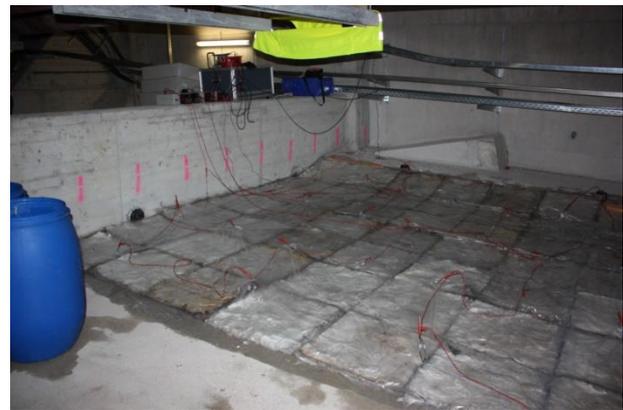
Fig. 2. ECE electrode layout on the box girder floor slab

Hollow box girder floor slab: This is a typical, very beneficial application field for ECE, as chloride has penetrated into the mainly dry concrete of the floor slab from leaking drainage pipes that are meant to remove surface water from the bridge deck. Along with the repair of the drainage system, ECE can remove the chloride smoothly and without restricting the use of the bridge. Multi-stage applications, which might be necessary in case of deep chloride ingress and low concrete cover, usually do not cause technological or administrative conflicts. With the eliminated origin of chloride ingress, the corrosion protection in a floor slab can be restored by ECE durably, and no other, long-term or additional steps are required.

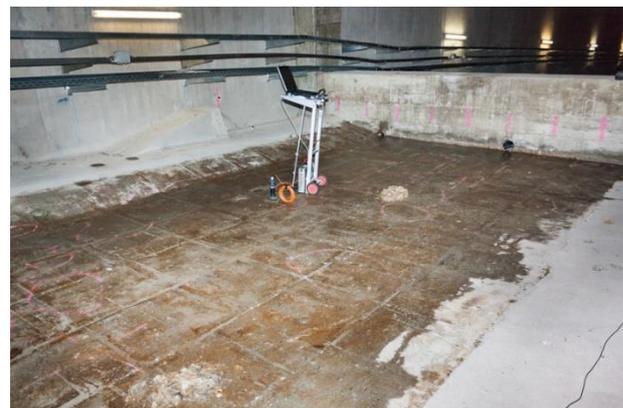
Fig. 3. Floor slab area after removing the ECE electrodes and while running the first corrosion measurements

All test locations have been surveyed with dust sampling, OCP and impedance measurements, GPM, LPR and TPM before ECE, directly after removing the electrodes and 3 months later. As can be seen in table 1, the chloride values in the rebar vicinity did not get reduced dramatically during the one-stage, 7-week application, but a very high amount of chloride has been analysed from the re-usable electrodes – ca. 100 g/m². The data obtained from the one test location in a delaminated area (yellow marked) did not deviate much from the other 3 locations, so the ECE seems to have worked there in a similar performance than on the other, undamaged areas.

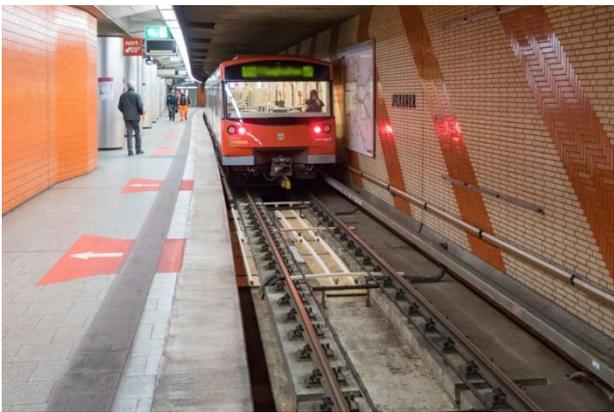
Fig. 4. ECE in the track bed of a subway under traffic

Track bed of a subway: In a subway station considerable amounts of chloride and rebars showing pitting corrosion have been found in the track bed area. The source of the chlorides remained unclear; one assumption was that it came from acidic cleaning agents which had been used over many years on the tiles of the adjacent wall.

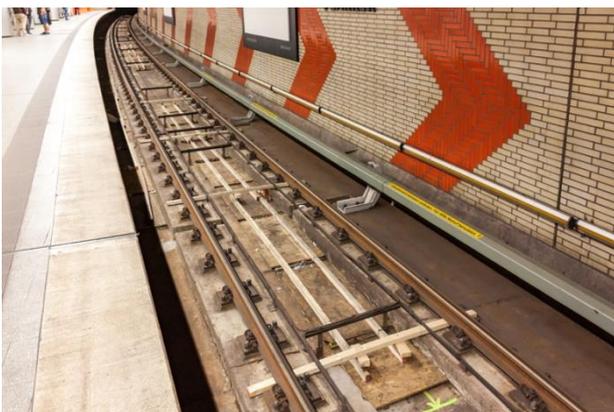
Fig. 5. View of the ECE electrodes and their fixing to the rails

After a corrosion diagnosis and extensive testing of the ECE equipment for its feasibility under these special circumstances (no influence of the running equipment on the automated train control, and that the electrodes and cables remain safely in their position also at full speed of passing trains), the application was run as designed in up to 3 stages of 6 weeks each per sub-area and intermissions of also 6 weeks between the applications.

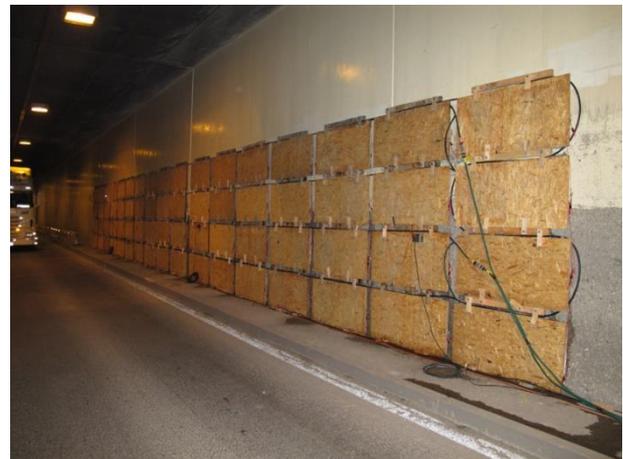
Fig. 6. ECE electrodes on the tunnel wall

Wall section of a highway tunnel: It was a special issue of this ECE application that it ran as part of a major repair project in the tunnel. This way, there was a strict schedule limiting the time of application and the accessibility of the wall section during the application. Furthermore, the power supply of the ECE was connected to the temporary power supply of the construction site, which caused frequent shut-downs during the first of two parts/ areas and required many site visits to replace fuses and to reboot the process. During the second part, high-capacity UPS devices were added that could filter voltage peaks and compensate short power interruptions even for the DC power supplies. In the first part, only 3.5 of possible 6.5 weeks operation time could be achieved, but in the second part the ECE worked during the available 6.5 weeks without interruptions.

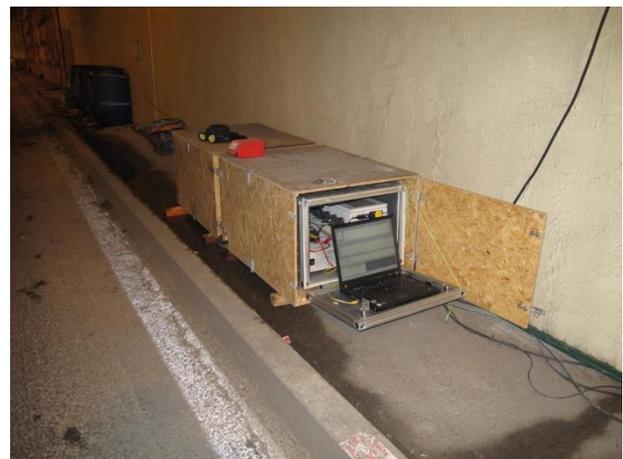
Fig. 7. ECE control centre and power supply

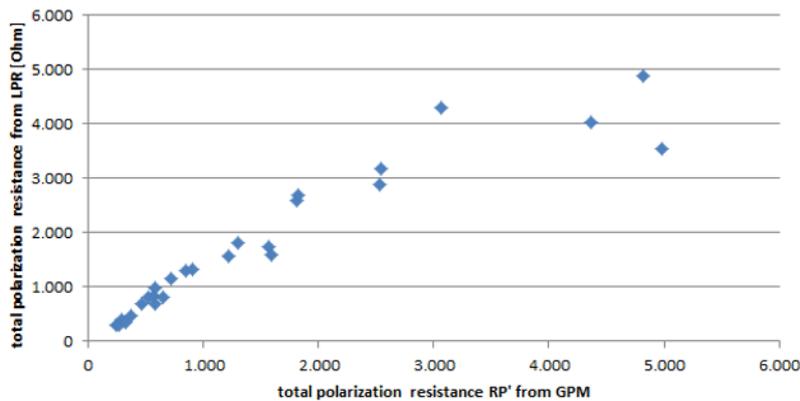
Fig. 8. Total polarization resistances R_p' from LPR versus R_p' from GPM

Generally, the data obtained from the enhanced corrosion measurements appear to be plausible and fit into expected schemes: $R_p' > LPR \geq R_p'$, GPM, as fig 8 shows (at least in the interesting range of resistances up to 3,000 Ohm). The I_{corr} values fit quite well in an exponential relationship with the R_B values from AC impedance and the R_p values from GPM (figs 9 and 10).

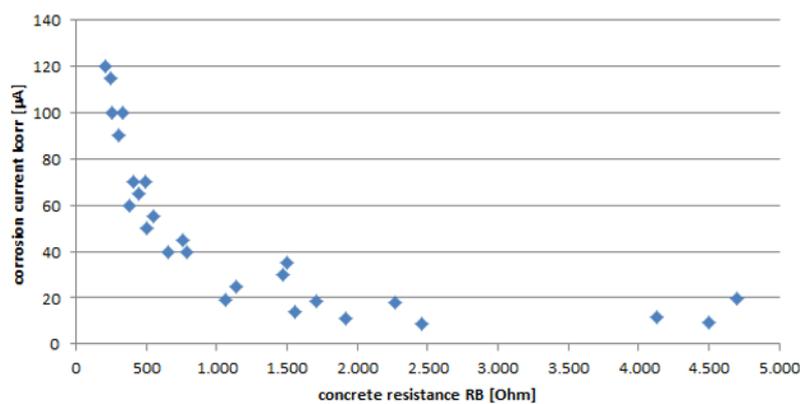
Fig. 9. Corrosion currents I_{corr} versus electrolyte resistances R_B

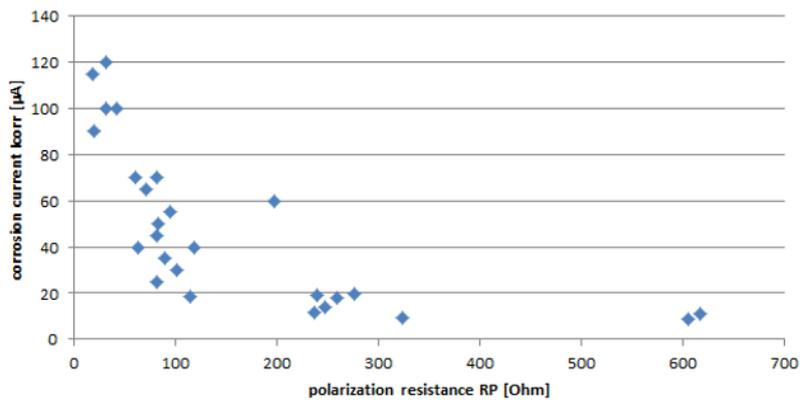
Fig. 10. Corrosion currents I_{corr} versus polarization resistances R_p

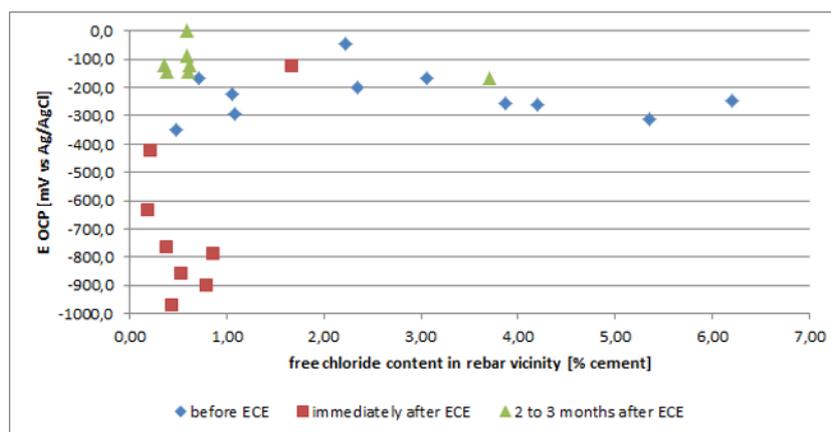
Fig. 11. Open circuit potentials versus chloride content in rebar vicinity at different stages of ECE

It should be mentioned that these data have been taken on very different structures at different stages of the ECE, which were tested under widely varying conditions. In another relation, the electrochemical data are displayed versus the respective chloride content in rebar vicinity (figs 11 to 13).

In fig 11 it can be seen that due to the partly intensive wetting and strong cathodic polarization, extremely negative potentials were measured. Apparently these influences did not affect the other measurements (AC impedance, GPM, LPR, TPM), which is an indicator for the feasibility of these measurements under conditions that won't allow a useful interpretation of potential measurement data or where varying moisture conditions make the potential assessment very difficult.

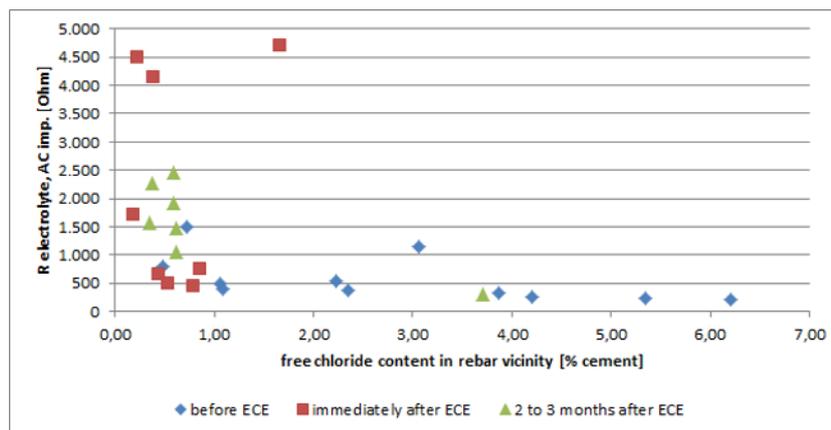
Fig. 12. Electrolyte resistances versus chloride content in rebar vicinity at different stages of ECE

The fit of the R_B and R_p data over the chloride values is not that excellent as over the I_{corr} values, very likely because the dust sampling has a larger "spread by coincidence" and does not match exactly to the test location of the measurement cell.

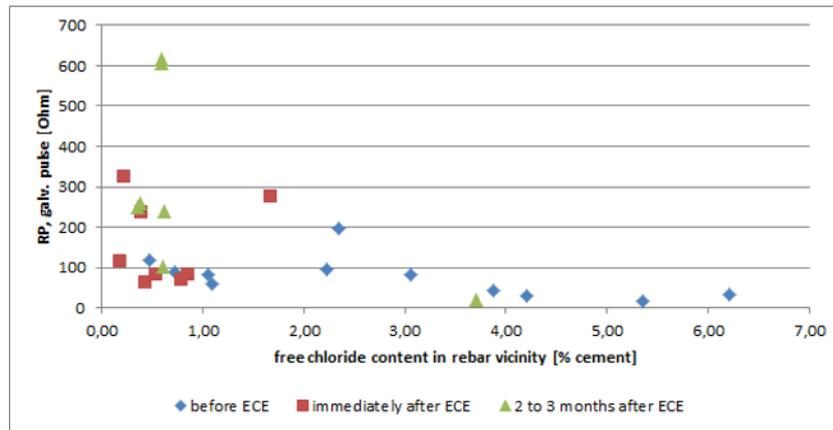
Fig. 13. Polarization resistances versus chloride content in rebar vicinity at different stages of ECE

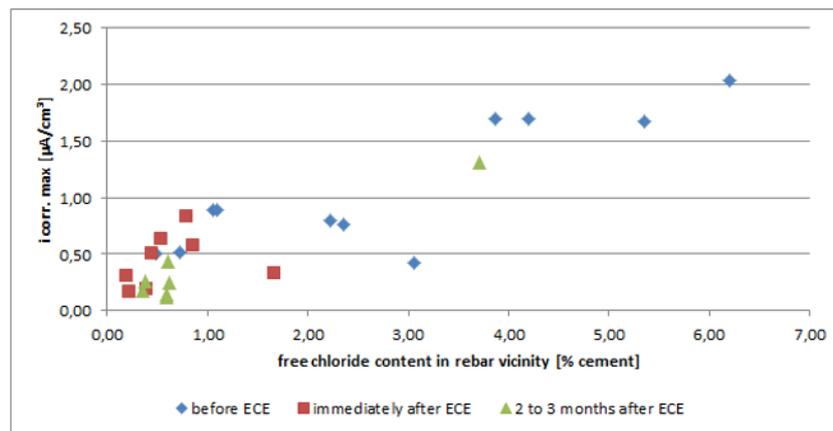
Fig. 14. Assumed maximum corrosion rates versus chloride content in rebar vicinity at different stages of ECE

Figs 14 and 15 show the dependency of the assumed corrosion rates on the chloride contents, and this refers to the conversion of the obtained, absolute I_{corr} values into specific corrosion rates according to the remarks made in the introduction of the TPM. One has to be aware of the uncertainties of that step, but with the suggested corridor between estimated minimum and maximum rebar areas the true corrosion rate should be covered reasonably.

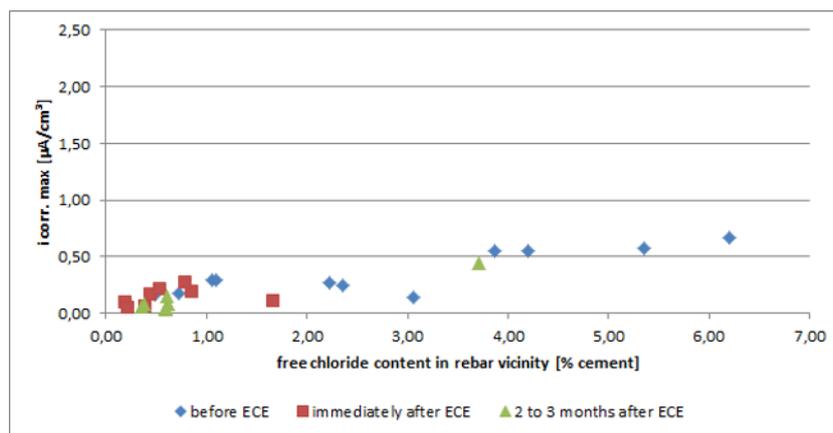
Fig. 15. Assumed minimum corrosion rates versus chloride content in rebar vicinity at different stages of ECE

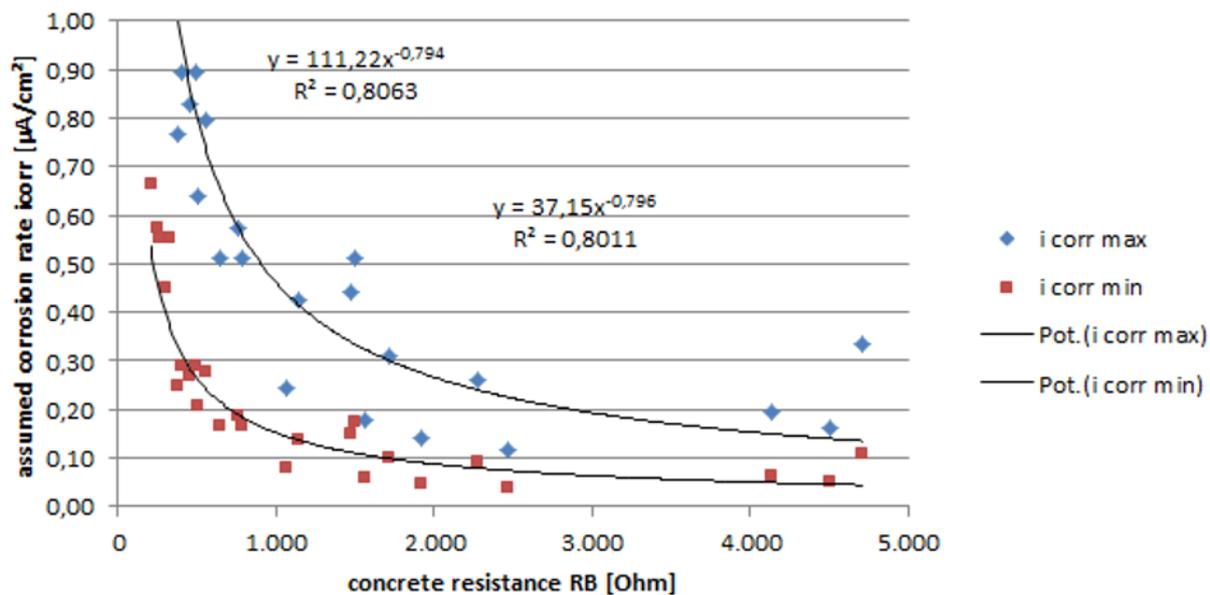
Fig. 16. Regression curves of the assumed maximum and minimum corrosion rates versus the concrete resistances

In figs 16 and 17, the minimum and maximum i_{corr} values are displayed against the respective R_B and R_P values. The 4 regression lines have a good fit to the data points ($R^2 > 0.8$), so it is possible to extract some limit values for R_B and R_P that may characterize passive behaviour. As passive corrosion rates, 0.1 or $0.2 \mu A/cm^2$ are commonly considered. In [7] these two values are assigned to the type of measurement cell; without a guard ring $0.2 \mu A/cm^2$ is suggested, which has been the case for the measurements discussed here. Table 2 summarizes the results:

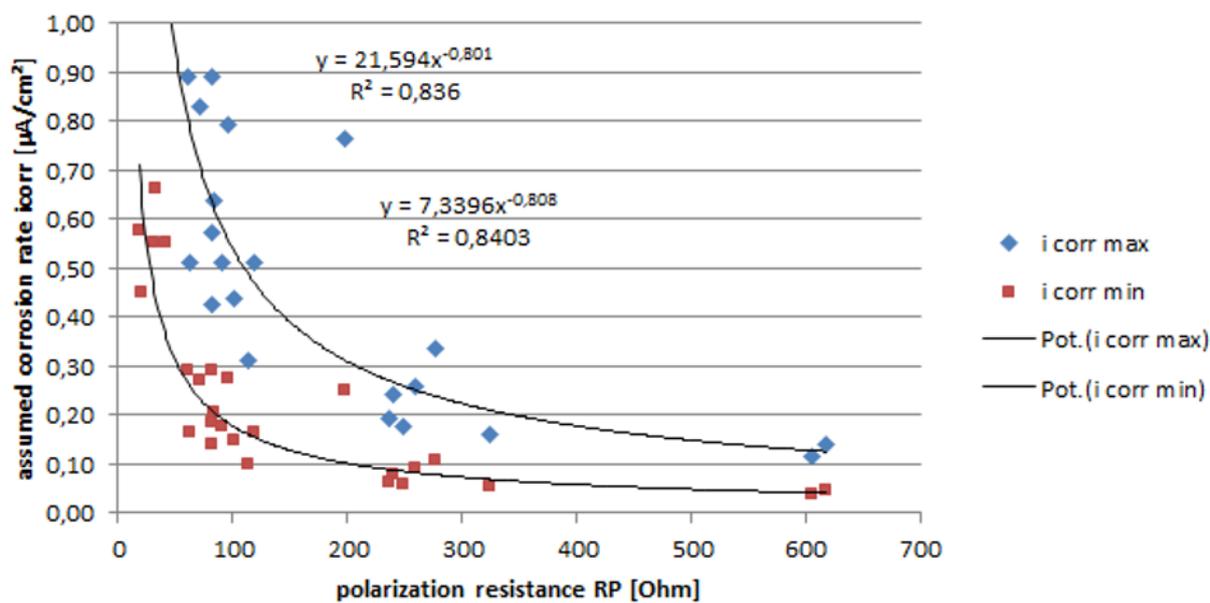
Fig. 17. Regression curves of the assumed maximum and minimum corrosion rates versus the polarization resistances
