Reinforced concrete corrosion prevention/reduction by hydrophobic impregnation

Michel Donadio¹, Mirdash Bakalli², Zeno Dan³

¹Sika Services AG, Switzerland

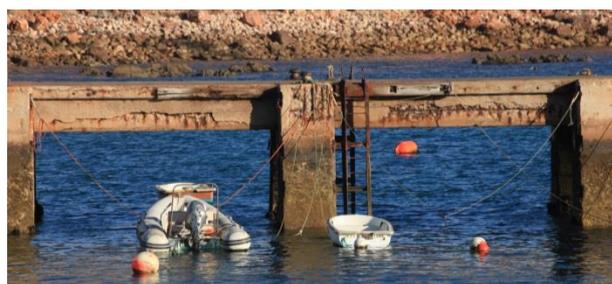
Fig. 1: Example of corrosion of reinforced concrete.

The steel reinforcement in concrete starts to corrode in the presence of moisture when the passive layer formed by the surrounding highly alkaline concrete matrix has broken down due to carbonation, or the presence of chlorides.

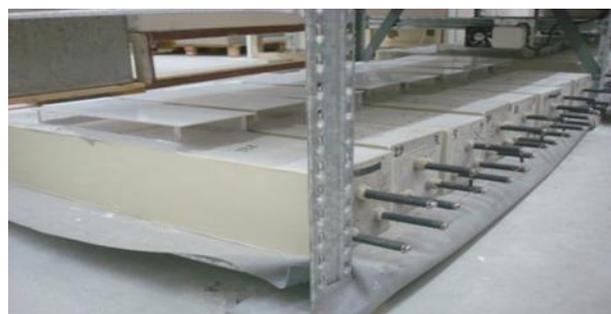
Fig. 1: Prepared concrete beams for corrosion testing.

The test specimens produced are concrete beams with dimensions 150 x 150 x 750 mm (6 x 6 x 30 in), each with three of the 12 mm diameter mild steel rebars

embedded. Two rebars are placed 38 mm (1.5 in) from the bottom of the beams, the third 43 mm (1.7 in) below the top surface of the beams.

After curing the specimens in a humidity chamber for 28 days, followed by storage for a month at approximately 23°C, a 5 mm (0.2 in) deep and 3 mm (0.1 in) wide notch was sawn into the top surface of the beams. The resulting concrete cover, measured below this cut notch, was 38 mm (1.5 in).

The sides and the bottom of the beams were painted with two coats of a 100% epoxy resin coating in order to prevent / limit water evaporation, as well as to prevent contamination from spills of the chloride solution during cyclic ponding.

The bottom rebars were permanently connected to each other with 1.0 mm diameter copper wire, and the top rebars were electrically short-circuited using a 10-ohm resistor soldered onto the copper wire.

A Plexiglas dyke, 305 mm long, 114 mm wide and 51 mm deep, was attached to the top surface of the cracked beams and sealed with an elastic polyurethane sealant. The dyke was used to expose the beams to a 3.0% (5.0%) by mass solution of sodium chloride using a 2-week wet, 2-week dry ponding cycle procedure. During the wet cycle, the dyke was filled to within 20 mm off the top with sodium chloride solution. The dyke was also covered with a plastic plate in order to avoid/limit water evaporation.

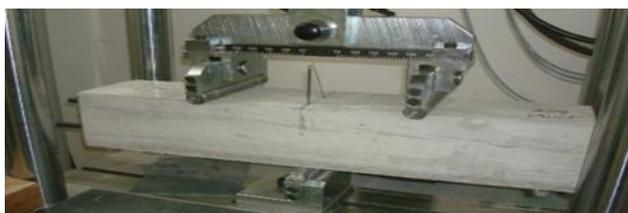
Fig. 2: Forced cracking.

Each beam was carefully cracked along the cut notch using flexural load bearing techniques, so that the crack extended down to the top rebar. Whilst under the cracking load, the crack was shimmed to a consistent crack size to be used throughout the whole corrosion test. For this purpose three to four 0.25 mm (0.01 in) thick stainless steel shims were inserted into the crack at intervals to hold it open once the load was released.

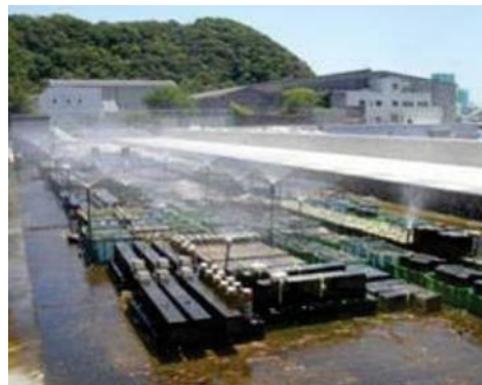
Fig. 3: Test site for salt spray exposure testing at the Kagoshima University in Japan.

All of the specimens with the surface impregnated materials were exposed to simulated splash zone conditions using the salt water shower. This test facility is located in the Kurihama bay area (Yokosuka, Kanagawa prefecture, Japan) and has artificially repeated dry and wet cycles, that is, salt water shower for about four hours and then natural drying in the air for eight hours in each cycle (Fig. 3). One day consisted of two cycles and the total exposure time was 10 years.

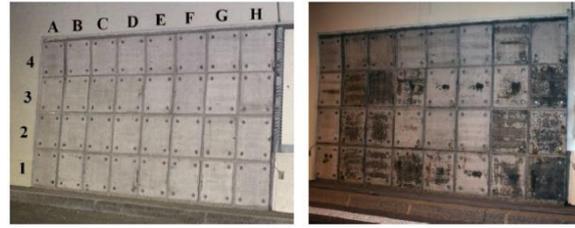
Fig. 4: Visual state of the concrete test panels in the Naxberg tunnel in the year 2000 (left) and 2012 (right).

The Naxberg tunnel is located on the Swiss A2 motorway, close to the Gotthard tunnel and at around 1000 m altitude. As a part of scheduled tunnel restoration work at the end of the 1990's, the opportunity was provided to place a concrete test panel in the tunnel wall at a distance of 50m from the north-facing tunnel entrance (Fig. 4). The panel consisted of 32 concrete plate specimens, each with the dimensions of 600 x 500 x 100 mm.

The author of this study concludes that it is clearly of benefit to protect such exposed reinforced concrete structures with this type of hydrophobic impregnations: “After 12 years of exposure only the plates that contained stainless steel rebar or were hydrophobically treated showed no rust spots on the surface”.

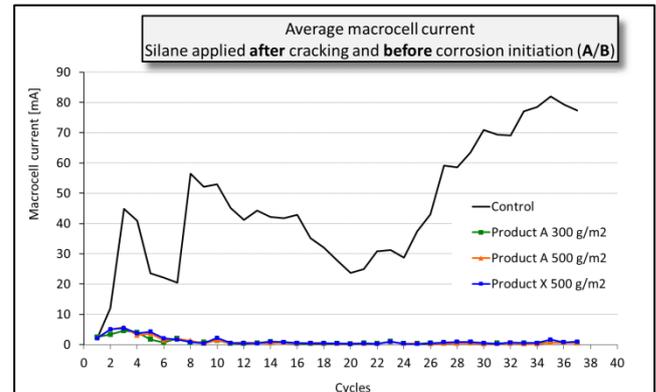
Fig. 5: Macrocell measurements – Silane applied after cracking & before corrosion initiation

Figure 5 clearly shows that the hydrophobic impregnation provides the best increase in protection when applied after the cracks have already formed.

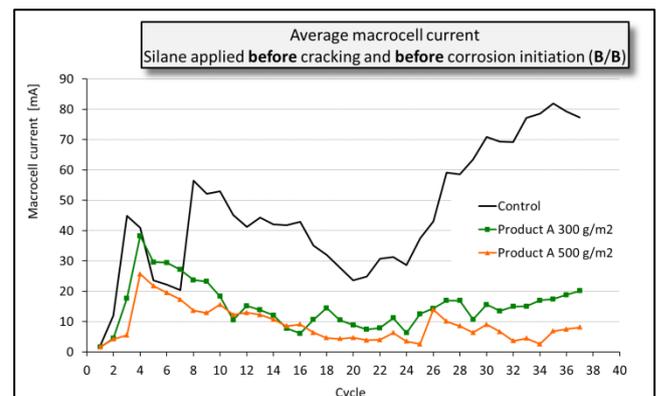
Fig. 6: Macrocell measurements – Silane applied before cracking & before corrosion initiation

When the cracks happen after application of the treatment (refer to figure 6), we can also see the importance of the materials consumption (closely related to their penetration depth) in the level of protection.

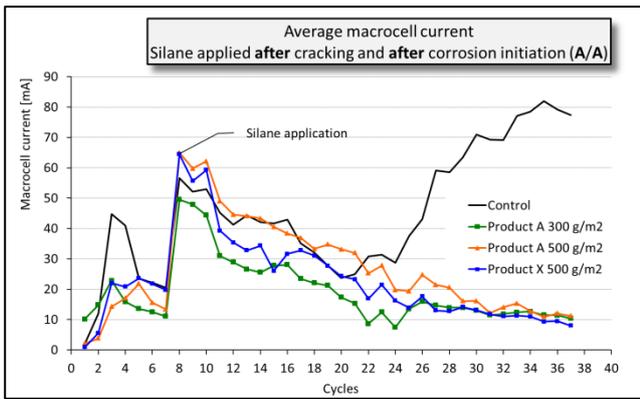
Fig. 7: Macrocell measurements – Silane applied after cracking & after corrosion initiation

Also when the treatment is carried out once corrosion is already advanced, we can also see a positive effect from the relative drying-out of the specimens on reducing corrosion activities – this is further confirmed by independent tests carried out by ZAG (Slovenian National Building & Civil Engineering Institute) [11].

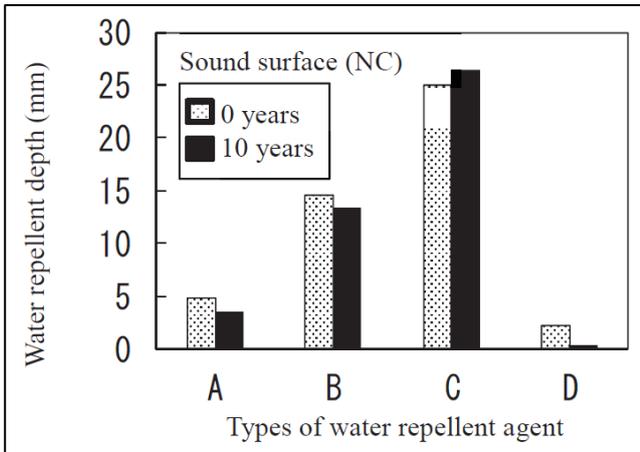
Fig. 8: Penetration depth of hydrophobic specimens at the start and at the end of the study

However, from the type of product selected and the penetration levels achieved (refer to fig 8), it clearly shows that to obtain efficient protection against corrosion, even in the presence of cracks, high performance, deeply penetrating products such as the cream (B) and gel (C) will provide significant protection. This 10 years study also shows the limited efficiency of silicate based products (E & F) in arresting the corrosion.

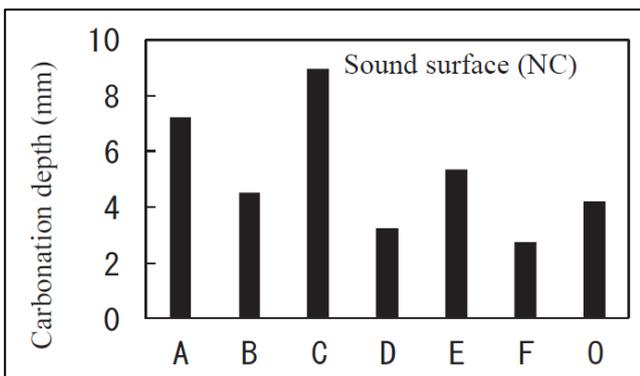
Fig. 9: Carbonation depth of treated specimens versus control (O) on non cracked concrete surfaces.

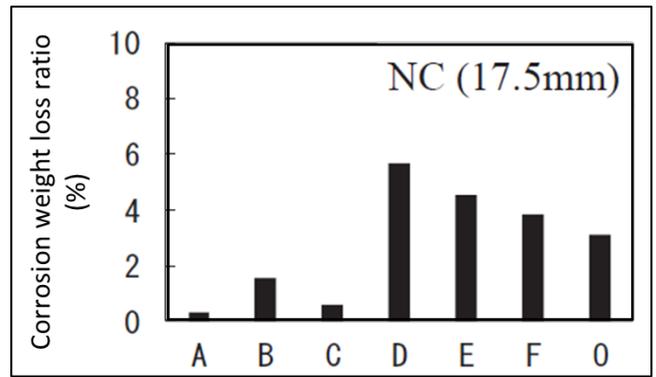
Fig. 10: Corrosion levels with low concrete cover on non-cracked surfaces.

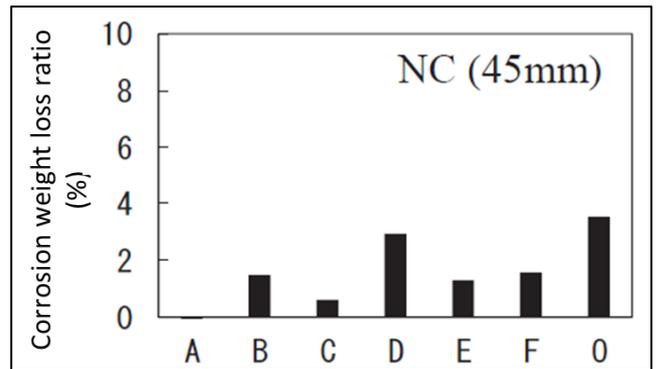
Fig. 11: Corrosion levels of normal concrete cover on non-cracked surfaces.

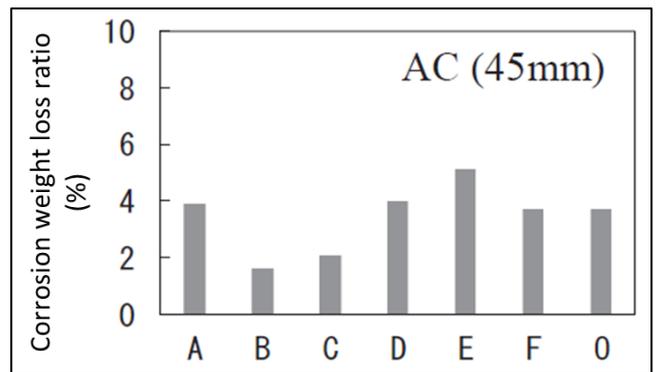
Fig. 12: Corrosion levels of normal concrete cover on cracked surfaces – surface treatment carried out AFTER cracking

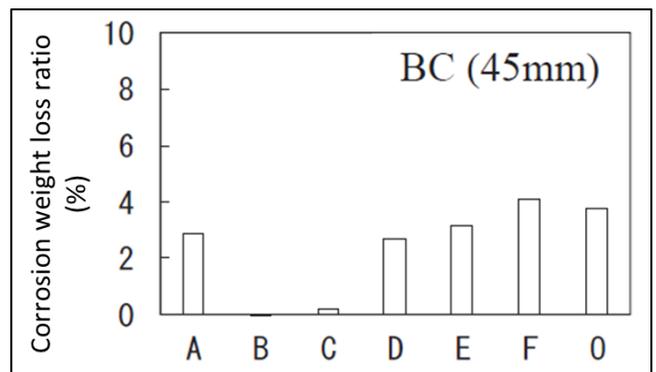
Fig. 13: Corrosion levels of normal concrete cover on cracked surfaces – surface treatment carried out BEFORE cracking

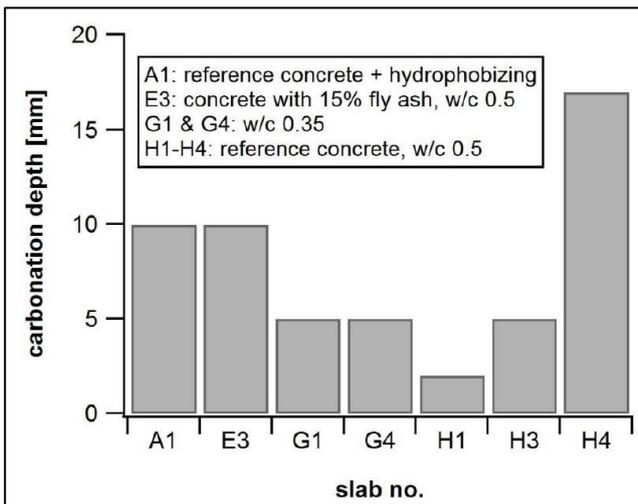
Fig. 14: Carbonation depth after 12 years exposure in the Naxberg tunnel.

The carbonation depth (Fig. 14) of these different specimens confirmed the results from the Japanese study, showing that hydrophobic impregnation products are not intended for arresting carbonation.

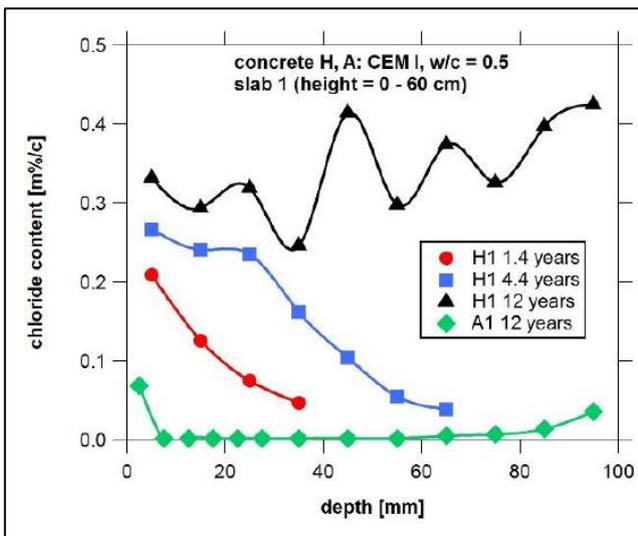
Fig. 15: Chloride profiles on the lower plate of the control specimens compared to the specimen treated with the hydrophobic impregnation.

However, Figure 15 above clearly shows the benefit of using these types of products for arresting the penetration of chlorides as at the typical depth (50 mm) of steel reinforcement. The control specimens show that after 12 years of exposure chloride levels up to almost 0.4% by weight of cement, whilst the specimens treated with hydrophobic products show no chlorides penetrating the concrete at this depth.

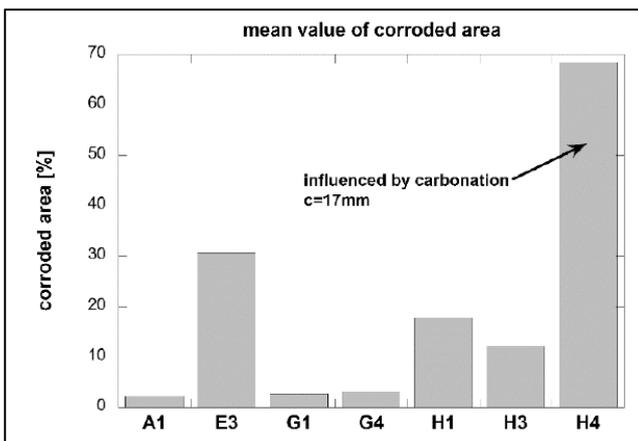
Fig. 16: Average corroded surface area of the steel rebars

Figure 16 shows a low level of corrosion in the treated standard concrete specimen at the same level as the concrete with a very low water / cement ratio (G).
