Challenges of preserving modernist concrete

Ann Harrer^{*1} and Paul Gaudette²

¹ Associate Principal, Wiss, Janney, Elstner Associates, Los Angeles, California, United States

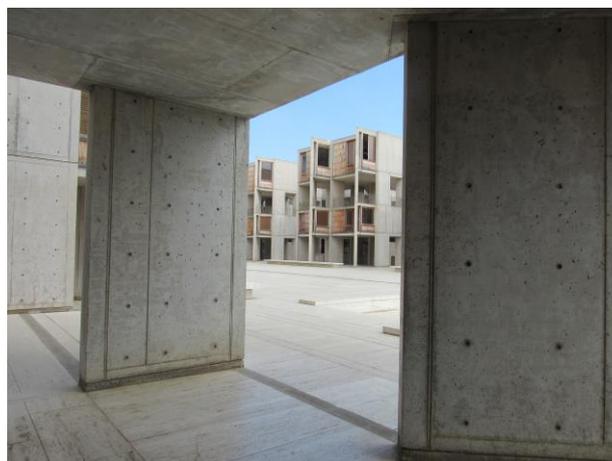
Fig. 1. Exposed concrete finish at the Salk Institute for Biological Studies, designed by Louis Kahn. Photo by the authors.

One defining characteristic of modernist concrete structures is that the finish of the exterior of the building often is exposed concrete. The exterior is detailed and defined by the concrete material, placement method, and finishing procedures. Figures 1 through 3 are examples of exposed concrete finishes of modernist concrete structures.

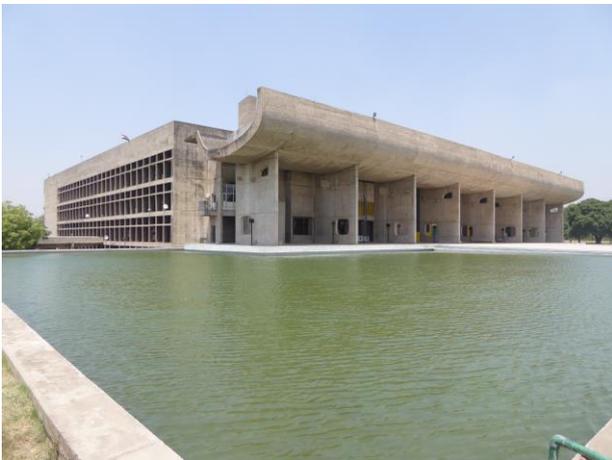
Fig. 2. Exposed concrete finish at the Legislative Assembly in Chandigarh, India, designed by Le Corbusier. Photo by the authors, 2016.

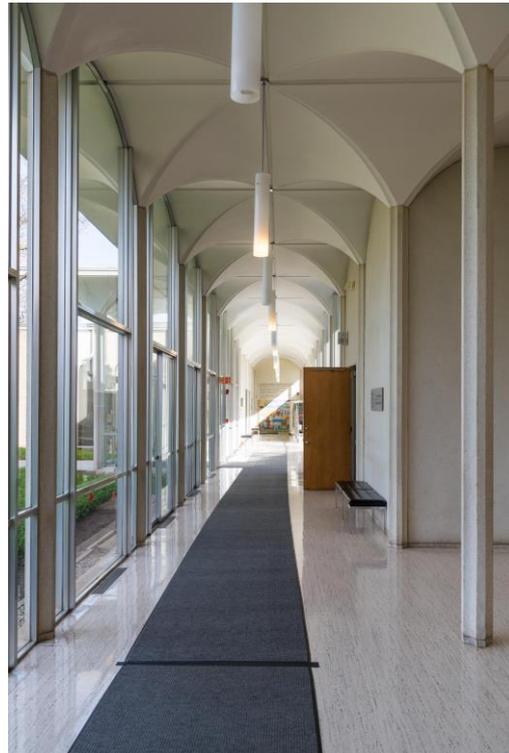
Fig. 3. Exposed interior concrete architectural elements at North Shore Congregation Israel in Glencoe, Illinois, designed by Minoru Yamasaki. Photo by the authors.

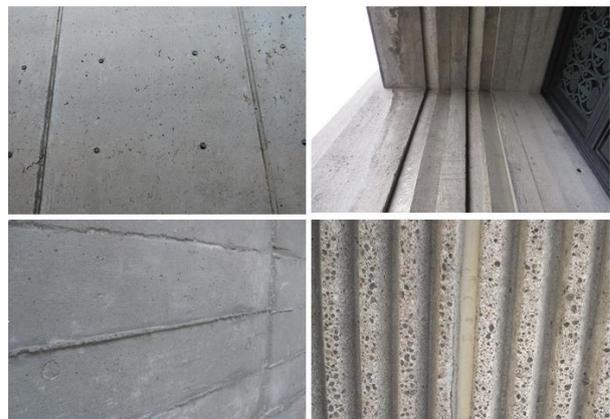
Fig. 4. Examples of variations in the exposed concrete finish in modernist concrete structures. Photos by the authors.

Some of the various finishing techniques used historically as well as today included exposing the aggregates, retaining the texture from the formwork for a rougher finish (board form), and rubbing to create a smooth finish (Figure 4).

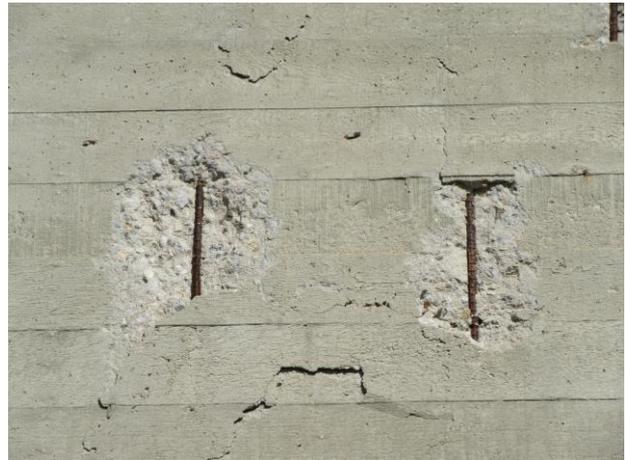
Fig. 5. Delamination and spalling at exposed concrete are examples of distress and deterioration that should be documented as part of a visual condition survey. Photo by the authors.

3. **Field Investigation** - The field investigation should include the observation and documentation of the structure, including verification of as-built construction and identification of architecturally or historically significant elements, and documentation of deterioration and distress (Figure 5).

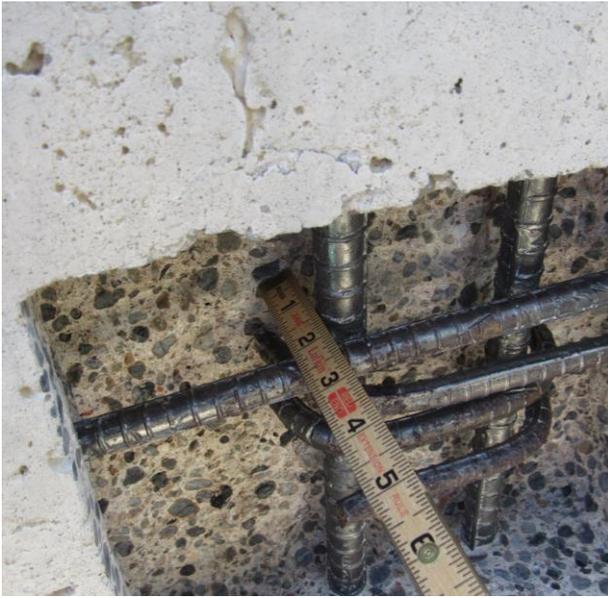
Fig. 6. Removal of concrete beyond the corroding reinforcement bar to allow removal of corrosion product and to address underlying distress mechanism. Photo by the authors.

The rehabilitation approach needs to consider technical concerns, such as deterioration mechanisms and durability, characteristics of the original concrete as well as the aesthetic considerations of matching the original concrete elements [4]. Most importantly, the rehabilitation approach should address the underlying causes of the distress or deterioration of the concrete to minimize continued deterioration or premature failure of the repairs. This may require removal of historic fabric, such as in cases where removal of concrete to access all sides of a corroded bar is necessary to mitigate the ongoing corrosion (Figure 6). Removal behind existing reinforcement bar also allows for repair material to be mechanically anchored.

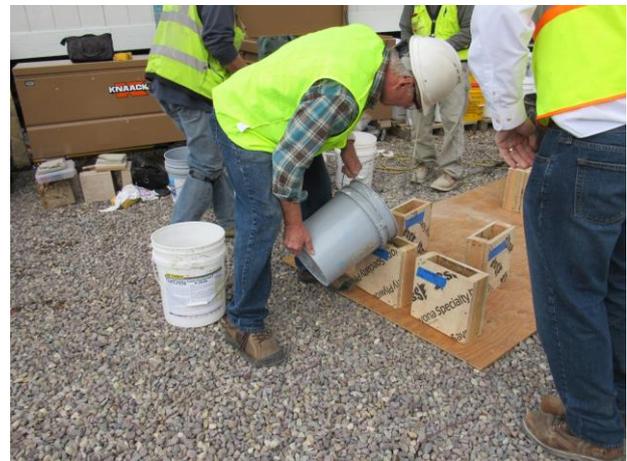
Fig. 7. Completion of off-building trial samples and mock-ups prior to the start of repairs to confirm appropriate performance of the concrete mix design, placement procedures, and finishing techniques. Photo by the authors.

The results of architectural concrete repair work are dependent to a great extent on the experience of the concrete repair contractor and the level of craftsmanship of the person performing the work. Prior to the start of an architectural concrete repair project, it is important that a mock-up and trial repair program be performed. As the level of craftsmanship of anyone implementing the repairs is critical to the overall technical performance as well as the final aesthetic, it is imperative to establish the desired level of craftsmanship prior to the start of work. Mock-ups and trial repairs are necessary to confirm the developed rehabilitation approach (Figure 7).

The successful completion of samples, mock-ups, and trial repairs will demonstrate the level of craftsmanship, the ability to achieve the necessary technical characteristics, and the match to the aesthetic details of the existing structure. Production repair work can then begin. Trial concrete repair work at the building should be completed to achieve the desired craftsmanship level established during the samples and mock-ups. During the implementation of the concrete repairs, craftsmanship needs to be maintained at a high level to achieve a final result that is acceptable and matches the existing concrete in color, finish, and texture. During the repair work quality control measures, including sampling and testing of plastic and hardened concrete is recommended. Field testing should include monitoring the batching and mixing of the concrete repair materials with slump, air content, unit weight, and other typical quality control testing. Cylinders should be cast and compressive strength testing conducted regularly. In addition, testing of the repairs, once adequately cured, to confirm
