Field investigation of slab deterioration due to carbonation in a concrete building

Abstract. This paper presents an investigation on a deteriorated slab of a two-story building located in Johannesburg, South Africa. The structure has been in use as a residential building for more than 60 years. The top slab of the first floor was delaminated and reinforcement bars were severely corroded. Condition assessment of the building was done using the Schmidt hammer test, cover-meter survey and half-cell potential measurements. In addition to the non-destructive tests done, X-ray diffraction and scanning electron microscopy were also conducted on the deteriorated concrete.

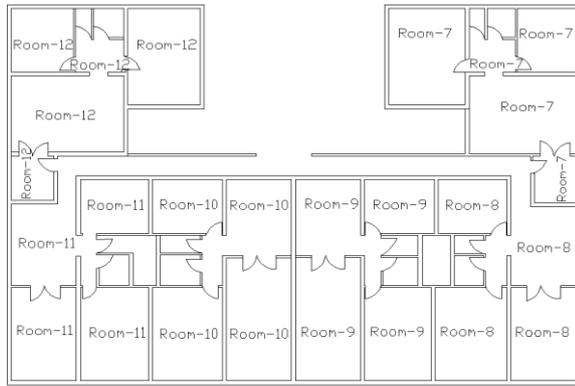
Fig. 1. First floor plan of the reinforced concrete building labeled from Room-7 to Room-12.

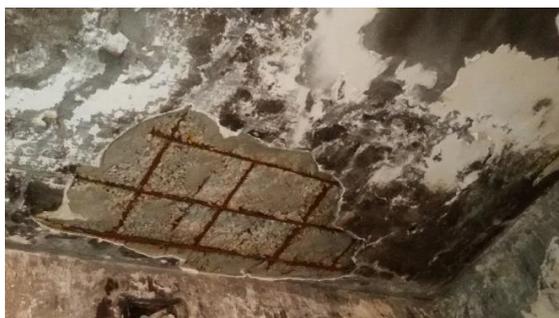
Visual inspection is typically the first step in condition assessment. Hence, the assessment commences visual inspection with photographic recording and documenting the visible deteriorations such as spalling, loss of concrete cover and corroded reinforcement bars. Fig. 2 gives a distressed area showing total loss of the concrete cover and severe corrosion of bars at the soffit of the roof slab.

Fig. 2. Exposed rebars and delamination at Room-9 of Fig. 1.

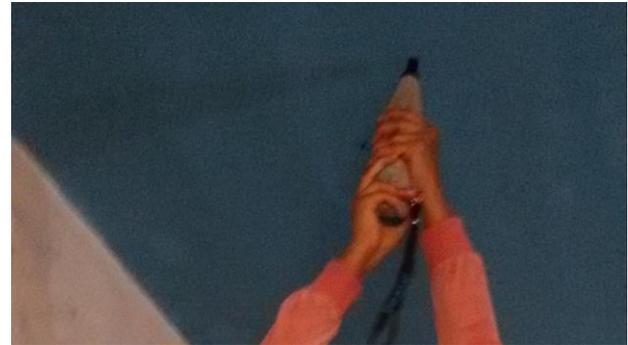
measurements were conducted on all 26 rooms (from Room-7 to Room-12) in 1m x 1m grid space of the slab in Fig. 1. Altogether 1294 data points of rebound values were collected. Using the manufacturer's data, the rebound values have been converted into corresponding compressive strengths. Fig. 3 shows the Schmidt hammer test in progress.

Fig. 3. Schmidt hammer measurement at the soffit of the roof slab.

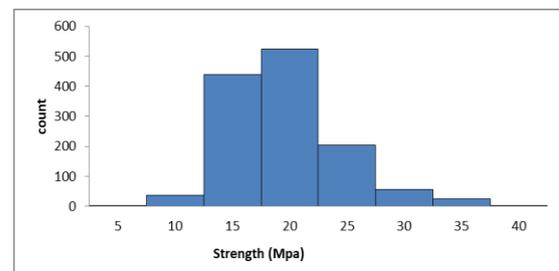
The indicative concrete strength data obtained have been plotted in a histogram shown in Fig. 4. The mean compressive strength was found to be 17.1 Mpa with a standard deviation of 4.9.

Fig. 4. Histogram of Schmidt hammer test data.

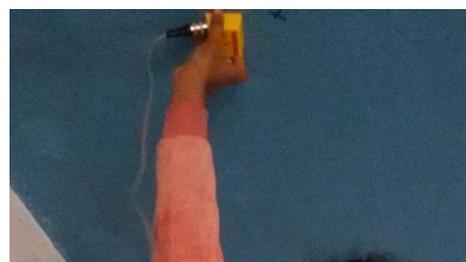
A cover-meter survey was conducted to determine the concrete cover depth and to check bar location. The same grid of 1m x 1m as mentioned in Section 3.1.2 was used for the cover-meter survey as well. Fig. 5 shows the actual cover meter measurements being conducted. Fig. 6 gives a plot of the concrete cover results in a histogram. The 2580 data measurements collected, gave a mean concrete cover of 19.5 mm with a standard deviation of 5.2.

Fig. 5. Cover-meter measurement at the soffit of the roof slab.

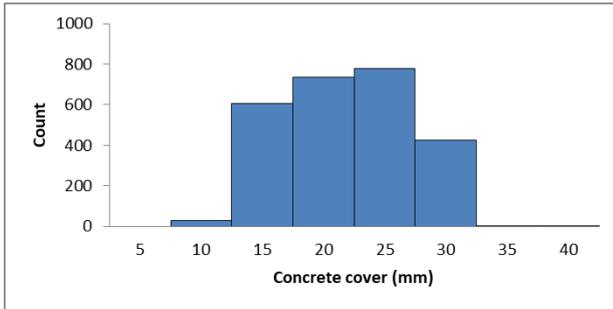
Fig. 6. Histogram of the cover-meter results.

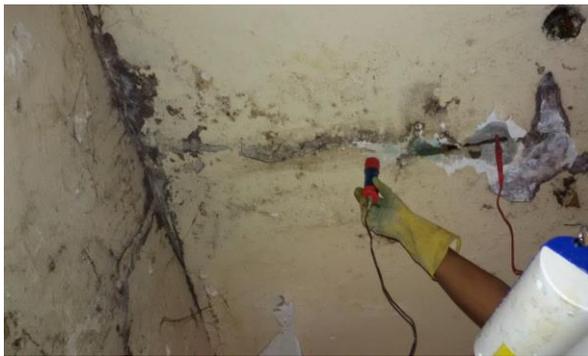
The half-cell potential method was used to assess the corrosion level of steel reinforcement. A total of 155 data sets were collected. Fig. 7 shows the half-cell potential measurement in progress. The measurements were taken at random spots across the slab soffit. Also given in Table 1 are data showing the minimum and maximum values obtained at the various locations. It can be seen that the readings ranged from +85 mV to -687 mV. All the data obtained has also been plotted in a histogram shown in Fig. 8. The mean half-cell potential reading was -202.9 mV with a standard deviation of 138.0. Most highly negative half-cell potential readings were recorded at points where there was roof leakage and delamination. These highly negative readings were likely due to oxygen starvation.

Fig. 7. Ongoing half-cell potential measurement at the soffit of the roof slab.

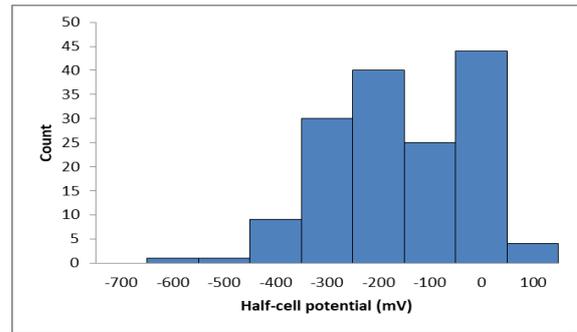
Fig. 8. Histogram of the half-cell potential measurement data.

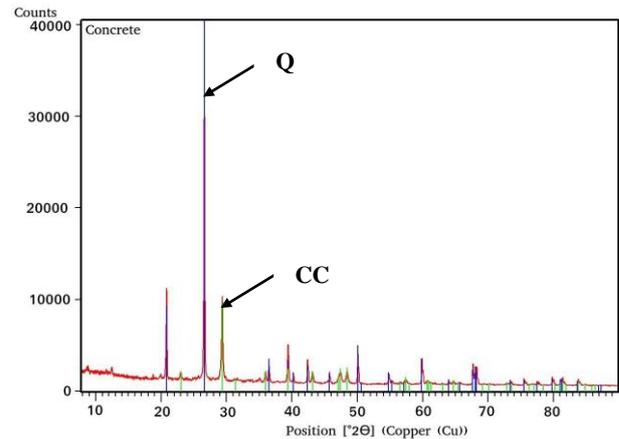
XRD analysis was conducted at 40 KeV, 15 mA using a Rigaku MiniFlex 600 Benchtop diffractometer with Cu-K α radiation ($\lambda = 1.5418 \text{ \AA}$) over 2θ angle of $0^\circ - 90^\circ$ at room temperature. Fig. 9 shows the presence of calcium carbonate, which may be attributed to carbonation as per Equation (1).

Fig. 9. XRD pattern of the concrete sample, showing calcium carbonate (CC) and quartz (Q).

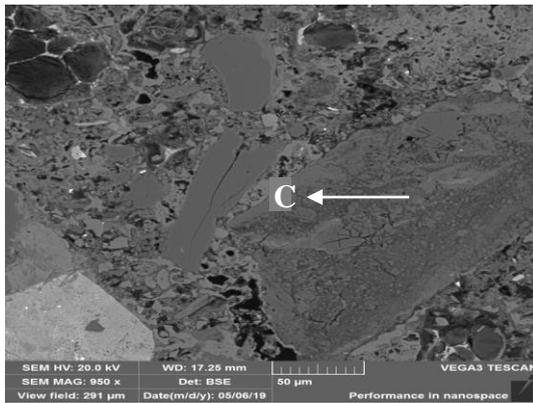
SEM coupled with Energy Dispersive Spectroscopy (EDS) were used to examine the morphology (see Fig. 10) and the presence of metal ions (see Fig. 11) in the concrete sample, respectively. The presence of calcium (Ca), silicon (Si), carbon (C), and oxygen (O₂) in the concrete sample was identified using EDS analysis (see Fig. 11) which supported the XRD results.

Fig. 10. SEM image of the concrete sample. Symbol C indicates the location where the EDS analysis was performed.

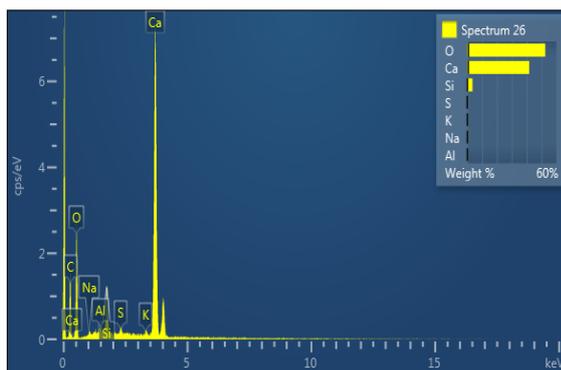
Fig. 11. The result of EDS analysis taken at the point marked with symbol C in Fig. 11.
