Alternative method for minimally invasive determination of the wood fragility from cultural heritage assets

Abstract. The main objective of the paper is to present an alternative, original method, as a minimally invasive technical solution, to determine the hardness of the damaged wood from the cultural heritage objects. For comparison, standard hardness determinations, Brinell and Janka methods are considered. The correlation of conventional hardness test results with the Brinell method, compared to the proposed MARK 10 test shows that less equivocal methods can be used for equally sensitive values. The minimal invasive measurement solution offers advantages in use and is a novelty with applications for the polychrome wood restoration. In order to determine the destructive level of several methods that determine the hardness of the wood, the different areas of the imprint left by the penetrator are compared: Janka hardness = 100 mm², Brinell hardness to maximum 78 mm², Mark 10 puncture being only 1.41 mm². The general conclusion of the paper highlights the strengths of the researched alternative, experimented and presented by us in order to determine the level of degradation of t

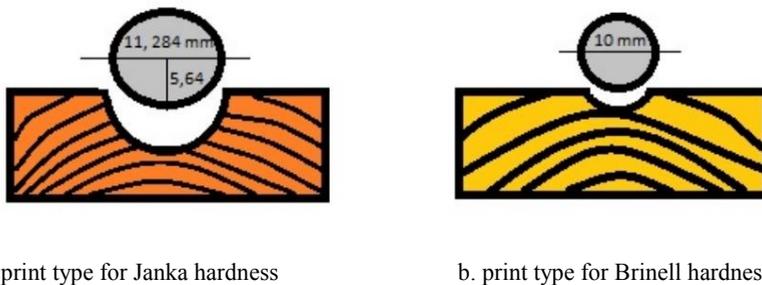
Fig. 1. Graphic examples of standard hardness print types

Janka hardness, according to ASTM D143-94,[8] is used as a minimally destructive test to estimate the strength and stiffness properties of wood. Currently, Janka hardness is a primary method used to assess the consistency of wood species for commercial and industrial use.[6] The Janka method (Figure 1.a) uses a ball with a diameter of 11,284 mm, which is pressed into wood to a depth equal to the radius, resulting in a 1 cm² imprint. In this way, the force read on the universal machine dial is the real hardness of the wood, expressed in daN/cm² (this is explained by the fact that the hardness is usually expressed as the bulk of the resistance of the wood as the ratio between the force and the surface of the crushed section. The area of the tested section in our case is unitary) [3].

Brinell Hardness testing (EN 1534-2000) [9] consists in using a 10 mm diameter steel ball (Figure 1.b.) which is pressed with a predetermined force of 100 daN; pressure is maintained for approximately 25 ± 5 seconds. The imprint has a certain diameter which is calculated as the arithmetic mean of two perpendicular diameters. After obtaining its value, the Brinell hardness with equation (1) is calculated, expressed in N/mm².

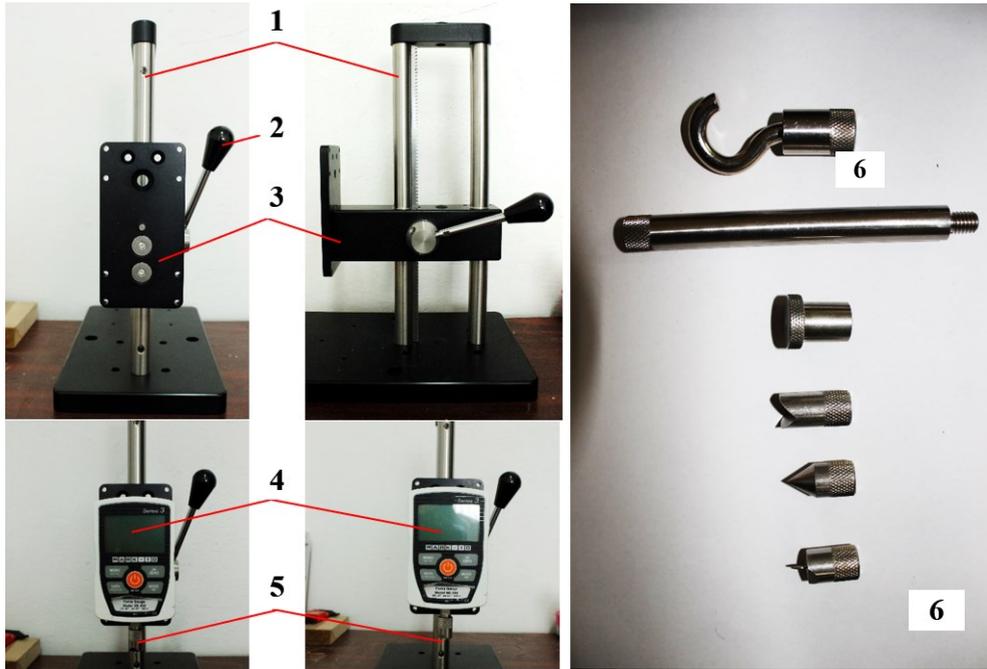
Fig. 3. Device with dynamometer Mark 10: 1 - dynamometer displacement columns; 2 - drive lever; 3 - dynamometer support plate; 4 - dynamometer; 5 - penetrator dial; 6 - current compression and traction peaks of the dynamometer

The Mark 10 (M3-200) digital machine measures forces in Newtons, in a range of 0-1000 N, and is designed to test compression and traction in many applications (including the wood panel of heritage items), using tips of different forms (Fig.3).

The device consists of: stand with columns, rack, centering and fixing plate, drive lever, dynamometer, penetrator (puncture tip).

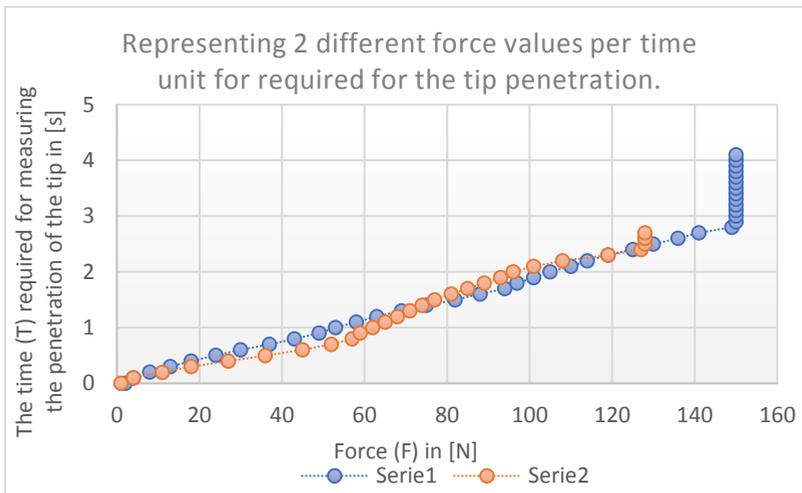
Fig. 4. Graphical determination of the push force and the time required for the tip to penetrate. Report of records with the Mark 10

The device has a software to help collect and process data through a computer, also to record and graphically transfer the time it takes the measuring tip to penetrate and the force needed to drive it in (Figure 4).

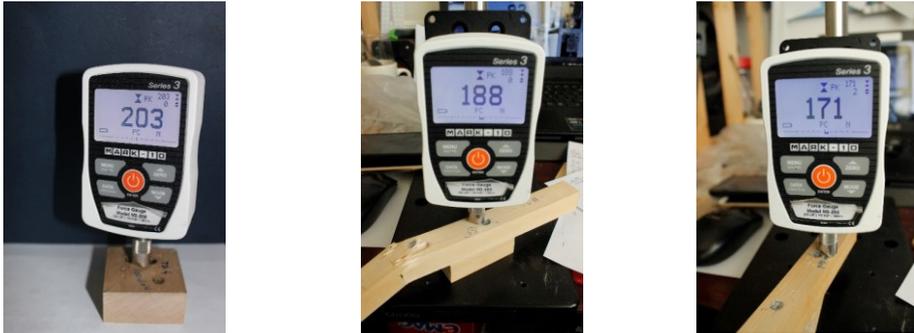
Fig. 5. Comparative determination of puncture force (HM) and Brinell hardness (HB) on new, healthy wood sample

The material used for this study was healthy lime tree (*Tilia cordata* Mill.) and/or degraded. The samples (TD 4, 9, 10) had square sections of 20x20 mm and 50x50 mm, with variable lengths. These were subjected to the two types of testing, i.e. Brinell hardness and Mark 10 hardness (Figure 5). Measurements were made on three types of samples, degraded wood without treatment, new and healthy wood and wood with consolidation treatment, specific to the restoration field.

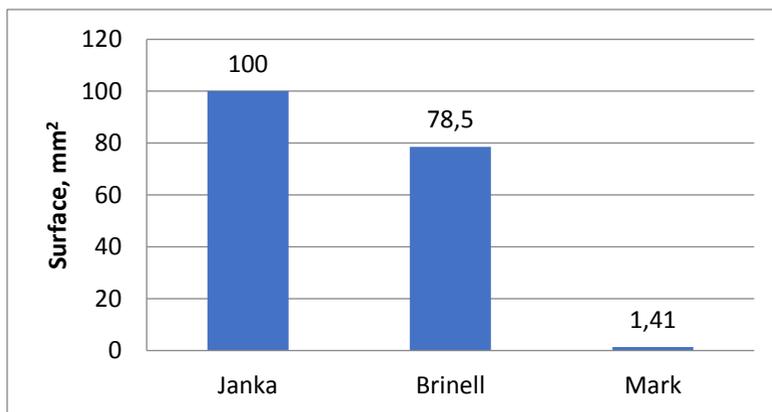
**Fig. 6.** Maximum imprint of Janka, Brinell and Mark hardness

When comparing the imprint of the three methods, it can be noticed that the Janka hardness, with a diameter of 11.284 mm, produces a 100 mm² mark, the Brinell method, with a ball of 10 mm produces a maximum of 78.5 mm² and Mark 10, with a diameter of 1.34 mm leaves a trace of 1.41 mm² (Figure 6).

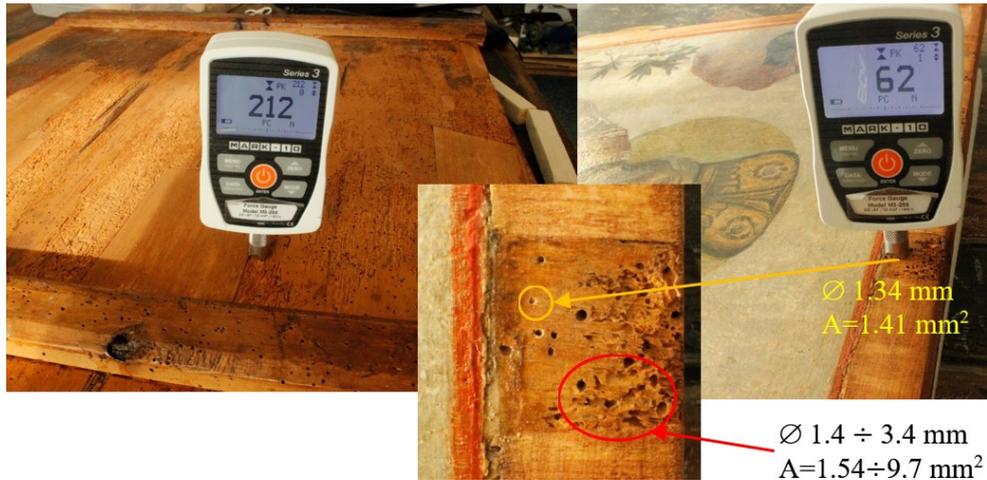
Fig. 7. Comparison of the tip of the measuring tip with the flight aperture caused by the xylophage insects: a) tip Mark 10, $\text{Ø } 1,34 \text{ mm}$ $A= 1,41 \text{ mm}^2$, b) flight holes, $\text{Ø } 1.4- 3.4 \text{ mm}$, $A=1.54 -9.07 \text{ mm}^2$. Values obtained after consolidation treatments showing improvement in hardness.

The fact that the smallest damage is caused by the Mark 10 apparatus, the remaining hole diameter is smaller than a xylophage insect flight hole (Fig.7). This process, using this device, and comparing it with a standardized method, is a novelty element at national and international level, with direct application to the degraded wood restoration of heritage objects.

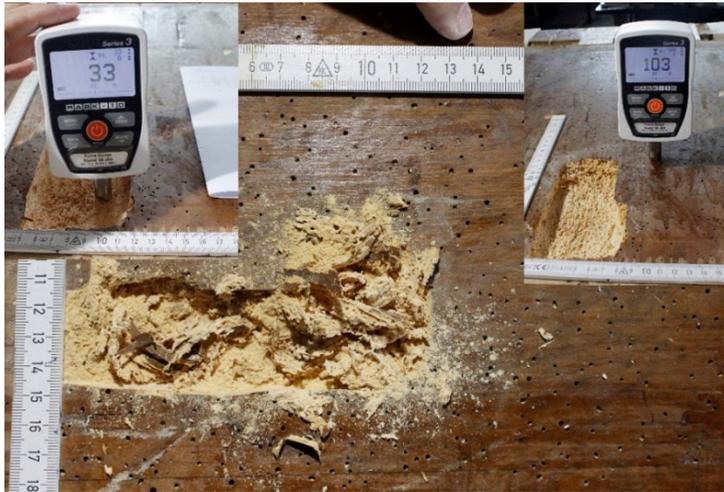
Fig. 8. Hardness determinations with Mark 10 before consolidation treatments

As the wood has variable deformations, the entire HM (N/mm^2) hardness values (Figure 8) have been differentiated (Table 2). The efficacy of the treatment was determined with the Equation 4).
