Critical analysis of localization of micro-hydropower plant in the superior basin of Argeş river

Abstract. The purpose of this work is to anticipate the most important consequences generated by the installation of a micro-hydropower plant on mountain rivers, on the main components of the environment, and also to identify and locate the potential disruptions caused by the implementation of these projects. In addition, the authors would like to clarify certain aspects regarding the changes brought to the natural setting, the extent to which they affect the components of the environment, the capacity of nature to withstand these micro-hydropower plants and to naturally or artificially recover after the project is put into operation. Another aim is to establish measures for limiting the modifications that appear in time due to the installation of the micro-hydropower plants in order to ensure the good functioning of the respective plants. The main anthropic factors, that represent the subject of the analysis, act synergically, thus making it difficult to understand the impact of this project on the environment, especially since nature recovers itself under certain circumstances.

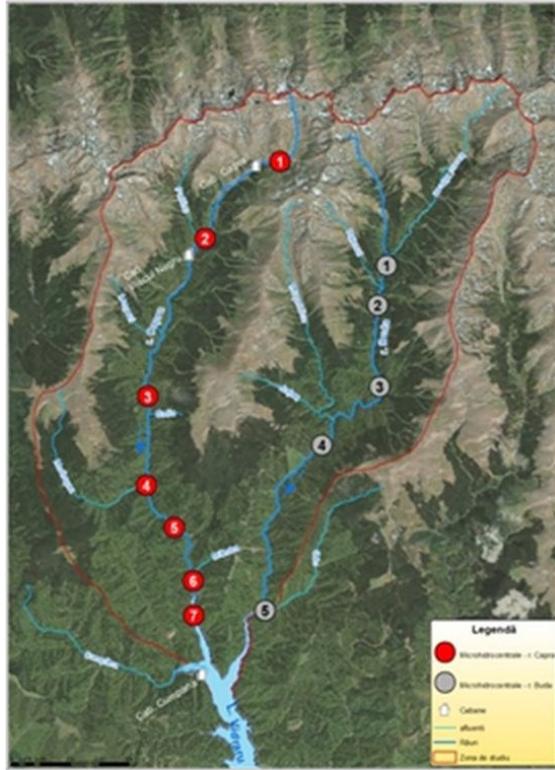
Fig. 1. Localization of micro-hydropower plants on the Capra and Buda Streams

The micro-hydropower plants (MHC) in the superior basin of the Argeş River are located on the Capra and Buda Streams. These two tributaries of Argeş river spring from the main peak of the Făgăraş Mountains and lose their waters in Vidraru reservoir (Figure 1).

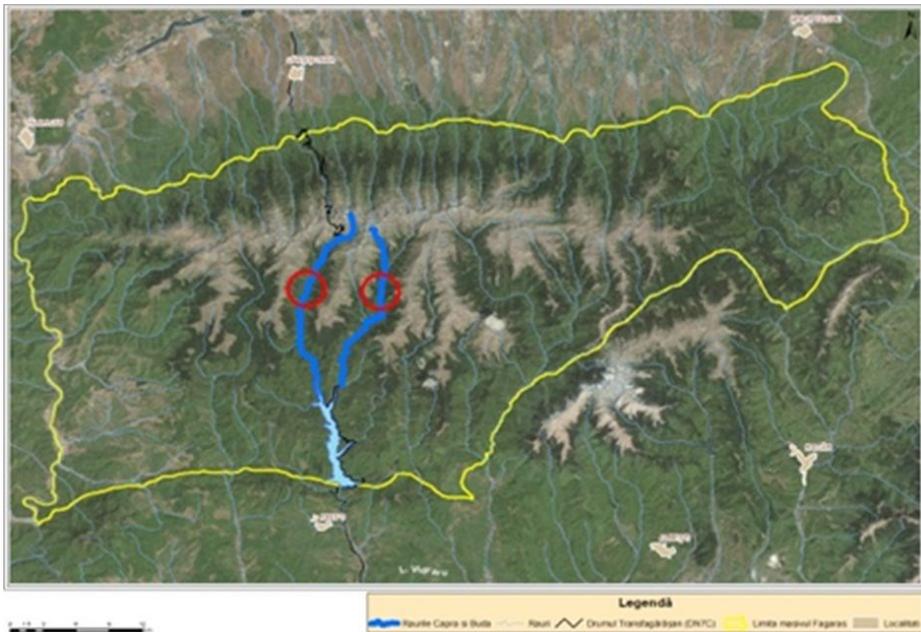
Fig. 2. The studied area in the Făgăraș Mountains community site

The two tributaries of the Argeş River, respectively the Buda and Capra streams from the southern slope of the Făgăraş Mountains, where the 12 micro-hydropower plants are located, are included in NATURA 2000 site (Figure 2).

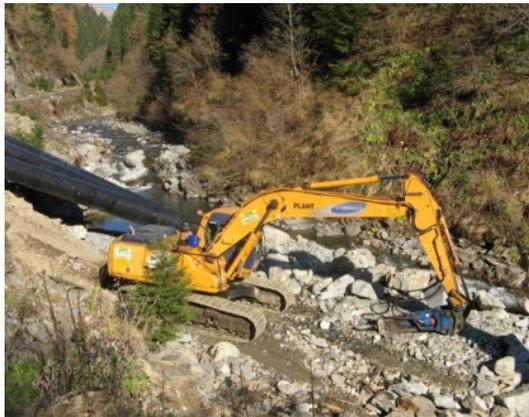
Fig. 3. Machinery in the bed of Capra stream

By introducing machines into the bed (Figure 3), the natural course of the river/stream interferes with water becoming a mixture of mud and rock particles in which every form of life disappears.

An efficient solution after the completion of the works is the ecological reconstruction of the slopes, banks and bed, which has been visibly narrowed (Figure 3), thus enabling the species to return to the affected area.

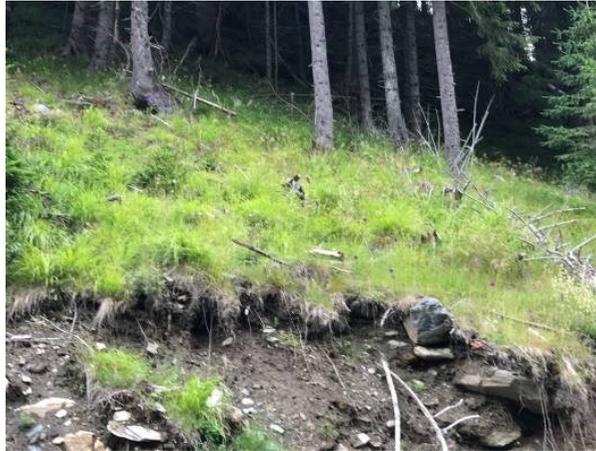
Fig. 4. Soil degradation

Degradation of the stream bed can cause soil erosion processes in the vicinity of watercourses and even effective soil losses (Figure 4).

By carrying out works along the water courses, the soil was compacted along the bed, the project also involving the traffic of heavy machinery.

Also, the slopes in the immediate vicinity of micro-hydropower plants become unstable after vegetation cuts, on narrow surfaces.

This has caused the erosion of the soil and has created the premises of local landslides, which in turn lead to the destruction of the vegetal soil.

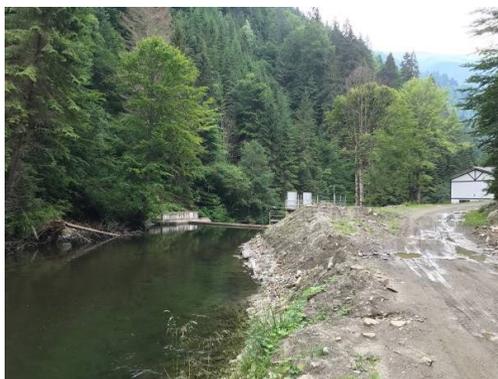
Fig. 5. Accumulation dam on the Buda Stream

The transition from the mountain streams to a series of five small reservoirs on the Buda Stream (Figure 5) and seven on the Capra Stream led to the increase of local humidity and the production of fog under certain conditions.

In addition to the minimum required flow on downstream of the dam, an essential change is made on the stairs, which establish the connection between the accumulation basin upstream of the water inlet and the downstream course. Their installation and functionality are extremely important, as salmon populations have deteriorated quantitatively and qualitatively downstream of dams.

Although all 12 dams are provided with fish stacks, they are not functional as they are set on the banks and often the volume of water is insufficient.

An efficient solution, for upstream access of common trout (*Salmo trutta fario*) to spawning, would be the correct dimensioning of fish steps and the positioning of the ladder foot downstream of the main stream, because the trout instinctively chooses the most difficult route but provides maximum protection and survival of the species.

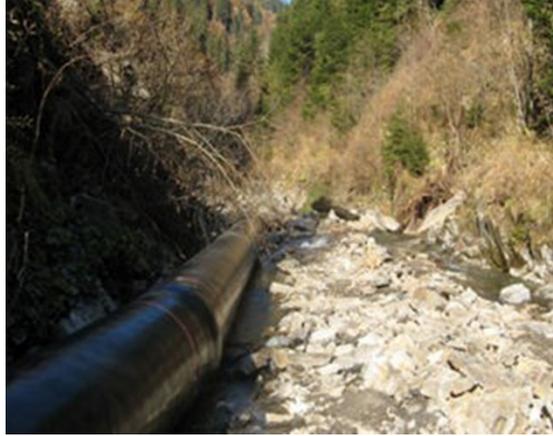
Fig. 6. Modification of hydrological balance, degradation of vegetation, Buda Valley

The riparian vegetation has also been altered by the change in water balance (Figure 6), respectively the variation of the hydrostatic level along the Capra Valley.

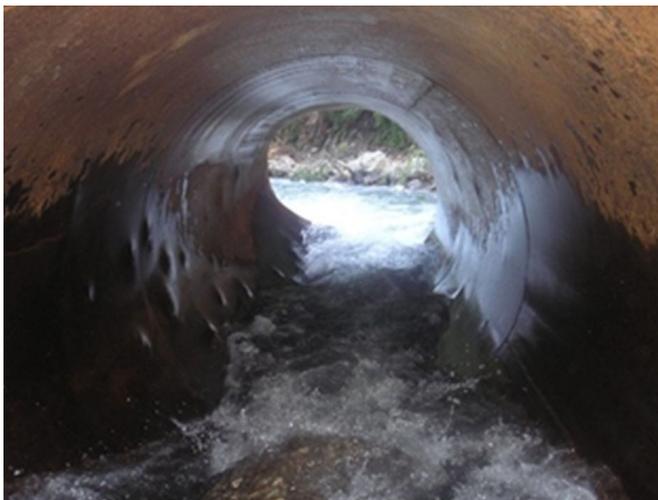
Fig. 7. Micro-hydropower plants pipes

The steel duct that accompanies one of the banks of the stream bed, from the first micro-hydropower plant to the water inlet of the last micro-hydropower plant, does not provide optimal conditions for the fish population, trout living in very oxygenated water. There is no light in the pipe (Figure 7), the fish do not have food, and the humidity is very high.

All of this has irremediably affected the biodiversity of the studied area, leading to alarming fishing mortality in the Buda Stream and the actual lack of fish in the Capra Stream, as there is a nearly dry, non-flowing bed in place of a mountain stream with constant an ecological flow (Figure 7), as required by the law and no longer provides living conditions for fish.

Another alternative to avoid deforestation would be to identify on these sectors solutions to avoid habitat loss by modifying the path of the pipeline.

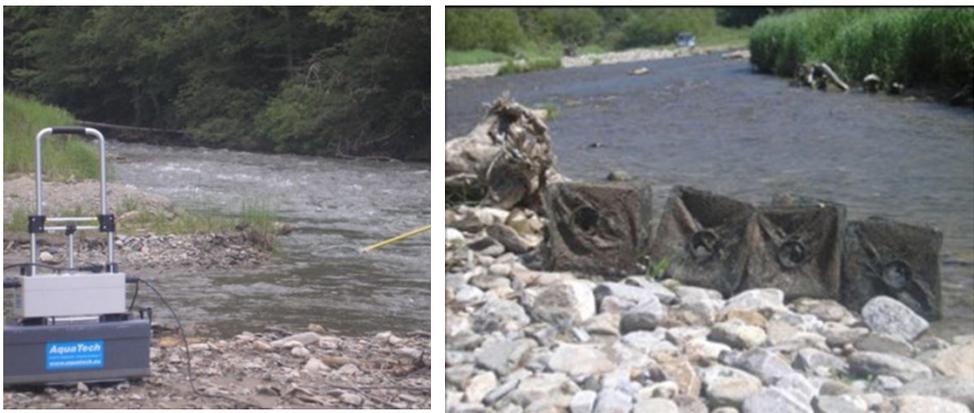
Fig. 8. Fishing with electrofishing and fixed bag fishing methods

Two fishing methods were used to determine the fish populations: fishing with electrofishing and fixed bag fishing (Figure 8).

These two modern methods of fishing, applied in the waters of the Capra stream, revealed the total lack of lute (*Cottus gobio*) at all times of analysis. They also highlighted the lack of indigenous trout in all the seasonal harvesting campaigns of the mountain water.
