Church enclosure walls bearing capacity estimations and its validation on 3D models

Abstract. The paper deals with the nonlinear computational modeling of the baroque enclosure masonry walls. The main tasks are input parameters for efficient advanced numerical tools and techniques, which are based on nonlinear and quasi brittle constitutive FEM modeling. For the work was used the knowledge and results from the Broumov Group Churches survey acquired in the frame of international SAHC university cooperation. The goal of the contribution are real bearing capacity parameters of the composite enclosure walls, which leads from standard homogenization techniques. With regards to the material micro modeling of different wall configuration in longitudinal and transversal direction was done with ATENA 2D software to evaluate the safe bearing capacity of the walls. The set of models aim to assess the bearing capacity of the enclosure wall, which is the main structural element in the church. In detail, we will present results from the numerical investigation, and partial in situ testing, from Vižňov, Ruprechtice and Otovice. Finally, we will present calculation of cracks propagation on full 3

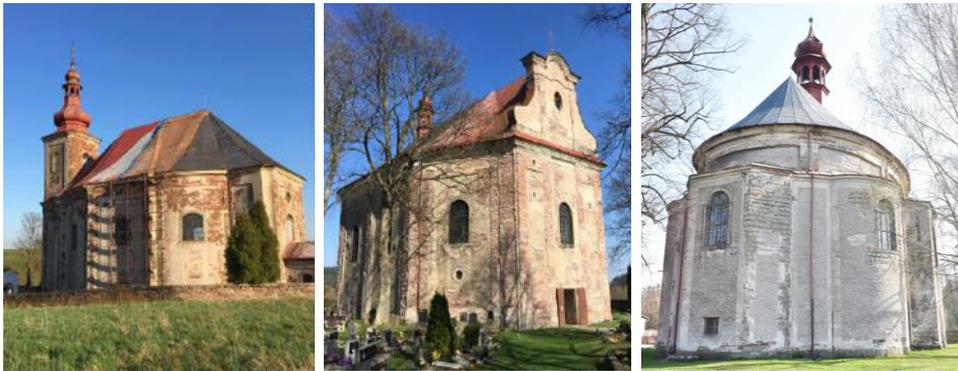
Fig. 1. (Left) St. Ann 1724-728, (Middle) Church of St. Jacob 1720-1723 and (Right) St. Barbara 1725-1727.

Church), more details in [5], Ruprechtice (St. Jacob Church), all details in [6], and Otovice (St. Barbara Church), details [7,8] are presented in the contribution.

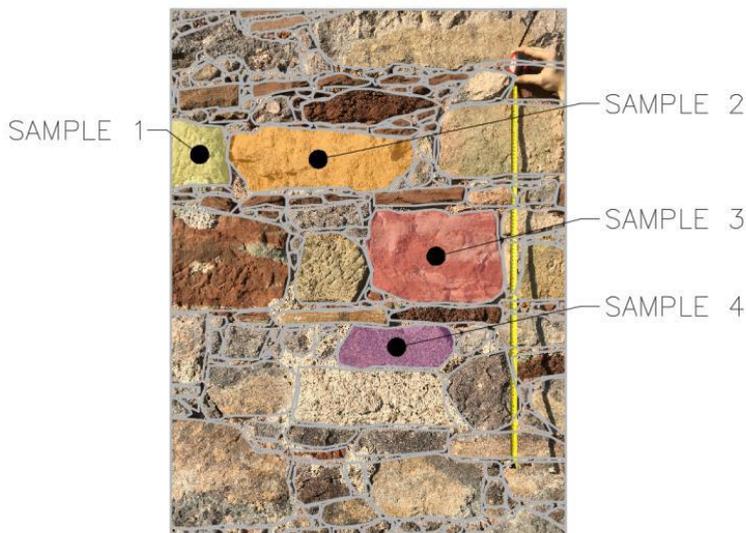
Fig. 2. Wall 1 sample considered in the analysis.

To best describe the strength of the different stones, present in the outer layer of the masonry wall, it was necessary to describe the strength of these different stone units. For the same reason, two different spots were chosen to perform the Schmidt hammer test on different types of stones. The wall samples which were chosen are of size 1 meter by 1

meter at two different locations in the church. Different combinations of the stones to build the masonry of the first spot are shown in Fig. 2.

As it can be seen from the above figure, four different types of stones were chosen to perform the superficial strength test. On each stone sample the rebound hammer was performed for 10 times and then the average value of the rebound number was chosen, this average number of rebound numbers was transformed into the equivalent strength values from the formula provided by the manufacturer of the equipment [9]. Following are the tables showing the strength of these sample stones obtaining by nondestructive testing.

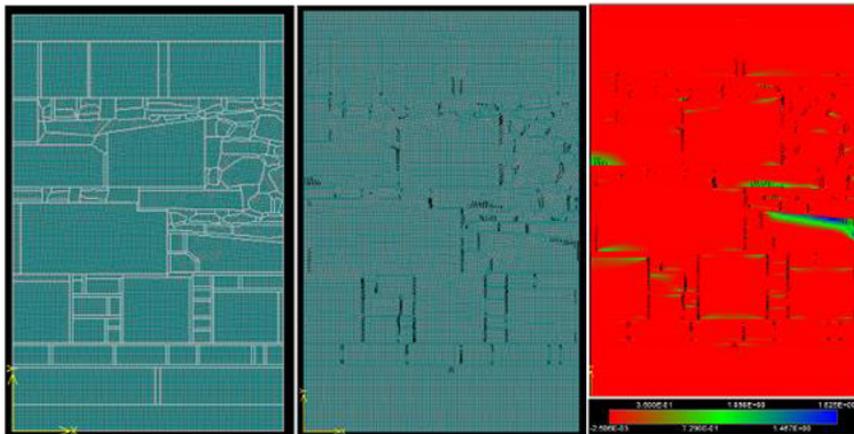
Fig. 3. Longitudinal Wall 1 configuration; crack patterns; maximum principal stress.

The walls are modeled as the combination of various stone units, lime mortar, and rubble masonry infill. From the different available stone units, mainly three different types of stones were observed to be present in the walls outer leaf, namely red sandstone, grey sandstone, and basalt. These stones are bonded together with the lime mortar [10, 11]. While for the internal leaf, rubble masonry was considered [12]. Here the values of the mechanical parameters used are derived from both the typical values of such stones and the values obtained by the Schmidt hammer test. Observing the degraded state of the outer leaf [13, 14, 15], it was considered to use the lower bound value as a general for these types stones present in the wall, which will be a conservative approach and will result in the lower bearing capacity of the wall. Furthermore, for modeling of the longitudinal wall section, since only a single layer of masonry can be modeled in this 2D model [16, 17, 18], to account for the effect of the multi-leaves wall, reduced parameters are applied on the outer wall masonry blocks that are modeled. The reduction factor is obtained by modeling only the outer leaf in the sectional wall subjecting this wall to the same uniform loading, a load-displacement curve is obtained. The Young's modulus and the yield strengths are modified such that a load-displacement curve that is comparable to that obtained from the three-leaves wall model. The ultimate reduction factor used is a factor of 0.33 for Young's modulus and 0.8 for the yield strength and the shear strength [10, 19]. The mechanical parameters considered in the analysis are listed in Table 2. The results of numerical modeling are depicted in Fig. 3. and Fig. 4. Homogenized bearing capacities for longitudinal wall, coming from the numerical analysis, are listed in Table 3.

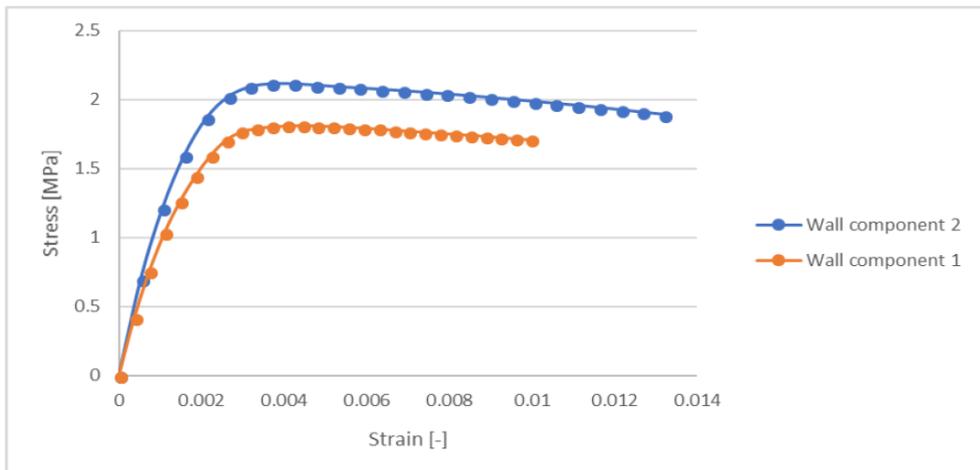
Fig. 4. Stress vs Strain plot of longitudinal wall configurations.

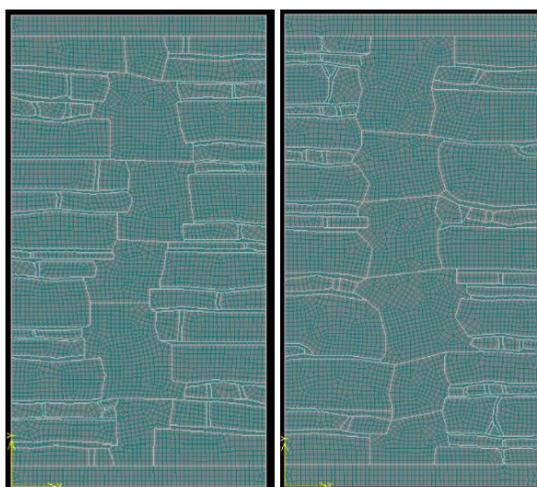
Fig. 5. Transversal wall configuration 1 (Left) configuration 2 (Right).

The analysis was performed on two different configurations of the walls. The differences were in the bricklayer assembling of the wall, as it is shown in Fig. 5. We performed uniaxial compression test in the numerical way. The compression test was driven by deformation, which was applied on the top of sample. All results and details are presented in [5].

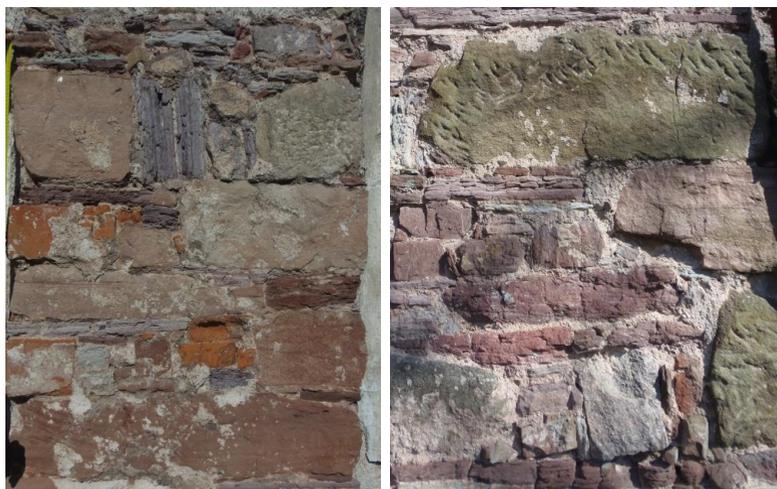
Fig. 6. Bricklayer assembling of the St. Jacobs wall; wall 1 (left) and wall 2 (right).

presented in the previous section. At first, brief visualization and some results from the locality Ruprechtice (St. Jacob Church). Bricklayer assembling is shown in Fig. 6.

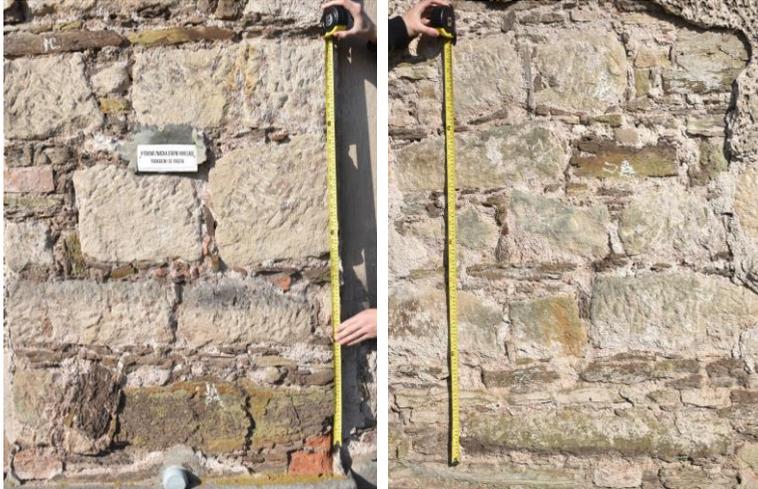
Fig. 7. Bricklayer assembling of the St. Barbara wall; wall 1 (left) and wall 2 (right).

Finally, we can briefly introduce visualization and some concluding results from the locality Otovice (St. Barbara Church). Information about the bricklayers skills and bricklayer assembling are presented in Fig. 7. Results of homogenization process are listed in Tables 7. and 8. More details are in [7,8].

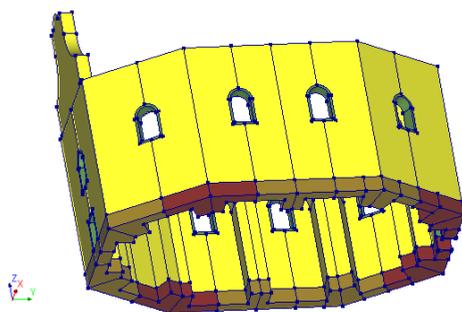
Fig. 8. Effect of soil deterioration of subsoil; in red zone was applied additional settlement 2.5 cm.

Crack patterns propagation was selected in the St. Jacob Church as an example. Crack patterns were visualized by the survey in site. The question is causality of the failure For FEM modelling was chosen in this case software DIANA [22]. DIANA offers different constitutive models for a wide number of analyses. “Total strain based cracked model” was selected for a cracking analysis in the St. Ann Church masonry. Not well working gutters cause non uniform settlement due to deterioration of the sand stones in the foundation. We can see in Fig. 8. The 3D model of the St. Jacob Church, where we highlighted red zone around the gutter vertical downpipes. The subsoil resistance is described by springs of resistance 21,9 (MPa). In the red zones was applied additional settlement 2.5 cm. Incremental strategy was divided to 25 steps. The masonry parameters, used in numerical calculation, are listed in Table 9.

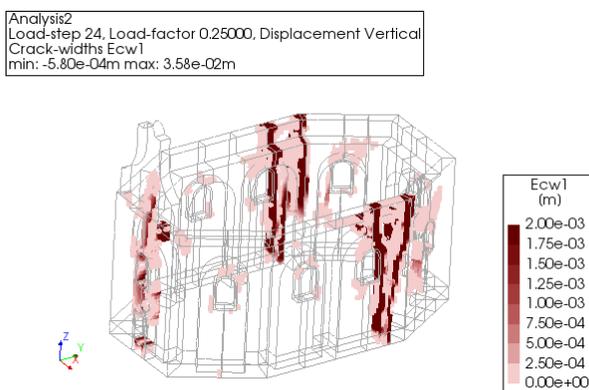
Fig. 9. Calculated cracks due to deterioration of foundations.

From the above figure the crack strain obtained in the structures can be found which occurred due to the increased differential settlements. Here it is interesting to notice that most of the crack strains that can be observed here were found to be in accordance of the damage observed on the site. This supports the considered hypothesis behind the occurrence of damages (due to differential settlements). More comments, scenarios of calculations and other details are in [6].

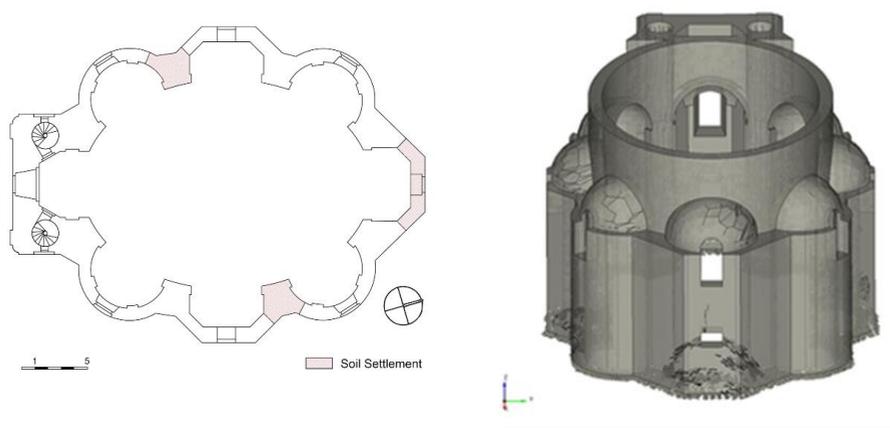
Fig. 10. Additional settlements and filtered crack width showing 15 mm (Severe) degree of damage.

identified through visual inspection. The loads were then applied to the structure in two different intervals. In the first interval, the loads comprised of the self-weight and the dead load were applied to the structure, along with a spring stiffness of 26.36 MPa. This caused a uniform settlement of 18 mm. Additional settlement of 80 mm was applied in the highlighted region, see Fig. 10.

Cracks of width larger than 15 mm corresponding to “Severe” degree of damage and expected to disrupt the functioning of the structure were filtered from the smaller cracks, Fig. 10. It was observed that at load step 80 which accords with 80 mm displacement showed a complete arch-like crack formation of thickness 15mm at the rear wall of the church. It is important to note here that, although this load can completely detach the section of the wall under the window, the failure is very local, therefore it is possible, that the superstructure would still prevent collapse. However, it is evident that the wall completely detaches itself from the superstructure and so, a differential settlement of 80 mm was taken as the failure criterion for the church. More interesting and complex information can be found in [8].
