Protection of the slab-column structures against progressive collapse

Abstract. The paper presents the problem of protection of reinforced concrete slab-column structures against the occurrence of a progressive collapse caused by punching in the support zone. The experimental studies and effects of recorded collapses indicate the necessity to use the appropriate reinforcement type, which will significantly increase the load capacity of the slab-column connection after punching. One of the ways to protect the structure is to use an integrity reinforcement as the most optimal method of strengthening. The contents explain the reasons for the application and description of issues related to this type of reinforcement. The conclusions from the use of this reinforcement based on the results of laboratory tests were presented.

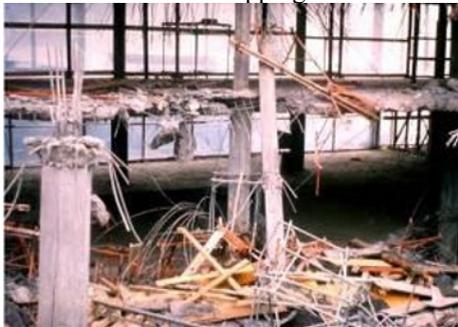
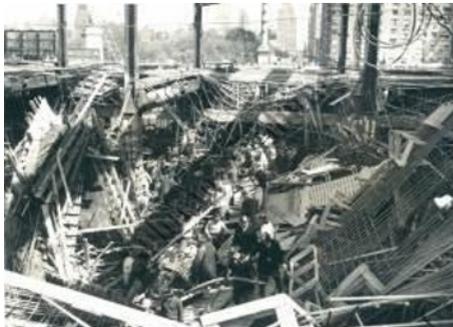
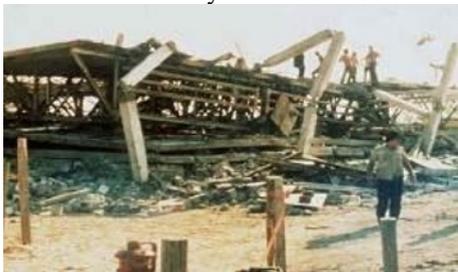
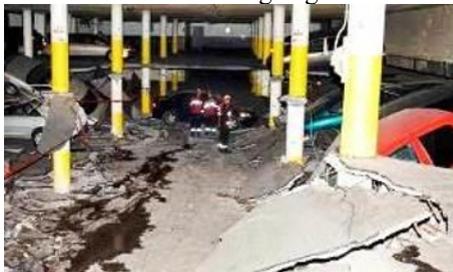
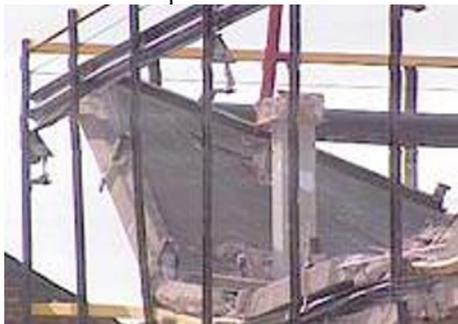
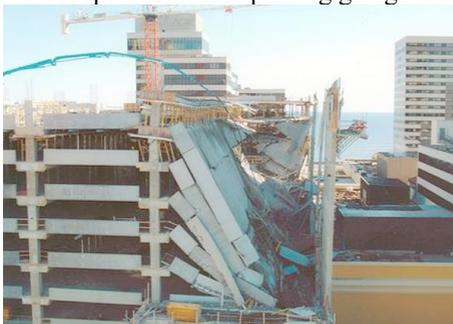
Fig. 1. Photos of selected failures of slab-column structures based on websites.

Over the last fifty years, many building failures and collapses of slab-column structures have occurred. Those incidents were predominantly caused by brittle fracture of concrete occurring locally at the column following the shearing or bending of a slab [22]. The imminent failure condition of the support zone preceding the punching was practically indiscernible. Hence, punching-induced building collapses led to the loss of lives and health impairment of many people, as well as to significant property damages [3] [4] [5]. For this reason, additional effective protection should be planned already at the design stage, enabling the avoidance or at least limitation of disastrous consequences in emergency situations. The list of building collapses of slab-column structures can be found in [21]. Sample post-failure images of selected buildings are presented in Fig. 1. Post-collapse research and building expertises have proven that the main reasons of failures were faults made both at the design stage and during the construction. As proven by the data [21], the majority of failures covered areas much larger than the surrounding of one slab-column connection, leading to partial or total building collapse [2] [3] [4] [5]. For this reason, the possibility of such situations should be prevented.

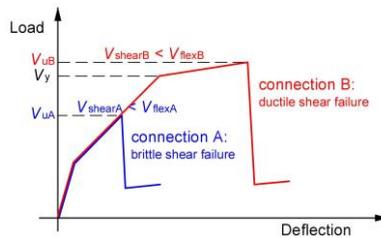
Fig. 2. Behavior of slab-column connections under conditions of the loss of shearing and bending capacity [1].

Research [1] (according to [22]) points at a significant difference between slab-column connections destroyed by shearing (A-type connection) and bending (B-type connection). Fig. 2 presents the change in the column displacement with regard to the slab in those connections under the rising load. If the shear capacity V_{shear} was lower than the bending capacity V_{flex} , brittle shearing failure of the connection occurred. Conversely, when V_{shear} exceeded V_{flex} , the stiffness of the support zone decreased as a result of the scratch spreading. The results suggested that the failure mechanism, and thus the limit load-bearing capacity of the connection V_u , depended on the geometrical dimensions of the connection and the parameters of the reinforcement used. Additionally, it was observed that the displacement of the column at the moment of failure was higher in B-type than in A-type connection. Notwithstanding the initiating factor of the slab-column connection, its load-bearing capacity was lost.

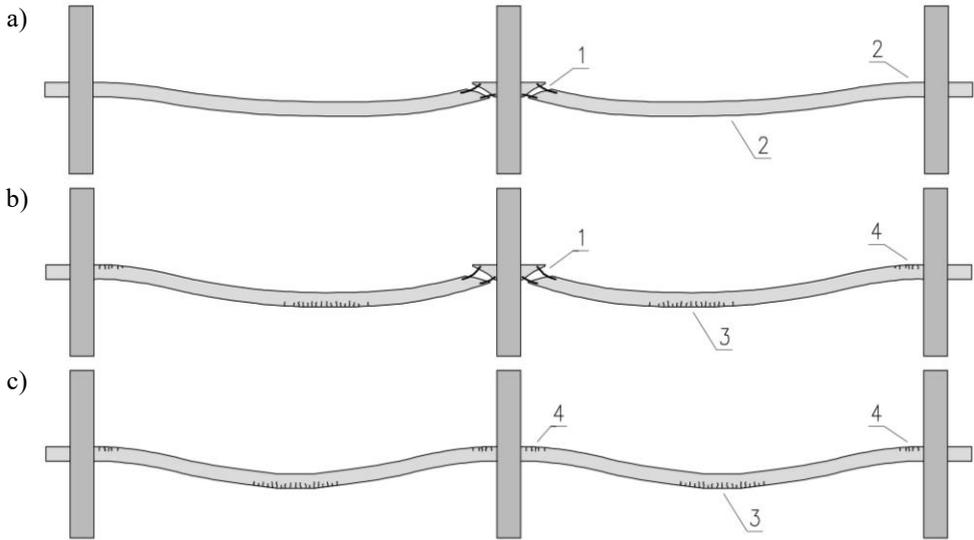
Fig. 3. Post-failure load-carrying mechanisms in concrete structures – tensile membrane action in reinforced concrete slabs after punching (described in the text): 1- area of punching, 2- lack of visible scratches, 3- many scratches of span area, 4- many scratches of support area.

- local damage (Fig. 3a) where the floor damage does not exceed the scope of three times the thickness of the slab – only punching occurs,
- general damage of the significant part of the floor adjacent to the connection (Fig. 3b), where punching of the support zone is accompanied by an effort of the span zone,
- general damage of a large part of the floor adjacent to the connection (Fig. 3c), where a significant effort of the span zone occurs without punching – most commonly when the support zone includes shearing reinforcement.

Regardless of the final failure mechanism and notwithstanding the failure location, the damaged elements of the floor slab may finally hang on the columns, only if bottom reinforcement in the form of continuous bars was used [15]. In such a case, the structural arrangement presented in Fig. 3 may transform into a tendon structure where the load is taken over by axial tensioning forces resulting from a substantial deformation of individual structure elements [16]. Additionally, it should be stressed that punching-induced failure at one column can cause the forces to be redistributed and the load to be taken over by adjacent columns [20] [21].

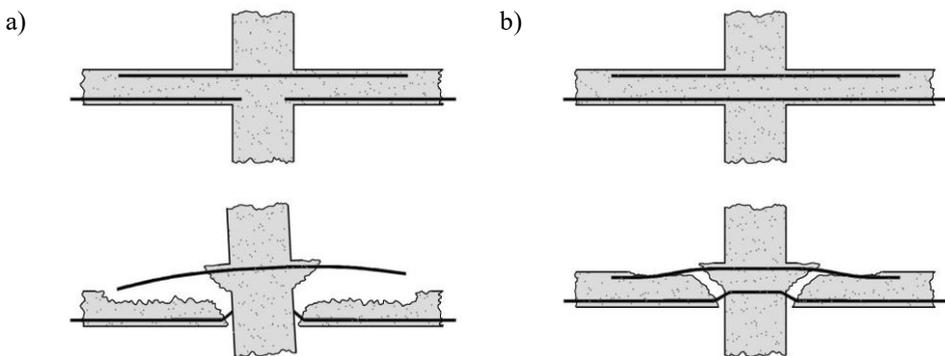
Fig. 4. Development of tensile membrane action in the case of monolithic, bi-directionally flexing plates: a) flat plate construction, b) internal field, c) edge field [8] [21].

According to the research [8], after punching in slab-column connections with continuous and discontinuous bottom reinforcement over the column, substantial differences in the failure mechanism occurred (Fig. 4). In connections including upper and bottom discontinuous reinforcement, after the punching failure the upper reinforcement bars were ripped off from the top surface of the slab, leading to a total loss of the column load-bearing capacity in the zone (Fig. 4a). Using additional, properly designed bottom reinforcement bars enabled the transfer of transverse forces onto the column (Fig. 4b). The presence of a continuous bottom reinforcement prevented the further spread of damages and could in consequence counteract the progressive collapse.

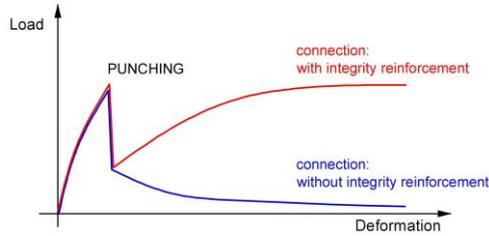
Fig. 5. Load-bearing capacity of the connection following the punching of a flat slab without and with integrity reinforcement [24].

The general behavior of a piece of a flat floor slab in a typical slab-column structure is presented in Fig. 5 according to recommendations included in [24].

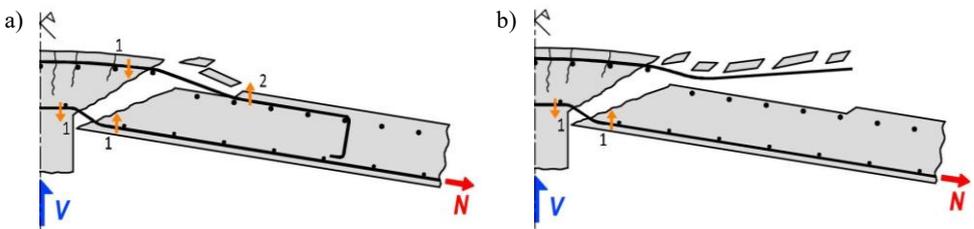
Fig. 6. Mechanism of transferring of shear forces through longitudinal reinforcement [74]: a) properly anchored top reinforcement, b) lack of cooperation of the top reinforcement [22] (1-action of bars on the concrete core, 2-action of bars on the cover).

After punching and with substantial deformations, the impact of other factors, such as the effect of dowel action and the impact of the compressed zone of concrete on the load-bearing capacity of the connection turned out to be minor [10] (according to [22]). Fig. 6 presents the possible behavior of upper reinforcement when slab-column connection with bottom integrity reinforcement becomes destroyed by punching. In the emergency state of the connection, the entire load will be transferred by the bottom longitudinal reinforcement. The integrity reinforcement bars will be deformed, and then will ensure the suspension of the slab on the columns as a result of tensile membrane action. The upper support reinforcement designed with regard to bending may potentially increase the load-bearing capacity after slab punching provided that proper anchoring is present (Fig. 6a). If the upper reinforcement has not its continuity properly maintained or is not properly anchored (Fig. 6b), the cover may start to spall, substantially or entirely reducing the extra load-bearing capacity. As the author's own research has proven, anchoring of the upper reinforcement as shown in Fig. 6 was not sufficient. Despite the double bending of bars, if concrete structure was substantially degraded, they were ripped out (Fig. 7).

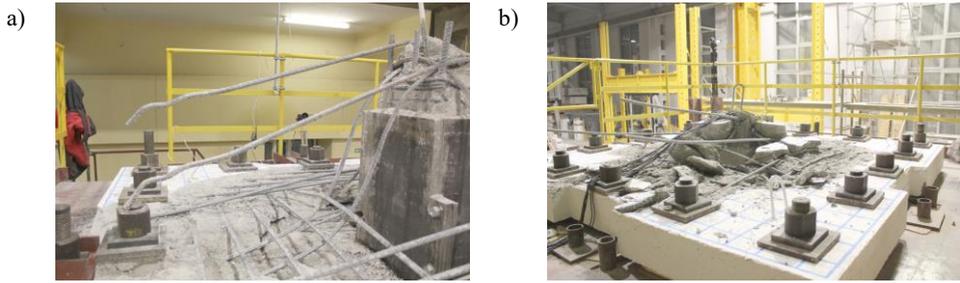
Fig. 7. View of top reinforcement bars – author's own research: a) anchored, b) without anchoring.

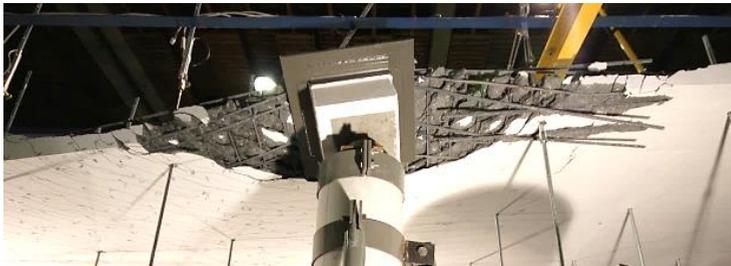
Fig. 8. View of bottom reinforcement bars – research of M. Wiczorek.

Similar was the situation when bottom reinforcement bars were overlapping. In such a case, under the impact of substantial deformations, the integrity reinforcement may be ripped out, resulting in spalling of the cover of the slab bottom surface. As a consequence, integrity reinforcement bars will stop acting and fulfilling their function. Based on the research, it has been concluded that integrity reinforcement (particularly if reinforcing bars have larger diameters) should be longer than $2l_d$ recommended in CSA A23.3 [25] and ACI 352.1R [23] or its continuity should be maintained by means of welding of mechanical connectors (Fig. 8).

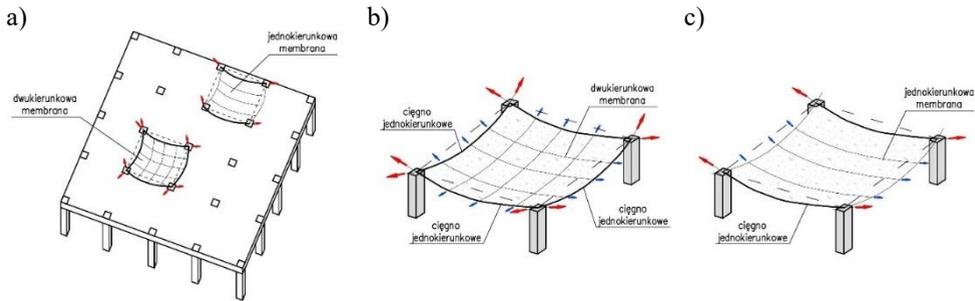
Fig. 9. Development of tensile membrane action in the case of monolithic, bi-directionally flexing plates: a) flat plate construction, b) internal field, c) edge field [15].

The possibility of the development of tensile membrane action in various types of concrete slabs in local failures was discussed by Mitchell and Cook [15]. They claimed that "*the key in preventing progressive collapse may be to design and detail slabs such that they are able to develop secondary load carrying mechanisms after initial failures have occurred*". Besides, they concluded that the tensile membrane action of the slab developed by well anchored reinforcing bars may be used for transferring the damage (Fig. 9). In such a case, the structure will be able to hang the damaged structure elements on columns.

According to the concept, the load shall be transferred by a cover created by reinforcing bars and tensioned in two directions, supported by one-way tendons hanging between columns (Fig. 9). Assuming that one-way tendon will be subject to uniform load of $0.5q_l^2$ per unit of length, its load-bearing capacity could be expressed as:

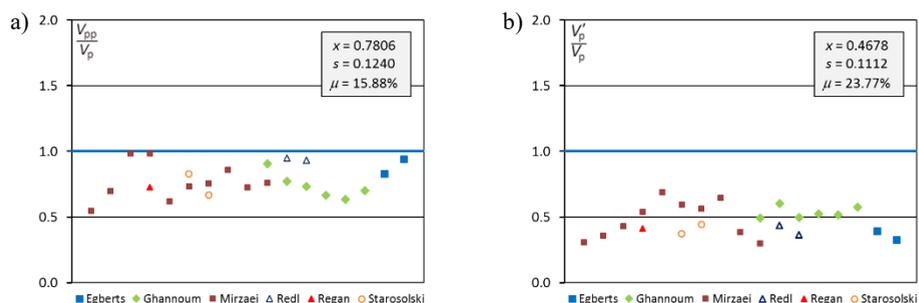
Fig. 10. Comparison of the load-bearing capacity after punching: a) with the value of the punching force, b) with the force value obtained just after punching.

As part of the analysis of the results obtained, the force V_{pp} accompanying the total failure of the models after punching and the value of force V_p accompanying the punching were compared. Based on this, the ratio of forces V_{pp}/V_p was determined to be within the range

of 55% – 98% (Fig. 10a). The value of ratio of the load-bearing capacity of models directly following the slab punching V_p' to the value of punching force V_p were considerably lower, i.e. from 31% to 69% (Fig. 10b).

As can be noticed, none of the investigations carried out allowed to obtain the value of force V_{pp} leading to the failure of slab-column connection after punching higher than the punching force V_p . The average ratio of the forces V_{pp}/V_p obtained was 0.78. Moreover, it has been determined that the minimum load-bearing capacity of the connection V_p' immediately after punching in models with integrity reinforcement has reached the value of only 30% of punching force V_p . Based on 23 results of various studies, the value of force V_p' was about 47% of the punching force V_p on average. This allows to infer that the remaining shearing capacity of the slab (i.e. 53%) should be transferred by integrity reinforcement.
