Experimental dynamic analysis of the existing footbridge in Dobřichovice town

Abstract. The paper presents an experimental dynamic analysis of the existing footbridge across the Berounka River in Dobřichovice town, Czech Republic. The experiment was realized in two stages. The main purpose of the first one was the vibration response determination of the footbridge induced by pedestrians. At first, the natural frequencies and mode shapes of its horizontal load-bearing structure were measured and then the footbridge was loaded by different groups of pedestrians. The response was observed and dynamic behaviour of the footbridge was evaluated. In the course of the second stage of the experiment, the dynamic response of the footbridge deck to pedestrian traffic was measured by two different methods using radar interferometry and classical approach realized by piezoelectric accelerometers. Basic objectives of the second stage were to evaluate the fundamental modal characteristics of the footbridge and to verify new approach to dynamic response measurement – radar interferometry realized by two synchronized radars.

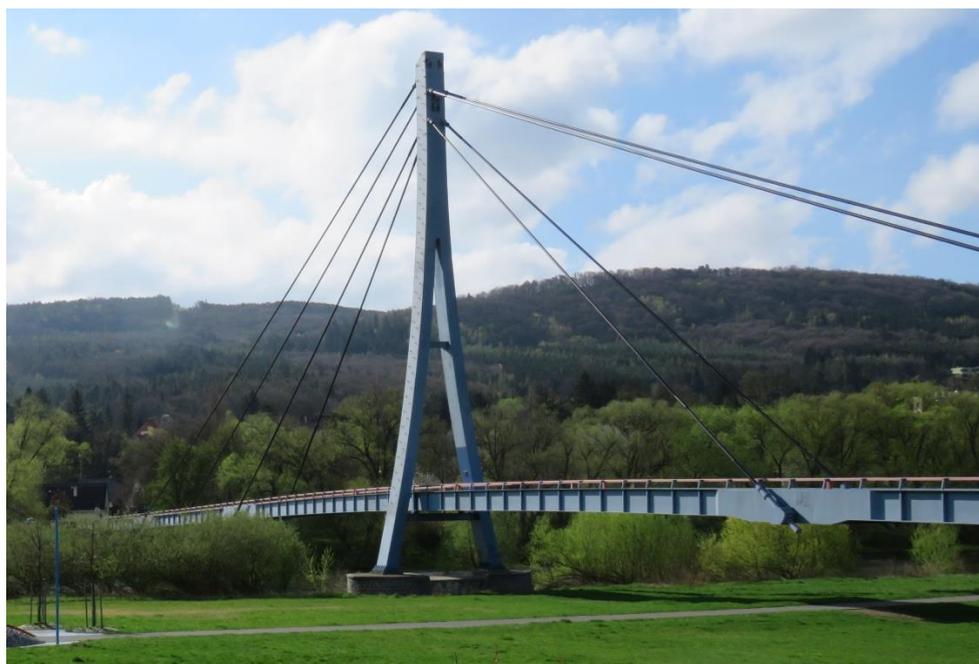
Fig. 1. The analysed footbridge in Dobřichovice town.

The studied footbridge was built in 2003 as a replacement for the original one, which was destroyed during the extreme flood in August 2002. The aim of the footbridge project was to design a structure that is not only of high quality and meets current standards, but also to be able to withstand floods of similar size to the one in 2002. For this reason, it also bridges inundation area on the left bank of the Berounka River (see Fig. 1).

The horizontal load-bearing structure is suspended on a 34.6 m high A-shaped steel pylon by means of a system of 4 pairs of stays (see Fig. 1). The stays are made up of 14 prestressing strands (shorter suspensions) and 16 prestressing strands (longer suspensions). As was said above, the horizontal load-bearing structure consists of two main welded steel I shaped girders of variable height from 1200 mm to 1400 mm. The axial distance of the main girders is 3400 mm over the entire footbridge. In the area of anchorage of the stays, the main girders

are increased to the height 1400 mm. In this area, the girder cross section changes smoothly from the I shape to a closed rectangular one. The change of the girder height is realized only on the lower flange of the girders (see Fig. 1). At an axial distance of 2.0 m, the main girders are reinforced vertically by steel transverse stiffeners with a thickness of 6 mm (see Fig. 1). The main girders are interconnected by steel cross girders of the I- below the concrete deck at the axial distance of 2 m (at the places of the transverse stiffeners). The bridge deck consists of a composite reinforced concrete slab (concrete C30 / 37 - XF1) and its thickness varies in the interval from 120.0 mm to 142.5 mm. The dewatering of the footbridge deck is realized by a cross slope of 1.5 %, where gullies are located at an axial distance of 10 m.

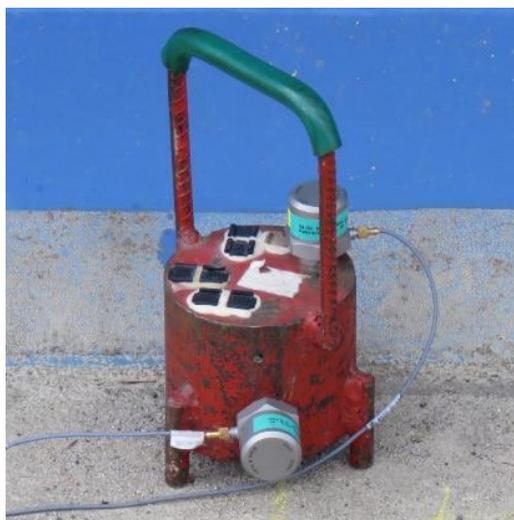
Fig. 2. Two acceleration transducers Brüel & Kjær Type 8344 attached to the steel weight.

a natural frequency of 10 kHz. During the measurement, the sensors were magnetically attached to steel weights (see Fig. 2) and via cables connected to the 4-channel data acquisition station Brüel & Kjær Type 3050-B with maximum frequency range 51.2 kHz and with 2×24 -bit A / D converter. During the experimental modal analysis of the footbridge, the data were recorded by PULSE software Brüel & Kjær. Subsequent analysis of the records was performed with ME'scope VES software Vibrant Technology Inc.

The dynamic response was observed by four acceleration transducers attached by a magnet to steel weights placed on the deck (see Fig. 2). At points on the left side it was measured only vertically, at points on the right side vertically and horizontally (in the direction perpendicular to the longitudinal axis of the footbridge) and only vertically at the reference point. The position of the reference sensor did not change during the whole experiment. The vibration in each cross-section was measured for five minutes to acquire the data sufficient for averaging in FFT with appropriate precision.

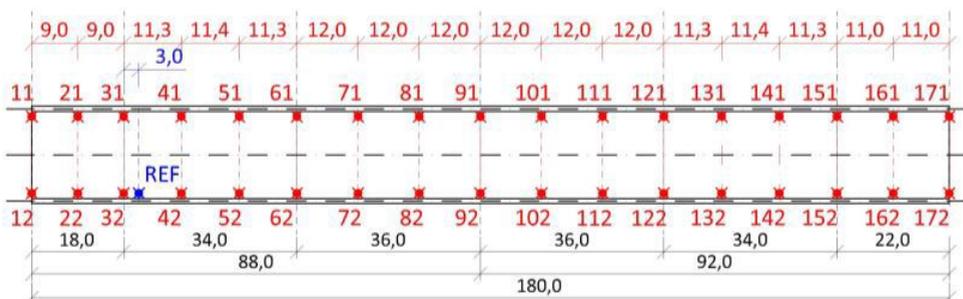
Fig. 3. The simplified ground plan of the footbridge with the marked observed points.

Seventeen cross-sections were selected for the experimental modal analysis. Such a number of cross-sections was chosen to evaluate a sufficient number of mode shapes and also to be able to carry out the whole experiment in one day. Two points were measured in each cross-section and they were located approximately 5 cm from the left and right web of the main girders. The measured points were marked with the number of the respective cross-section from 1 to 17 and with the number 1 or 2 for the position in the section (1 means the left side of the deck and 2 the right side), e.g. number 162 means the point in the 16th cross-section on the right side of the footbridge. The positions of the measured cross-sections with marked observed points are visible in a simplified ground plan in Fig. 3.

The reference acceleration transducer position was chosen based on the eigenmodes obtained by theoretical dynamic analysis. The reference position was located 3 m behind the first anchorage of the stays in the first footbridge span-(see Fig. 3). It was evaluated as the best position because of the most of calculated eigenmodes up to 5 Hz had at least some sufficiently high ordinate to measure their shapes. Only horizontal bending modes and some torsional modes should be problematic to measure because they should have higher ordinates in the second span according to the theoretical analysis.

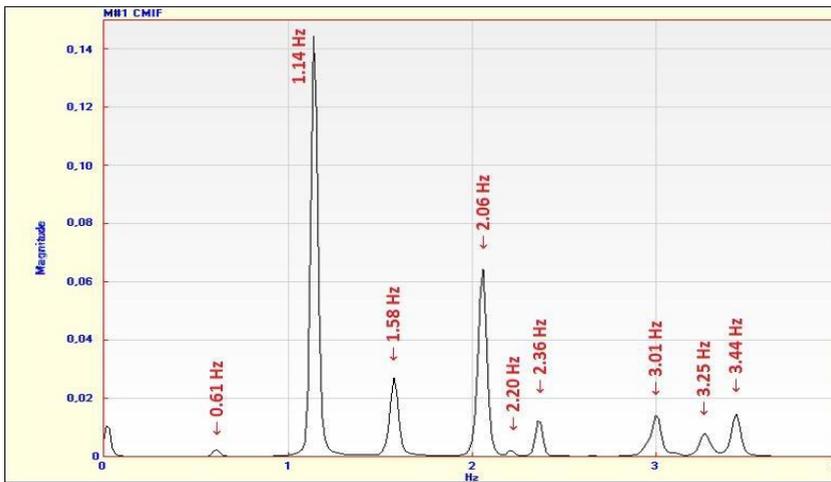
Fig. 4. Evaluated Complex Mode Indicator Function (CMIF) with marked identified natural frequencies of the footbridge.

Measured records of the dynamic response were processed in ME’scopeVES. At first, the data from all channels were transformed using Fast Fourier Transform (FFT) from time domain to the frequency domain. Frequency transfer functions of the operational deflection shapes (ODS FRF) were evaluated from these signals for all 34 measured points. The natural frequencies were evaluated from Complex Mode Indicator Function (CMIF), which is defined as the eigen values solved from the normal matrix, which is formed from frequency response function (FRF) matrix. CMIF can be computed from multiplication of normal matrix with its Hermitian matrix or by singular value decomposition (SVD) of normal matrix at each spectral line [10, 11]. The first nine natural frequencies (see Table 1 and Fig. 4) and mode shapes (see Figs. 5-9) were evaluated.

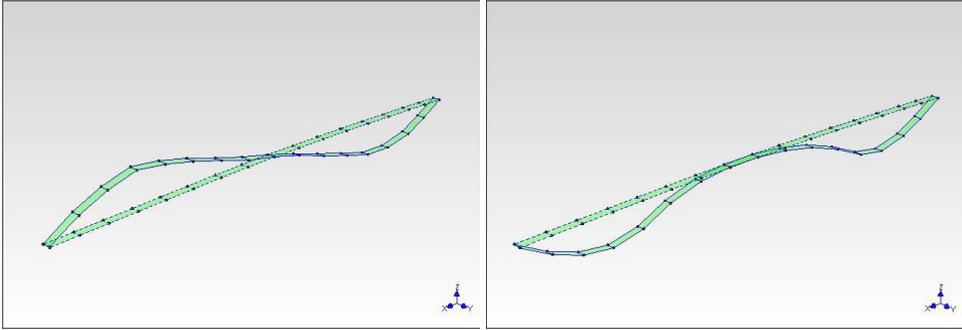
Fig. 5. The 1st and 2nd natural modes of vibration.

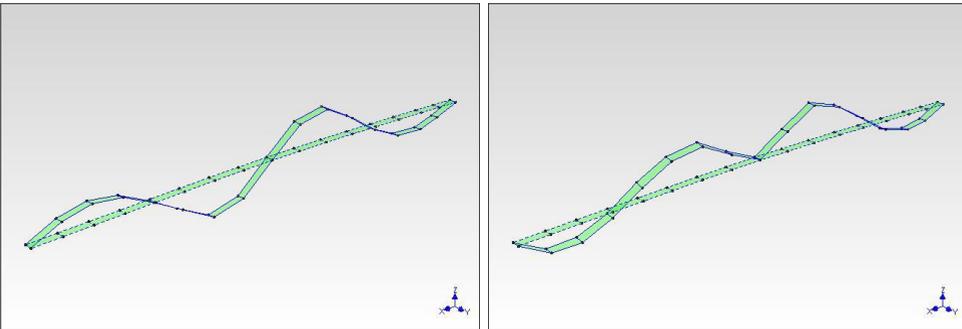
Fig. 6. The 3rd and 4th natural modes of vibration.

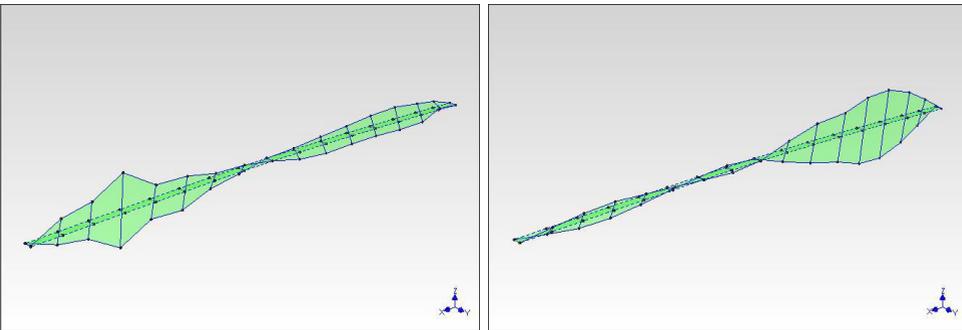
Fig. 7. The 5th and 6th natural modes of vibration.

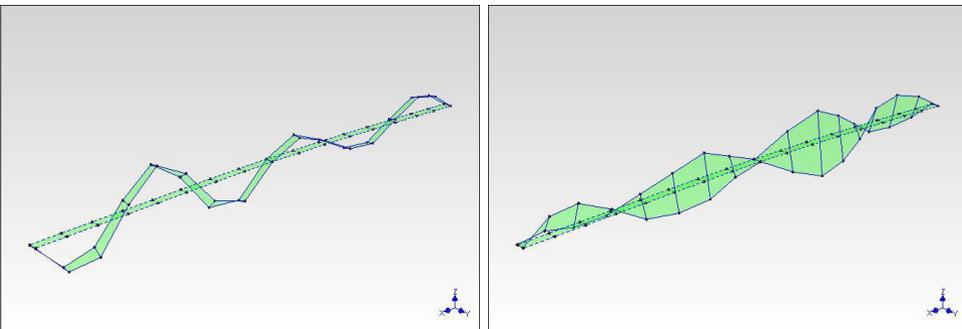
Fig. 8. The 7th and 8th natural modes of vibration.

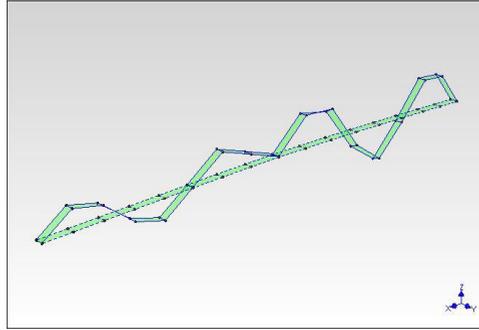
Fig. 9. The 9th natural mode of vibration.

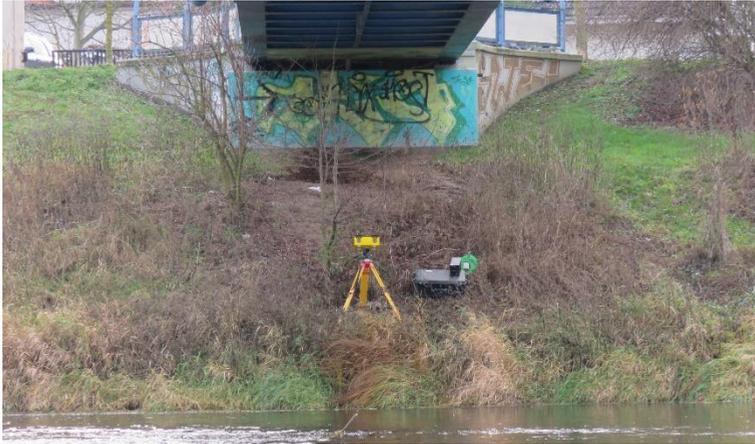
Fig. 10. The radar located under the footbridge in the course of the second stage of the experiment.

The new set of measurements was performed in December 2019. The basic reason for these experiments realized on the footbridge was to evaluate the fundamental modal characteristics of the footbridge and to verify new method of dynamic response measurement – radar interferometry realized by two synchronized radars (see Fig. 10).

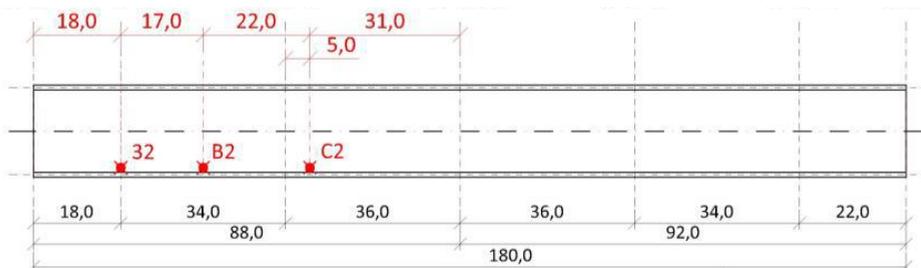
Fig. 11. The position of the acceleration transducers during the dynamic load test.

The dynamic load test was performed with the same equipment as during the experimental modal analysis described in Chapter 3.1. The positions of the acceleration transducers during the dynamic load test are shown in Fig. 11. The selected points were designated 32, B2 and C2. At points 32 and C2, vibrations were measured in the vertical direction only and at point B2 in the vertical and horizontal directions.

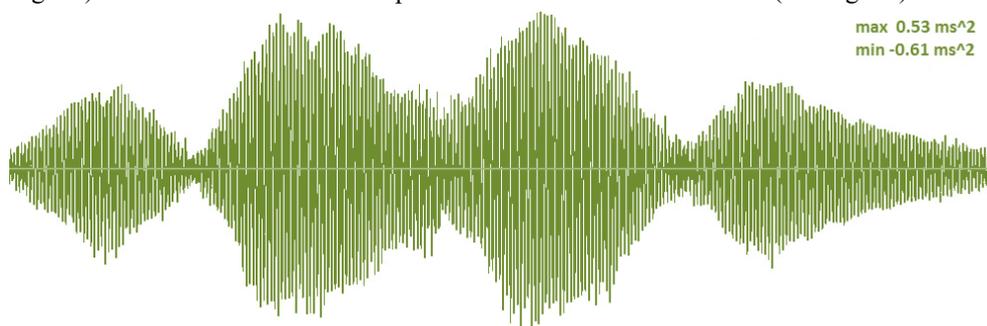
Fig. 12. The maximal measured vertical acceleration in the point B2, two pedestrians walking synchronously with the natural frequency $f = 2.06 \text{ Hz}$.

The maximal evaluated peak values of acceleration for two pedestrians walking on the footbridge were 0.61 ms^{-2} for the vertical vibration with the natural frequency 2.06 Hz (see Fig. 12) and 0.24 ms^{-2} for the horizontal vibration with the natural frequency 1.78 Hz (see Fig. 13). The maximal measured response for vandalism was 2.44 ms^{-2} (see Fig. 14).

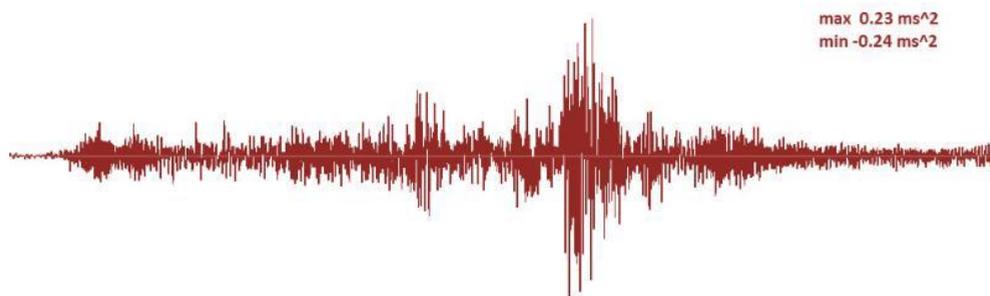
Fig. 13. The maximal measured horizontal acceleration in the point C2, two persons walking synchronously with the natural frequency $f = 1.78$ Hz.

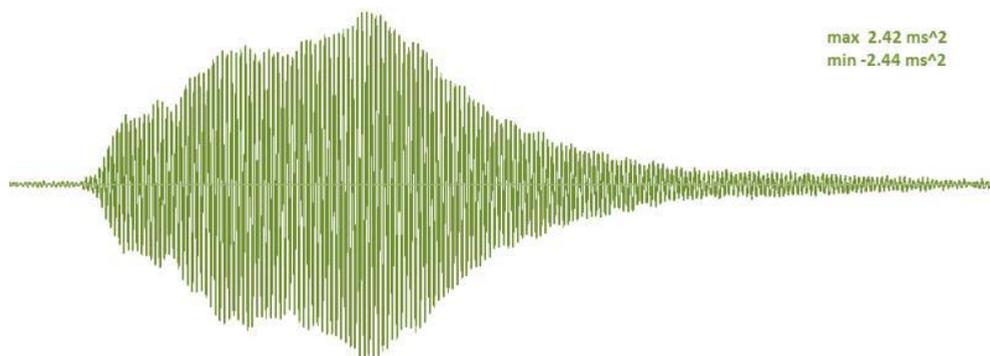
Fig. 14. The maximal measured vertical acceleration during vandalism.

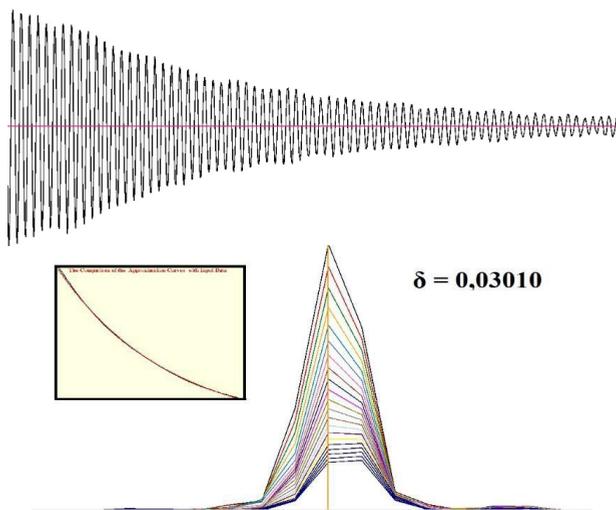
Fig. 15. The damping evaluation from the record focused on vandalism at 2.06 Hz.

The logarithmic decrement of the damping was evaluated for suitable records of the footbridge vibrations. It was evaluated using FFT multispectrum. Since the dynamic test did not interrupt traffic on the footbridge, most vibration records were not suitable for damping evaluation and the damped vibration of the structure was nicely recorded only in a few cases (see Fig. 15).

From the record focused on vandalism at 2.06 Hz, logarithmic decrement $\delta = 0.030$ was evaluated (see Fig. 15) and from vandalism records at 2.38 Hz, the average logarithmic decrements $\delta = 0.023$ was obtained.
