# Identifying preventive maintenance guideline for a combine harvester with application of failure mode and effect analysis technique

**Abstract.** The objective of this research was to study a risk assessment of the rice combine harvester using FMEA technique implementation and suggested the procedures to maintain the parts of the rice combine harvester by analyzing the causes of risk assessment of FMEA. The FMEA was also applied to specify failure causes and effects that occurred in the rice harvester. The obtained data were calculated for a risk priority number (RPN) and then sorted to be a descending order. The high RPN part was analyzed for the causes and effects and then suggested a preventive maintenance in near future. The results revealed that the highest RPN of 576 was found when a chain surface was considered and also showed the maximum risk among the considered parts in the rice combine harvester. While, the lowest RPN of 144 was found when a rice sieve part was considered but this RPN was still higher than that of 100 RPN which was required to specify the preventive maintenance.

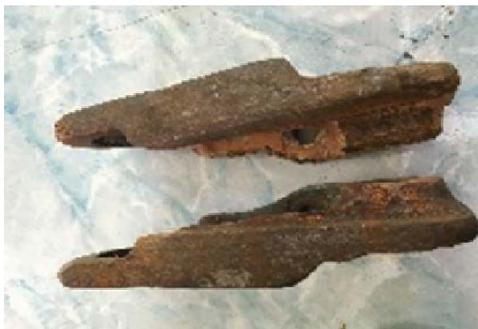
**Fig. 1.** Wear on chain surface.

1) Wear on surface of chain was caused by friction between chain and roller. It made the surface thinner and wavy as shown in Fig. 1. The risk could be detected by eye or surface measurement. Also, if the feeding system was operated inconveniently, this could be the signal that there was wear on surface of chain joint. Farmer could lubricate the chain joint and bring the part for surface hardening to strengthen the metal structure.

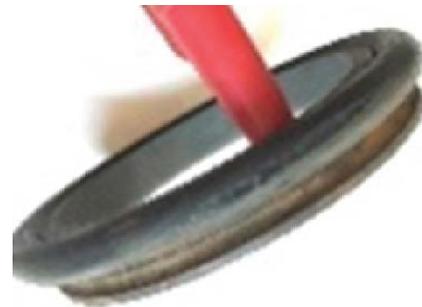
**Fig. 2.** Damage on oil seal for roller.

2) Damage on oil seal for roller was the rupture and the hardener of rubber material. This would lead to oil spilling from roller and then damaged other parts of the combine harvester as shown in Fig. 2. Farmer could detect this problem by noticing the trace of oil from oil seal for roller. If it was occurring, the immediate corrective action for farmer to take would be filling enough amount of oil.

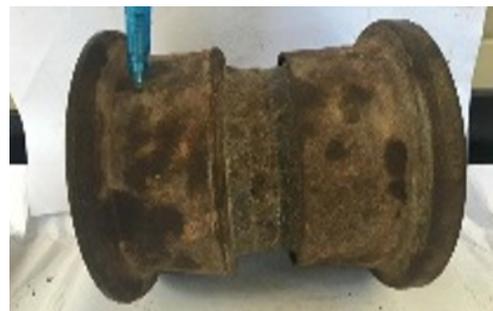
**Fig. 3.** Wear on surface of roller.

3) Wear on surface of roller was happening because of the friction between chain and roller. The surface of roller would be thinner and notched as shown in Fig. 3. If the size of roller was too small, the chain could fall off the roller. This led to unusual movement which could damage the combine harvester. The detection method was measuring the size of roller and checking the surface condition frequently. This problem could be solved by lubricating between chain and roller and bringing the roller for surface hardening.

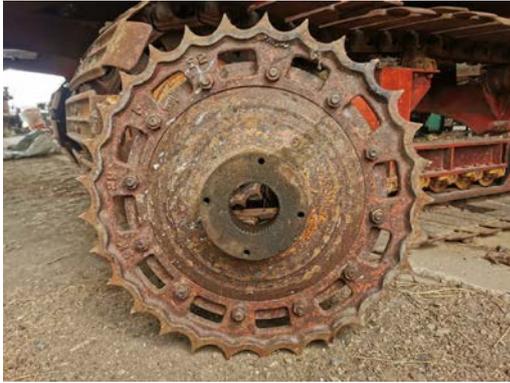
**Fig. 4.** Damage on sprocket.

4) Damage found on sprocket was spiked and thinner cog as shown in Fig. 4. This would make the sprocket's pitch wider. The feeding system of the combine harvester would not work in full capability. Farmer could detect this problem by noticing the size of sprocket's cog and take preventive maintenance by lubricating and setting alignment of sprocket frequently and surface hardening for the sprocket.

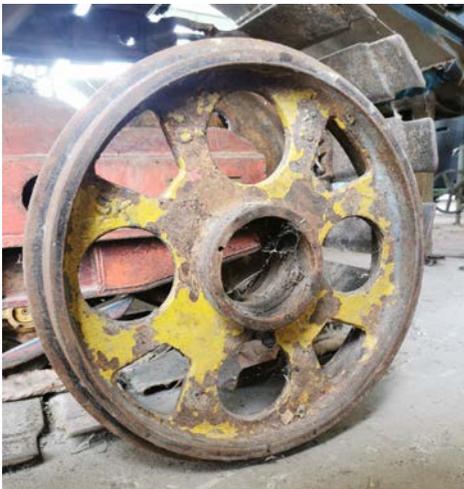
**Fig. 5.** Damage on wheel guide.

5) Damage on wheel guide was occurring at the ridge of wheel guide from the friction between wheel guide and chain. If the ridge was getting smaller, the chain would derail more easily as shown in Fig. 5. To observe this problem, farmer could monitor the surface of wheel guide and observe the alignment of wheel guide. The maintenance must be performed immediately. If not, it would affect other parts of the combine harvester. The actions included lubrication, setting alignment, and surface hardening of wheel guide.
