Strengthening of RC plates with mineral-bonded composite layers for enhanced impact safety

Marcus Hering^{1,*}, and Manfred Curbach¹

¹Technische Universität Dresden, Faculty of Civil Engineering, Institute of Concrete Structures, 01062 Dresden, Germany

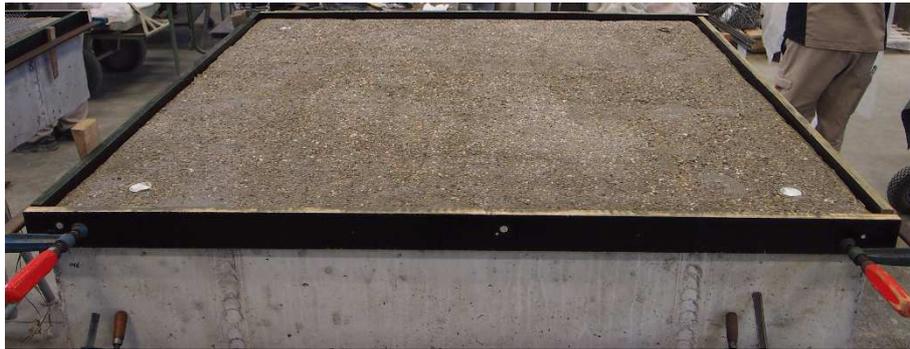
Generally, concrete surfaces are sandblasted to achieve the required roughness before a reinforcing layer is applied. Here, another variant was tested. Therefore, additional four RC plates were prepared during production in such a way that a washed concrete surface was created on the bottom side of the plates. For this purpose, retarder paper was placed in the formwork before concreting. With the help of this retarder paper it was possible to roughen the surface by blasting with water. The concrete surface was prepared in order to achieve a good bond between the strengthening layer and the plate to be strengthened via the surface roughness. In Fig. 1 you can see a rough surface. Before strengthening, the relevant surface was moistened, starting 24 hours before the strengthening works.

Fig. 1. Plate prepared for strengthening, picture: M. Hering.

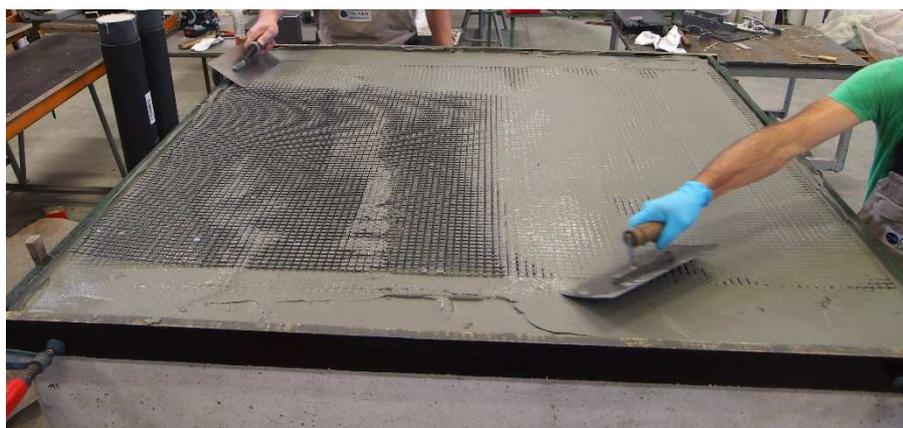
The thickness of these layers was 20 mm. When strengthening the component, first of all, approx. 7 mm Pagel TF10 [[17]] fine concrete was applied. The first sheet of reinforcing material was inserted into this layer. A further layer of matrix material (approx. 6 mm thick) was then applied, followed by the second layer of the reinforcement material. The work was completed with a final layer of approx. 7 mm fine concrete Pagel TF10. Fig. 2 shows the process of applying the strengthening.

Fig. 2. Application of the strengthening layer, picture: M. Hering.

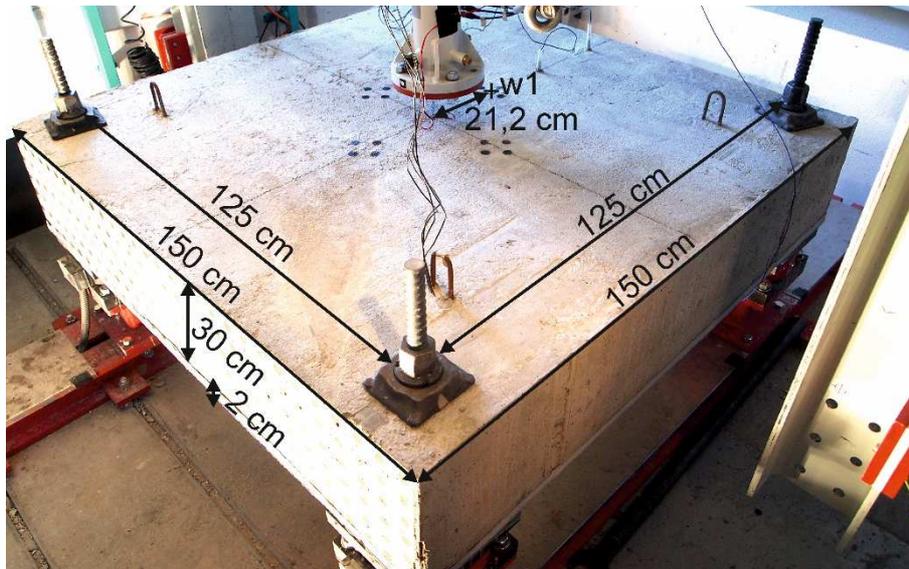
The experimental conditions for the tests on the strengthened RC plates corresponded to those described [[15]]: A four-point bearing located at the corners of the specimen was used for the plate. The distance between the centres of the supports along the edges of the specimen was 125 cm. The supports contained load cells with which the support reaction was measured. The load cells are positioned under the corners of the plates, see Fig. 4. The labels of the load cells are LC. Furthermore, the deformation of the plates was measured at two points, positions w1 and L1: w1 was located on the upper side of the panel, L1 on the lower ones, see Fig. 3 and Fig. 4. A flat, 380 mm (L_{imp}) long and 21.66 kg (m_{imp}) weighted steel impactor with a diameter of 100 mm (d_{imp}) was used for loading, see Table 1.

Fig. 3. View from above the specimen with dimensions, graphic by Hering.

Fig. 8 shows the displacements measured on the upper side of the plates at position w1 (see Fig. 3). The deformation of the non-strengthened reference plate PL141 was also added. This figure clearly shows the effect of the strengthening layer on the deformation behaviour of the plates. The reference RC plate deforms much more under the applied load than the subsequently strengthened ones. Furthermore, it can be seen very clearly that the unreinforced strengthening layer (PL147) also has a clear influence on the deformation. This is, however, significantly less than in the case of the test specimens which were strengthened with reinforcement layers. A direct comparison of the fabrics used for the strengthening layer shows that carbon fabric 2 was able to minimize deformation the most.

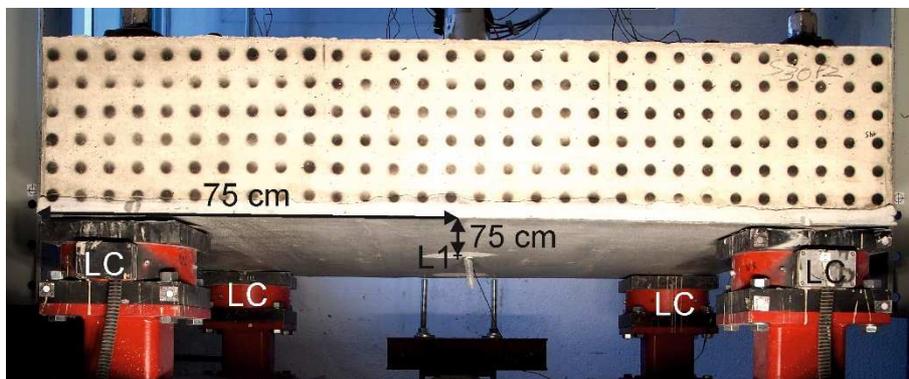
Fig. 4. View under the specimen with dimensions, graphic by Hering.

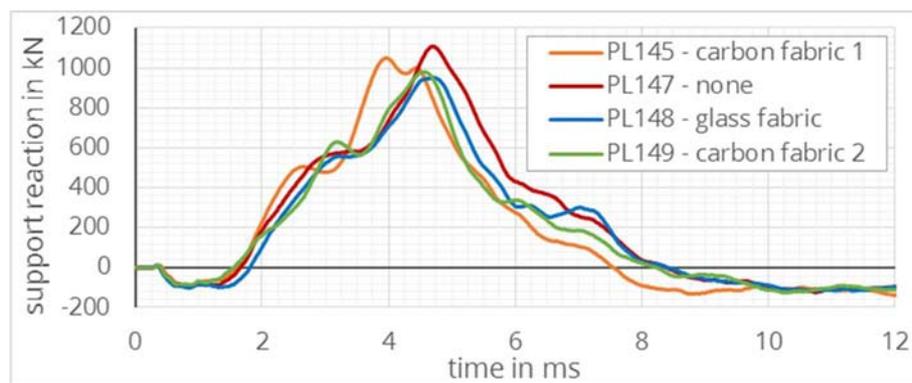
Fig. 5. Summarized reaction forces measured by the load cells, graphic by Hering.

Fig. 5 shows the support forces summed up from the four load cells. The support forces were recorded with a measuring rate of 200 kHz and only slightly smoothed by means of a moving average filter, which approaches a low pass frequency of about 20 kHz, see [[15]]. For the curves shown in Fig. 5, only the reaction forces were added up. No further processing of the measured data or compensation of the inertial forces were performed. A direct comparison within the test program carried out with the strengthened plates seems plausible, because:

From this, it can be concluded that the occurring inertial forces must be nearly equal for all strengthened plates, and thus they are included to the same percentage in the measured reaction forces. Even if we do not know the exact value of the inertial forces, the data of the different tests are therefore comparable. The recorded similar curves show that the experiments are comparable. Both the duration of the first load increase and its amplitude fit well together in all four experiments.

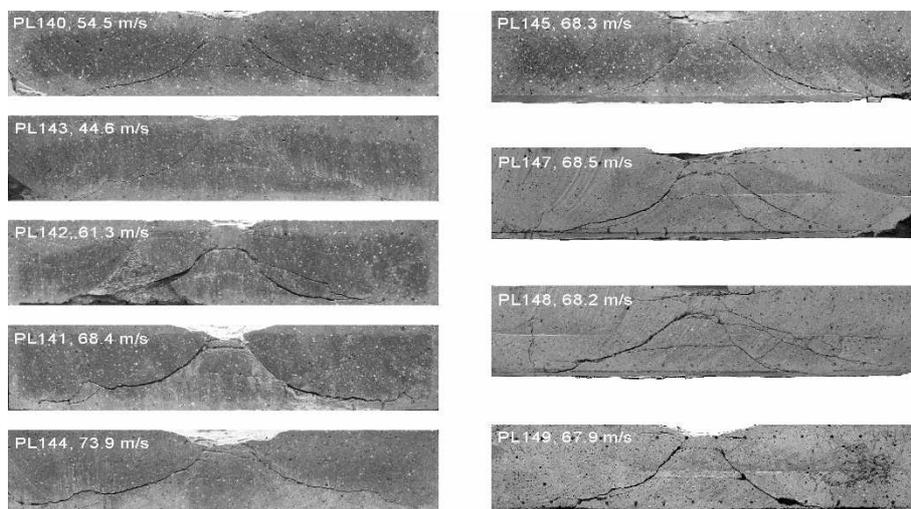
After conducting the experiments, the test specimens were cut in the middle parallel to two long sides using a concrete saw, Fig. 6. As a consequence, a direct examination of the damage inside the specimen was possible. In the left half of the picture, the sectional images through the 30 cm thick reinforced concrete plates are displayed (taken from Hering et al. [[15]]). The impact velocities and specimen labels used in each case were supplemented in the picture. The sectional images were arranged so that the velocity of the impactor increases from top to bottom. On the right half, the sectional images of the subsequently strengthened plates are shown (partly taken from [[8]]).

Fig. 6. Sectional images of the tested plates (30 cm thickness); PL140–144, see [[15]]; PL145 see [[8]]; PL147–149, graphic by Hering.

In Fig. 6, in the left half of the picture, one can clearly see how the damage inside the specimen increases with increasing speed [[15]] until the velocity of 68.4 m/s. From then on, the damage on the upper side of the test specimen also increases. If the sectional image of the subsequently strengthened RC plates are compared with these reference specimens, it can be determined that the damage pattern caused by the impact has the same characteristics for all specimens. The formation of a fracture structure is clearly visible in each case. This fracture body is separated from the rest of the test specimen by a crack. The crack begins on

the upper side of the plate in the area hit by the impactor and runs at an increasingly decreasing angle to the lower side of the plate.

The choice of the impactor velocity for the experiments with the strengthened plates was based on the damage of the reference RC plates documented in [[15]]. Fig. 6 shows saw cuts through the reference RC plates on the left side. On the basis of the internal damage to the plates as shown in these sectional views, it was a matter of debate to use approx. 61 m/s or

approx. 68 m/s as the impactor velocity. In both experiments a clear damage can be seen inside the plate. In the end, it was decided to use an impactor velocity of approx. 68 m/s. The decision in favour of the higher velocity is based on the need to ensure that the strengthening layer is activated. Therefore it seemed better to us to apply a little more impact velocity and thus more impact energy than too little. If there had been insufficient damage to the test specimen with the chosen configuration, the experiments would have had to be repeated. This had to be avoided.

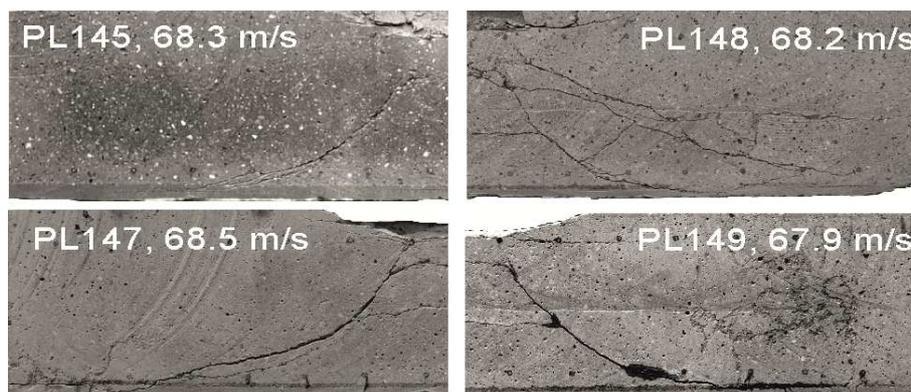
No separation of the strengthening layer and primary test specimen occurred with any subsequently strengthened plates. Furthermore, no spalling of the strengthening layer could be detected. Upon detailed examination (Fig. 7), it can be seen that the separation crack in test specimens PL145 (strengthened with fabric 1) is the least open compared to the other test specimens. Furthermore, an interesting characteristic in the crack path in the lower part of the plate can be found when looking at the test specimens PL147, PL148 and PL149. It can be seen here that the crack in sample PL147, whose strengthening layer was not reinforced, runs relatively straight through the strengthening layer. In contrast, the crack in samples PL148 (glass fabric) and PL149 (carbon fabric 2) propagates into the strengthening layer and then continues horizontally between the reinforcement layers of the strengthening layer.

Fig. 7. Detailed view of the sectional images – strengthened plates, graphic by Hering.

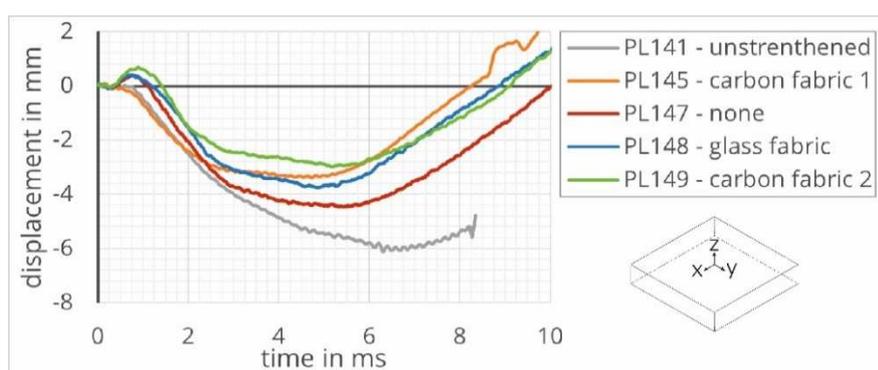
Fig. 8. Plate deformation measured at position w1 on the upper side of the plates near the impacted point, graphic by Hering.

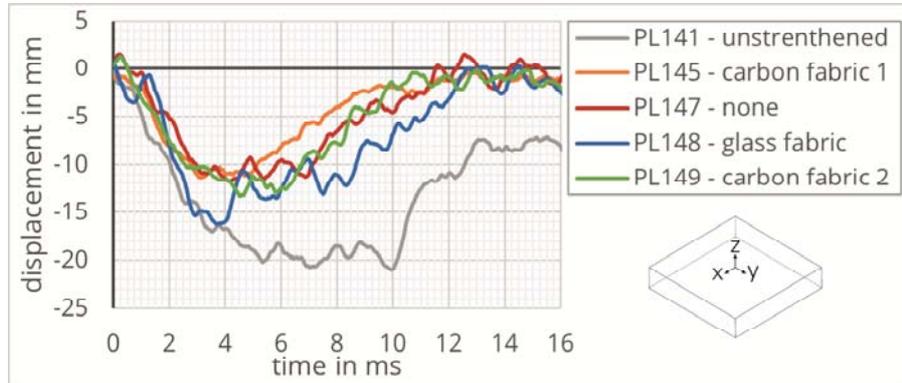
Fig. 9 shows the deformations measured at position L1 in the plate's centre directly under the centre of the point of impact on the bottom side of the plate. As expected, the reference RC plate shows the greatest deformation. The deformations of the strengthened plates are smaller here. The same tendencies can be identified in Fig. 9.

Fig. 9. Plate deformation measured centrally at the bottom of the plates (position L1), graphic by Hering.
