Non-destructive Inspection of Composite Aileron during Fatigue Test

Michal Podstawka^{1*}, Vladimír Snop¹, Petr Bělský¹ and Kristýna Kutiová²

¹VZLU – Czech Aerospace Research Centre, Strength of Structures Department, Beranovych 130, Prague 9, 199 05, Czech Republic

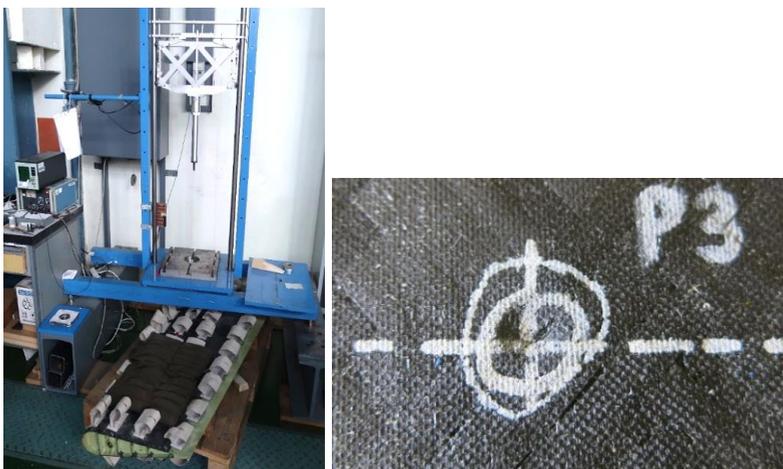
The operational defects were created as BVID (Barely Visible Impact Damage) after the completion of the second life of fatigue test using an impactor. BVID is barely visible surface damage which is not noticeable at the first glance. These BVID damages represent a high level of risk to the safe operation of composite components. The range of energy used for impacting was from 20 J to 50 J. The process of creating BVID defects on the SUPR system can be seen in Fig. 1.

Fig. 1. Creating artificial (operational) defects (on the left) and the impact damage (on the right)

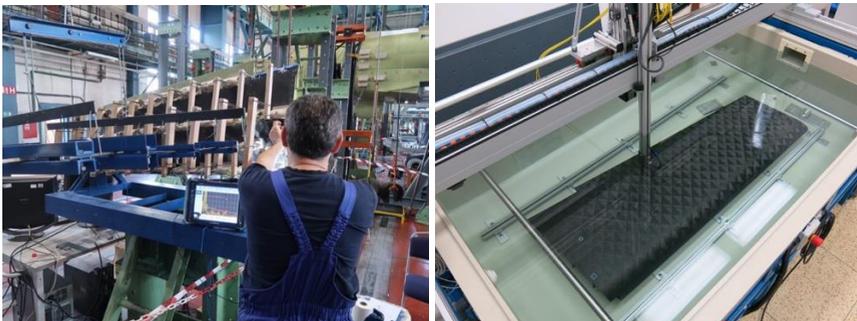
UT inspection using both conventional and immersion phased array techniques (using 3-axis automatic system). The phased array (PA) technique is based on the usage of a probe set, in combination with special electronic circuits, which could shape the beam. PA probes consist of a set of miniature piezoelectric transducers. The setting of output parameters for each transducer separately forms the beam.

For the ultrasonic testing, the ultrasonic device Olympus OmniScan MX2 and the conventional Olympus V 203-RM 5 MHz and phased array Olympus 5L128-I2, 5 MHz probes were used.

Fig. 2. NDT inspection (UT) during fatigue test of the aileron (on the left) and immersion phased array techniques before the fatigue test started (on the right)
