Experimental measurement of dynamic loading and numerical analysis of gas pipeline damaged by corrosion

Abstract. The paper presents the results of the expert works in the area of diagnostics, repair, and reconstruction of the steel pipelines of the transit gas pipeline (TP) on Slovak territory. One part of our work included dynamic measurements of a steel casing pipe located under the railway. This pipeline was damaged by corrosion and it was necessary to evaluate its safety.

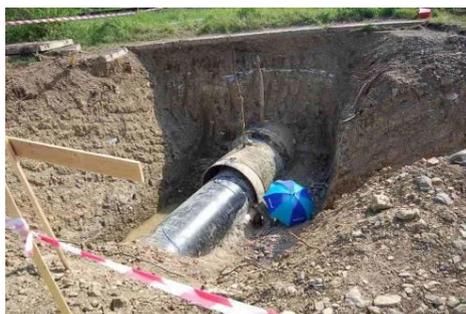
Fig. 1. Excavation at the measuring point

On the other side (Slánské Nové Mesto), where the measurements were performed, the height of the cover layer above the pipeline was approximately 2.5 m (Fig. 1). There were significant cracks in waterproofing found on both sides. The values of vibrations and stresses were measured in three places - on the outer tube of the casing, on the inner tube of the casing and on the gas pipeline. The measuring points are shown in the Figure 2.

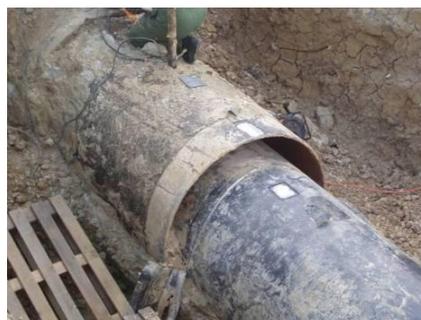
Fig. 2. Measuring points

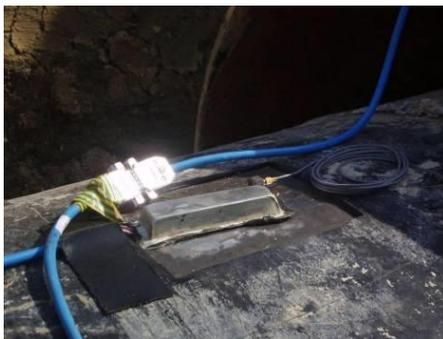
Fig. 3 Strain gages

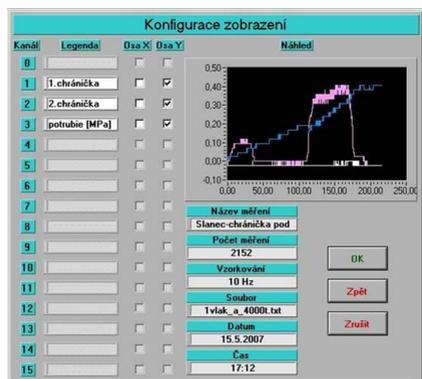
Fig 3. Strains measurement results

Gradually, 15 train sets (passenger trains, express trains, and cargo trains) moving along the normal gauge were monitored. Trains on the wide gauge were registered after 4:00 p.m. The strains measured by passing on a normal gauge train were in the minimum ranges (0 - 1MPa). The total maximum vibration values ranged from of 0.08 to 0.1 mm. Measurements were performed at the lower limits of sensor sensitivity. The fact that the pipe stress state also changed during the train's passage is a proof that the load is transferred from the guard to the pipe via the centring rings.

The results of strains measurements during the passage of a cargo train (4000t) on a wide gauge line are shown in the Figure 4 and the frequency measurements are shown in the Figure 5. The maximum displacement of the pipeline caused by a cargo train passing through the wide gauge railway amounted to 125 μm . This data was then used in the theoretical analysis.

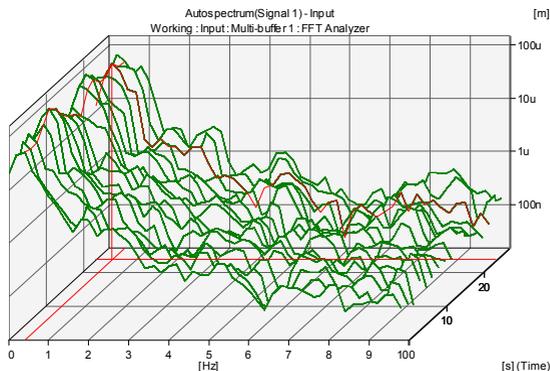
Fig 5. 8th Measurement - autospectrum (cascade) passing of cargo train on a wide gauge line

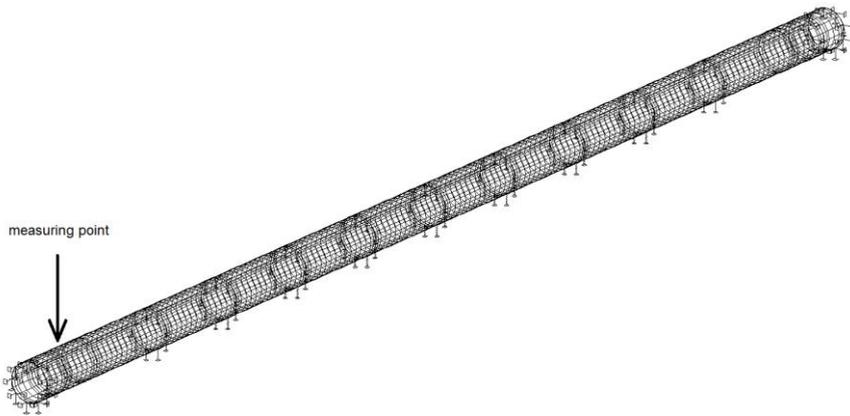
Fig 6. FEM model.

Due to the inaccessibility of the pipeline in the casing (it was not possible to provide experimental measurements), the only way to find out the stress level on the pipe in the middle of the casing was numerical calculation. In the first step, the load distribution from the train (UIC -71 and a heavy cargo train) through the embankment body was analysed, because the pipeline was in the depth from 3.9m (normal gauge) to 5.35m (wide gauge). In the next step, this load was applied to the FEM model of the pipeline (Fig 6). Calculated stresses were compared with the stresses measured in-situ approximately on the same place (end of the casing) (Fig 7.). After calibration of the calculation model, the change of stress state of the pipe was analysed on a model with reduced wall thickness as a means of simulating the corrosion effects. Maximal depth of corrosion loss was 3.5mm at pipe \varnothing 1220/18.9mm from material X70.

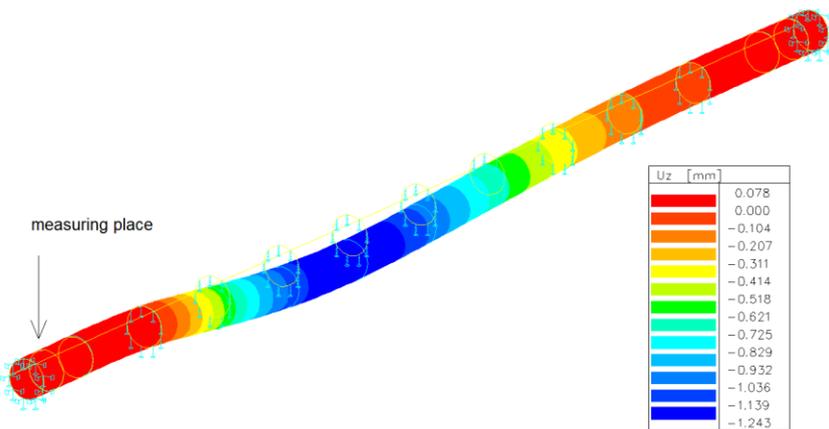
Fig 7. Displacements by passing of heavy cargo train.

The results show that if the stress at the end of the casing at the in-situ measuring point is 1MPa (as measured), the calculated stress caused by the passing heavy cargo train on the pipe inside the casing ranges between 7 and 10MPa.

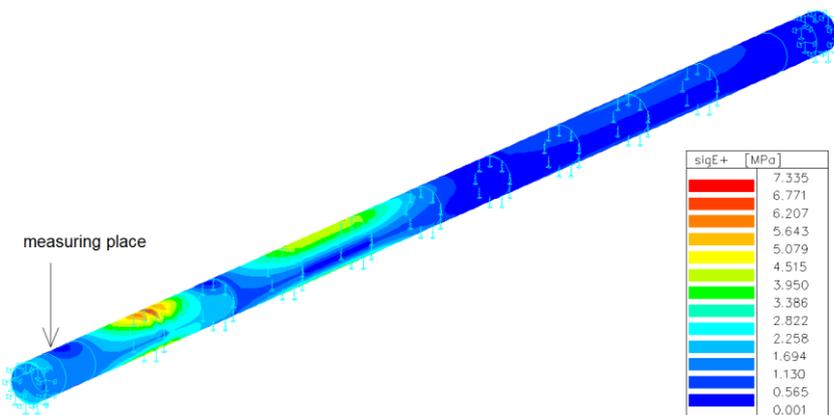
Fig 8. Stresses by passing of heavy cargo train.

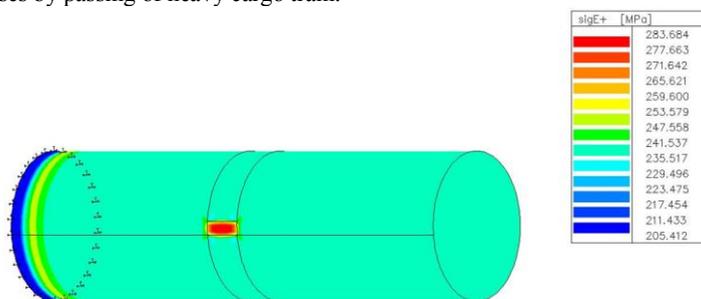
Fig 9. Stresses by local corrosion loss of 3,1mm and internal gas pressure 7,35MPa.

The second calculation shows that local weakening of the pipeline by corrosion will cause an increase of stress by more than 40MPa.
