# Cause analysis and simulation verification of a 220kV GIS basin insulator along surface discharge

**Abstract.** A surface discharge fault of 220kV GIS basin insulator during power transmission has been analyzed. Combined with on-site disassembly inspection, data from previous tests and structural design, the fault point is determined and the fault cause is preliminarily analyzed. In order to verify the correctness of the analysis results, this paper uses the finite element method to mathematically model the accident basin insulator, and formulates the boundary conditions for the calculation of the electric field inside the basin insulator. The simulation results show that there is a distorted electric field on the surface of the basin insulator, which is the main reason for creeping discharge. The preventive measures are summarized for the creeping discharge fault of the basin-type insulator to avoid the occurrence of similar accidents.

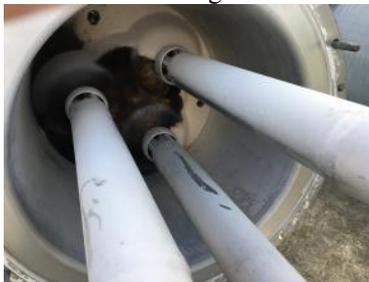
**Fig. 1** Vent basin insulator and conductor at fault side

After on-site inspection and equipment opening inspection, it was found that there was severe discharge at the top of the transition section between manufacturers A and B (plant A side), and there was no discharge trace on the other side of the basin insulator (plant B side), only on the conductor Scattered with white powder. On January 25, 2018, the factory staff conducted a physical inspection of the GIS of the fault section on the spot. Serious discharge marks were found on the surface of the ventilated basin insulator on the fault side, and a large amount of dust was scattered on this side, which is due to the effect of SF6 gas on the arc. The resulting material is shown in Figure 1.

Preliminary analysis is based on the premise that the insulation margin of the GIS gas chamber design is relatively low, and due to the operating over voltage caused by the bus tie switch closing, the transition conductor structure of the wide and narrow barrel diameter and the voltage equalization base of the conductor root The phase-to-phase aggravated the distortion of the electric field, and then caused the surface discharge phenomenon on the surface of the failed basin insulator, which eventually led to the occurrence of the failure.

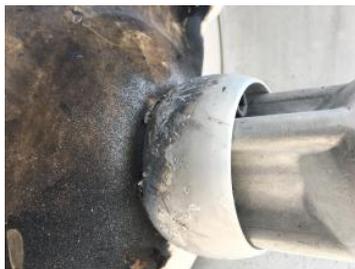
**Fig. 3** Phase B conductor base

The B and C three-phase conductors have serious discharge traces on the base roots, and the B and C traces are more obvious. There are some traces on the edge of the shell, and no discharge traces are found in other parts. As shown in Figures 2, 3, and 4.

Comparing the three-phase discharge situation, it can be seen that the interphase electric field distortion degree of the base is higher than the electric field of the conductor to the shell. No discharge traces were seen on the non-faulty side vented basin insulator and conductor fixing base.
