# An objective assessment strategy for industrial reinforced concrete structures – Case study.

**Abstract.** Due to the booming construction wave between the 60's and 80's, a lot of reinforced concrete structures are now approaching their intended service life design. Concerning the industrial sector, an unforeseen shutdown of production processes due to urgent maintenance or repair actions of reinforced concrete structures can have major consequences for owners and managers. Therefore, it is important that they get a clear view of the current state of their structures in order to shift towards a more proactive maintenance. In order to recognize and assess both classic and more complex damage phenomena, a scientific approach to translate collected field data towards a service life and inherent repair strategies for the concrete structure is adopted by means of an in-house developed data analysis tool DIMCoSt (Durability Information Model for Concrete Structures). The objective assessment strategy is described in this paper by means of a case study. The subject of the case study is concrete storage silos. Although the applied methodology is mainly universal, each case has its own e

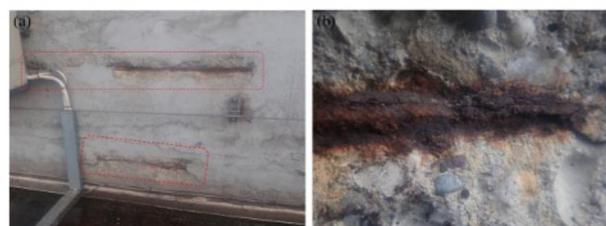
**Fig. 3.** Examples of damage patterns for the storage silos

The damage visible at the walls of the storage silos was different for the different construction phases. For the silo tower from construction phase 1A, the damage was mainly characterized by rebars without any concrete cover, spalling of the concrete due to corroding steel reinforcement and damage of previously executed patch repairs as shown in Fig. 3 (a) and (b). For the silo block and the silos from construction phase 1B and 2 the main damage patterns were horizontal and vertical cracks, damage of previously executed patch repairs, spalling of the concrete and surface weathering as shown respectively in Fig. 3 (c), (d) and (e), (f).

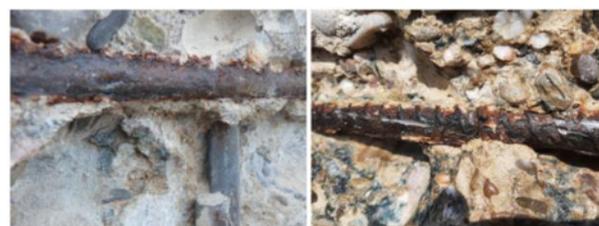
**Fig. 9.** State of the reinforcement of phase 1A (left) and phase 1B (right)

Based on the half-cell potential measurements, the condition of the reinforcement was checked by locally exposing steel reinforcement bars. This location is always chosen at the point where the most negative steel potential is measured and in a zone where no rust or cracks are present at the surface. Additionally, the section of the reinforcing bars has been measured. In case of phase 1A, smooth steel has been observed with a nominal diameter of 10 mm and a spacing of 250 mm between the horizontal bars and 250-300 mm between the vertical bars. Phase 1B has ribbed reinforcing bars with a diameter of 10 mm vertical and a diameter of 14 mm horizontal. The spacing is respectively 300 mm and 200 mm. An example of the state of the reinforcement for each phase is shown in Fig. 9.

The application of ICCP is the most appropriate technique for phase 1 (both silo tower and silo block) to prevent the degradation of the silos in long term. For almost all investigated locations the reinforcement has progressed into a moderate to severe degree of local or global corrosion.

The application of ICCP is considered to be the most efficient. In case of execution the following technical aspects are relevant.

- The existing reinforcement is electrically continuous for all examined reinforcement zones.
- Active corrosion of the reinforcing steel was found at all locations. This mainly concerns the horizontal bars, which is the main reinforcement, but with the lowest concrete cover.
- The reinforcement amounts are uniform for each phase (1A and 1B) and are relatively low. A density of approximately 0.25 m<sup>2</sup>steel/m<sup>2</sup>concrete and 0.30 m<sup>2</sup>steel/m<sup>2</sup>concrete must be taken into account in the design of the ICCP system.
