# Concrete of tomorrow: corrosion performances in marine environment

**Abstract.** Concrete is the most used construction material worldwide, but it often faces durability issues due to rebar corrosion, and cement production can be energy consuming. Attempts to improve its resilience versus corrosion while reducing its carbon footprint are ongoing at an international level. In this objective, in France within the framework of the national project PERFDUB, a series of reinforced concrete walls were cast with innovative concrete designs, two shapes of rebars and two concrete covers. The standard performances of the different concrete mix designs were evaluated at a laboratory scale. Then the walls were exposed in the French La Rochelle harbor, in the tidal zone in order to monitor the evolution of the corrosion of the bars for a period of twenty years. The first results of the electrochemical follow-up of these reinforced walls are presented in this paper.

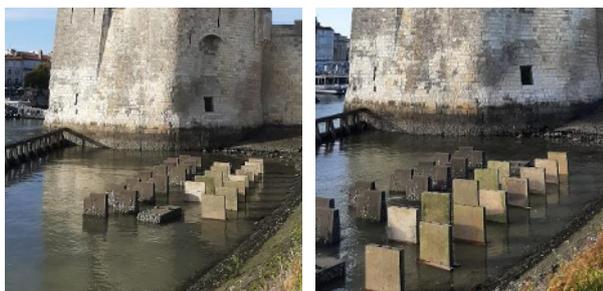
**Fig. 9.** During the tide's descent, the bottom of the walls remain immersed for a longer time.

Another phenomenon can be observed on the potential maps, which exhibit an electronegative gradient from the top to the bottom of the walls on both faces, but clearer with the lowest concrete cover (RL10 and HA10, Fig. 6). The explanation could come from the duration of the tide's descent on the one hand, as the bottom of the walls stays wet a longer time, which favors more electronegative values (Fig. 8). On the other hand, when the tidal coefficient is low, the walls are not totally immersed (Fig. 9), which means that the top of the walls remain in the open air and can dry, while the bottom is totally under water.

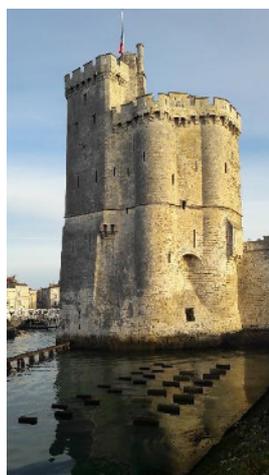
**Fig. 10.** At high tide with low tidal coefficient, the top of the walls remain in the open air.
