# Autogenous Healing in Ultra-High-Performance Fibre Reinforced Concrete: application in two reduced scale water reservoirs

Marta Caballero-Jorna<sup>1,\*</sup>, Hesam Doostkami<sup>1</sup>, Marta Roig-Flores<sup>2</sup>, and Pedro Serna<sup>1</sup>

**Abstract.** Self-healing is defined as the capacity of a material to repair internal damage without any external intervention. In the case of concrete, this process can be autogenous, which is the natural capacity of the material. Ultra-High-Performance Fibre Reinforced Concrete (UHPFRC) has a high self-healing potential due to its high binder content with a low w/b ratio and its crack pattern with multiple micro cracks. This paper describes two UHPFRC water reservoirs, which were designed to minimise the volume of concrete used. The design is made of ribbed thin walls where shrinkage cracks are likely to happen. The objective of this work is to study the autogenous healing capability of this concrete in these cracks. The two water reservoirs have internal dimensions of  $1.30 \times 0.75 \times 0.70 \text{ m}^3$  and with 20 mm thickness in the centre of the walls. These walls displayed cracks ( $w < 100 \mu\text{m}$ ), which were

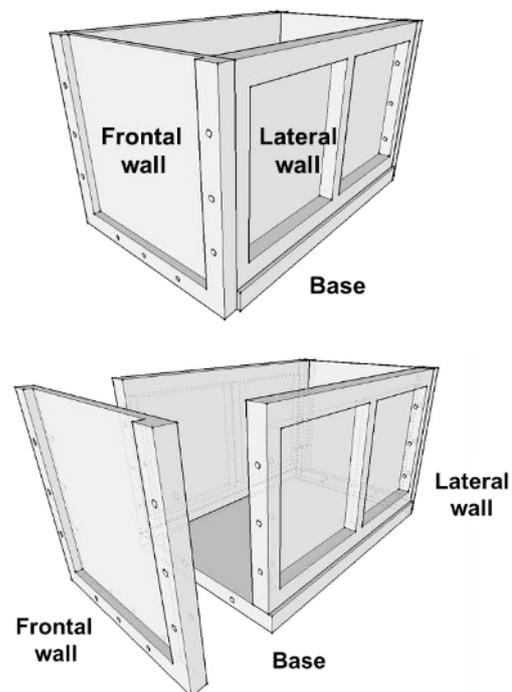
**Fig. 1.** 3D diagrams of the designed reservoirs indicating its elements.

The reservoirs were designed with a precast concept, where the elements were manufactured independently and subsequently assembled. Fig. 1 displays the elements of each of the water reservoirs, which consisted of: two frontal walls, two lateral walls, and one base. The frontal and lateral walls were assembled with bolted joints, displayed as small circles in the diagrams. The assembly process will be described in a later section.

The frontal and lateral walls were designed to have 30 mm thickness in the centre of the wall and the perimetral ribs had a section of  $80 \times 60 \text{ mm}^2$ . The central area was unreinforced while the ribs were reinforced longitudinally with  $2\Phi 6$  rebars. The frontal walls do not have the top rib as displayed in Fig. 1.

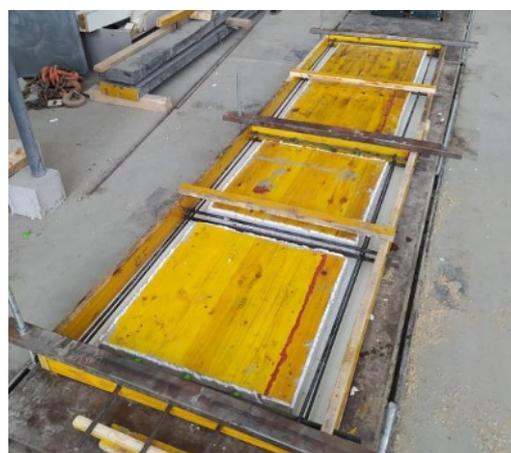
**Fig. 2.** Formwork and placed rebars for the lateral walls

The two lateral walls of reservoir no.1 were cast on 10th September 2020 (Fig 2), and on 18th September 2020, the two lateral walls of reservoir no.2 were cast. The four frontal walls (two per water reservoir) were cast on 14th September 2020 (Fig 3).

After this process, the formwork and reinforcement for the base elements were prepared. The frontal and lateral walls were placed in their final position. Frontal and lateral walls were fixed to one another by using threaded rods and nuts. Fig 2 shows these rod elements in the lateral walls' formwork and the holes prepared for the connection in the frontal walls' formwork (Fig 3). At this stage, the precast walls were around 10-14 days.

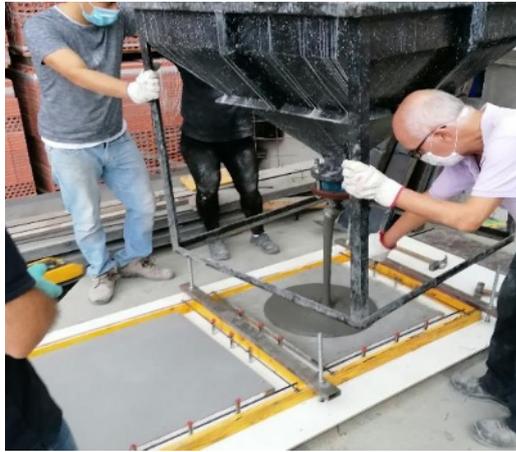
**Fig. 3.** Formwork of the lateral walls and UHPFRC being poured into the formwork of the frontal elements.

The self-compacting properties of this UHPFRC mix allowed casting all the ribs easily. Fig 3 shows the mix being poured into one of the formworks for a frontal wall.

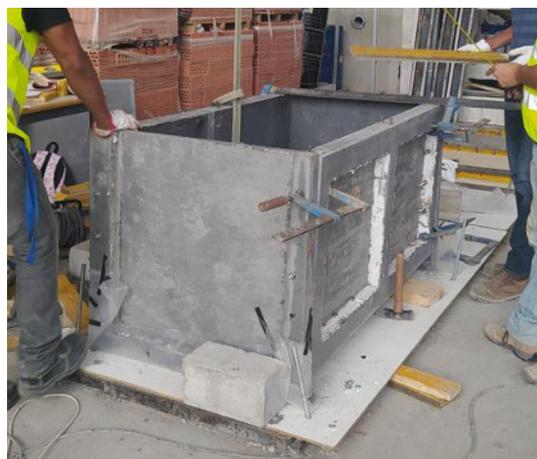
**Fig. 4.** Frontal and lateral walls placed before pouring UHPFRC for the base of a reservoir.

During the pouring process of the bases, clamps were used as an additional support for fixing the elements in their position. Additionally, plastic sheets were placed to ensure no leaks of UHPFRC were produced (see Fig 4). Fig. 5 shows the pouring process for producing the base of one of the reservoirs, which was done by pouring from the interior of the element, and thanks to its self-compacting properties, the material flowed and was distributed throughout the formwork.

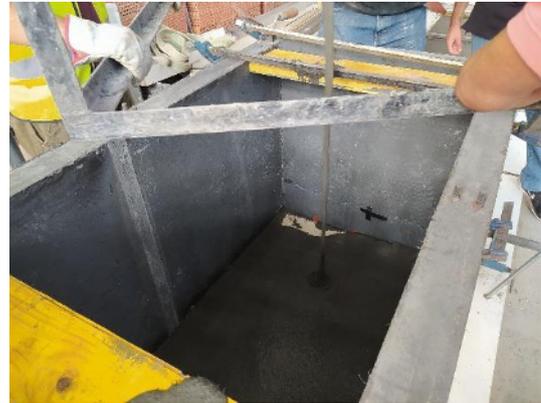
**Fig. 5.** Pouring UHPFRC inside the formwork for producing the base of the reservoirs.

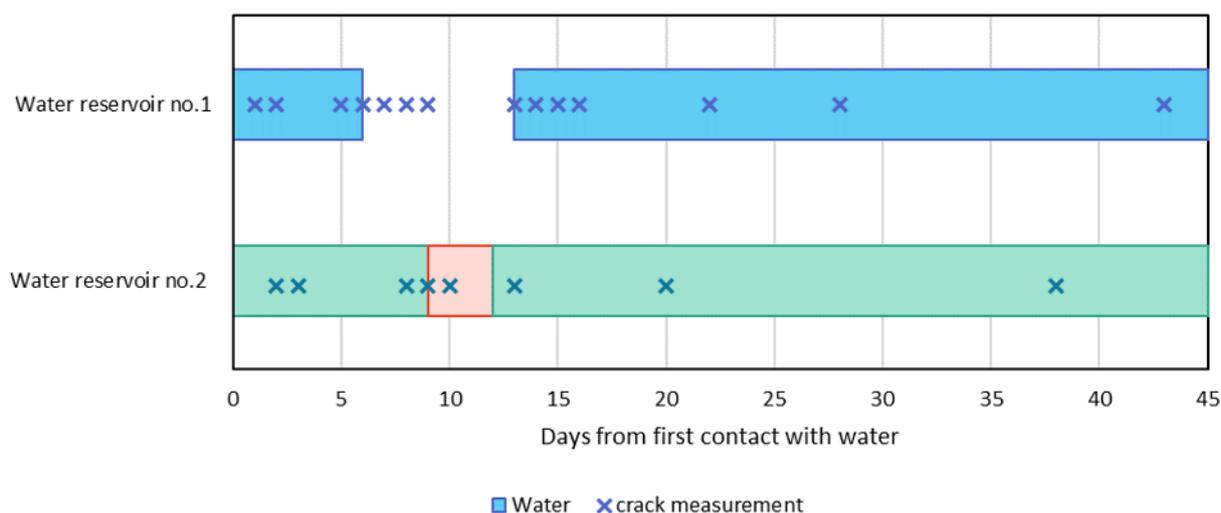
**Fig. 6.** Chronology of the presence of water in the reservoirs (bars) and crack measurements (crosses). The period of time without water in water reservoir no.1 is displayed as an empty area. The period of time with warm water in water reservoir no.2 is displayed in orange.

In order to analyze the self-healing performance, time 0 of healing is defined as the day when the reservoir is put in contact with water for the first time since water is the agent needed to promote the self-healing reactions. The chronology of filling the reservoirs with water and dates of crack measurements are displayed in Fig 6.

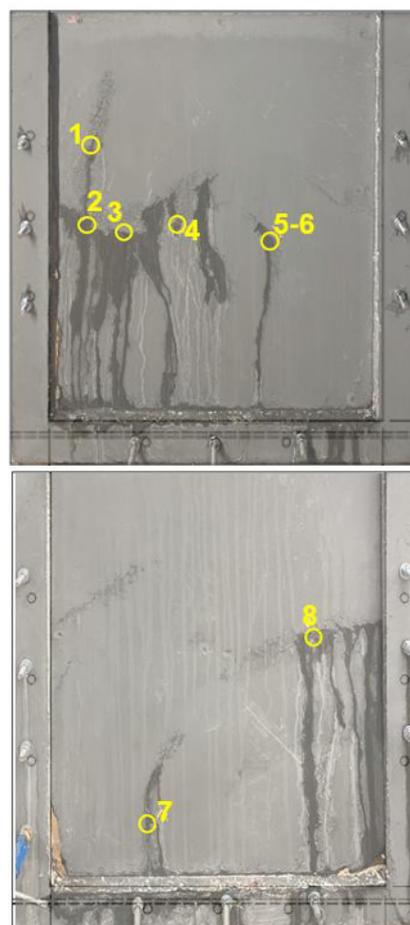
**Fig. 7** Frontal walls of reservoir no.1 with water leakage marks

In order to evaluate the self-healing capability, the crack sizes on the two frontal walls of the two reservoirs were measured using a YINAMA Wi-Fi microscope. Among all the crack branches, the most representative cracks were chosen from those with apparent water leakage. Eight cracks from water reservoir no.1 were monitored (marked with circles and numbered in Fig 7) for 43 days. Four cracks from water reservoir no.2 were monitored for 37 days as well.

started at the confluence of the walls with the base, reaching 1/3 of the wall height. The highest cracks appeared in the middle of the wall. The horizontal cracks appear in the frontal walls. The crack patterns that were produced in the frontal walls of water reservoir no.1 are displayed in Fig 7. The crack pattern in water reservoir no.2 walls were very similar.

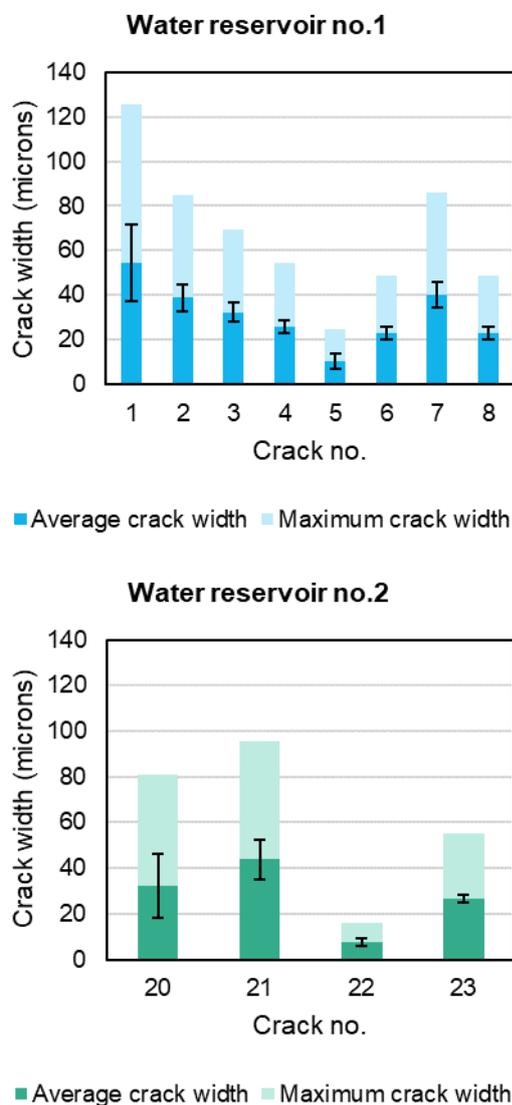
**Fig. 8.** Average and maximum crack width values were measured in the two water reservoirs before healing. Average values include standard deviation as the dispersion whiskers.

The average and maximum initial crack opening were measured in the frontal walls of the two reservoirs. These values are displayed in Fig 8 for the two reservoirs. All the cracks were below 100  $\mu\text{m}$  (with the exception of one local reading), and the average value measured was generally below 50  $\mu\text{m}$ . The low crack width values detected explains that cracks were not located before filling the reservoir with water, but they could have been present during the curing or assembly stages.

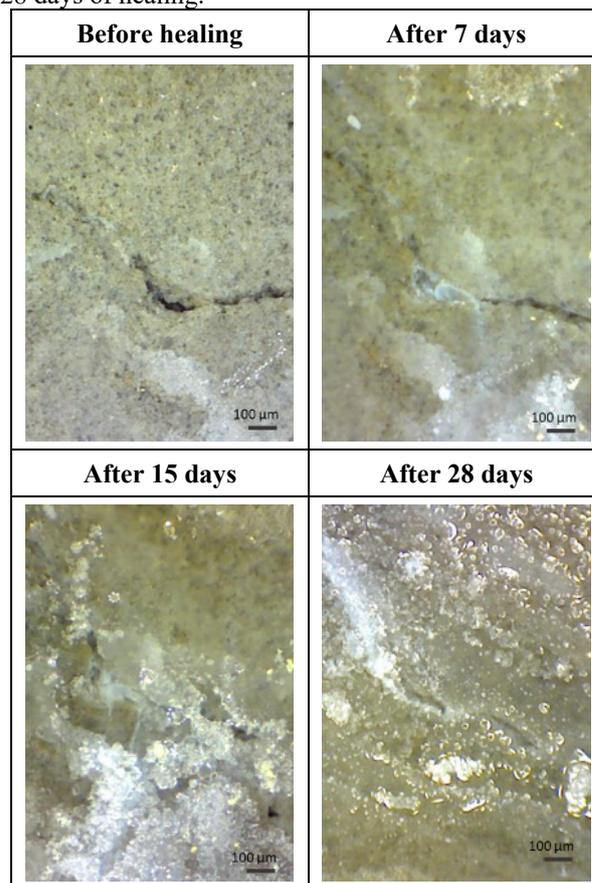
**Fig. 9.** Example of visual healing of a crack on the 1<sup>st</sup>, 7<sup>th</sup>, 15<sup>th</sup>, and 28<sup>th</sup> days after filling reservoir no.1 with water.

Fig 9 shows the crack closing evolution of one representative crack of a frontal wall of water reservoir no.1. The photos show that after 7 days in contact with water cracks are partially filled with white deposits due to the self-healing reactions, and after 15 days the crack is

visually filled completely. Surface deposits are also detected after 7 days, which are more present after 15 and 28 days of healing.

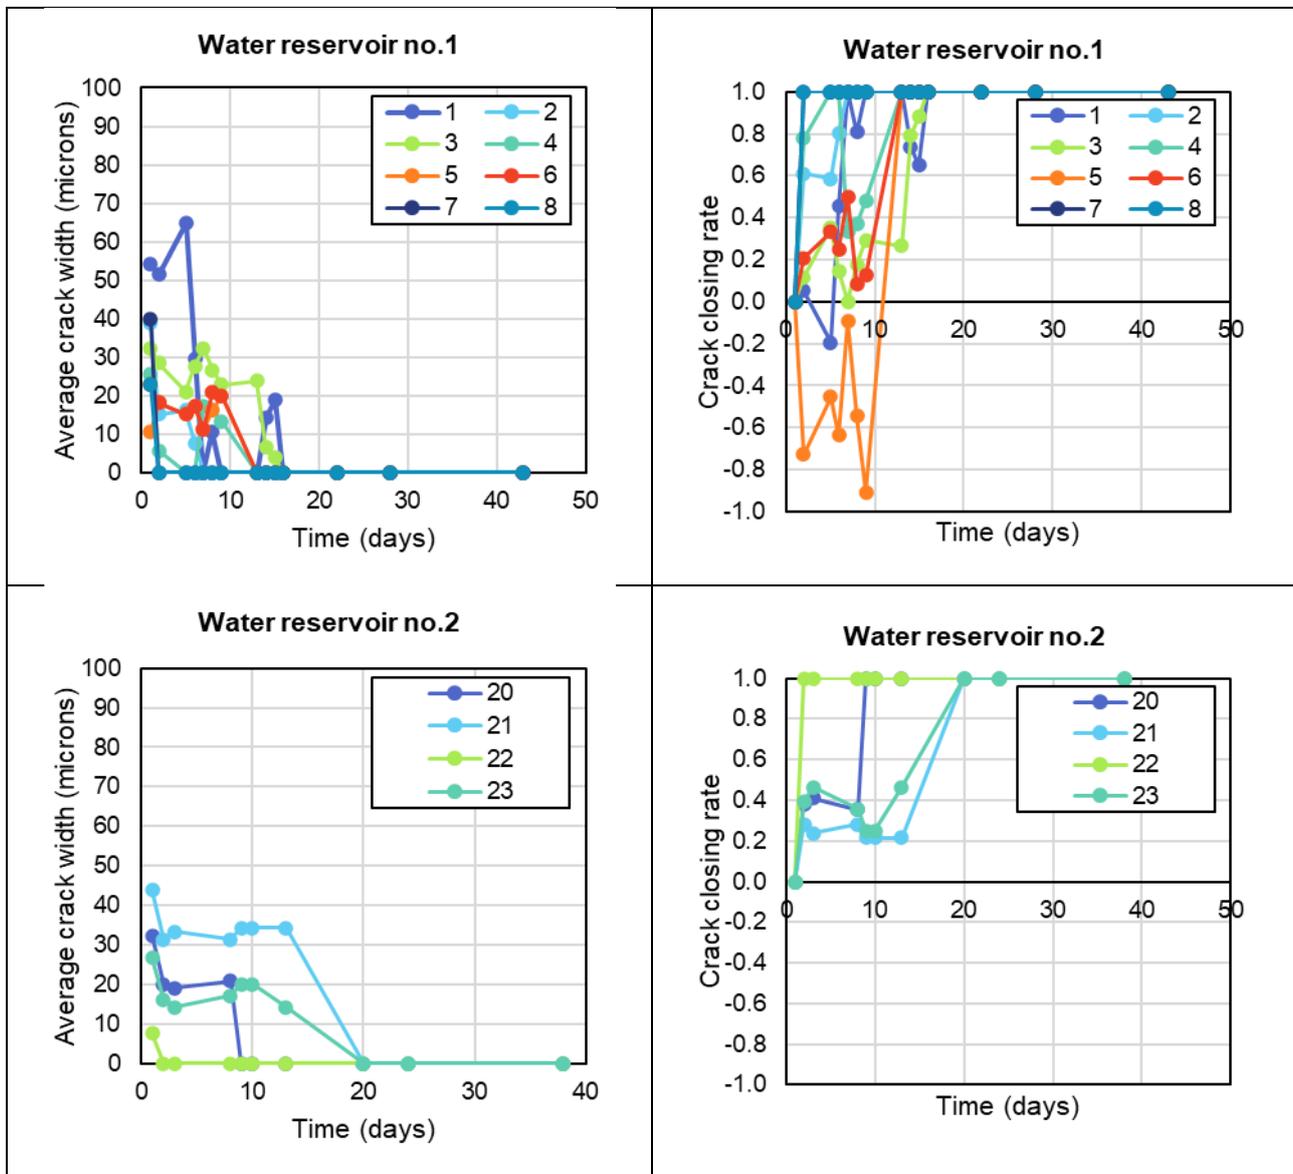
Fig. 10. Top row: Water reservoir no.1, bottom row: water reservoir no.2. Left column: crack width evolution. Right column: Crack closing rate of the cracks monitored.

The crack width measurements on both reservoirs are presented in Fig 10 left column, where the horizontal axis indicates the number of days after filling the reservoir with water, which can be assimilated with the number of days from when effective healing can take place.

Fig 10 shows a linear descending trend for crack width in all the cracks on both reservoirs. Due to the small size of the cracks (usually lower than 80  $\mu\text{m}$ ), after 20 days of healing, almost all points of all the cracks were closed. As expected, larger cracks needed more time to be completely healed, while smaller cracks healed a few days after the first contact with water. Most of the process happened in the first week, which is consistent with the results from other studies [10], [19].

Additionally, the crack closing rate of each crack was evaluated using Eq. (1), and the values are displayed in Fig 10 right column, showing the gradual increase of the crack closing rate during the monitoring time. One crack had a slight reopening (negative closing rates), until day 9 of healing, followed by a full closing afterwards. Most of the cracks had complete closing after 20 days.
