Restoration of existing historic concrete structures with PE fiber strain hardening cementitious composites.

Abstract. Important historic buildings of the 20th century located in the seismogenic zones of the Mediterranean have been designed without the provisions of Eurocode 8; thus, they require strengthening to account for seismic excitations and to be rendered safe for use by future generations. A common disadvantage in historic concrete buildings is the insufficient or even null reinforcement in shear, which usually results in brittle shear failures. This research focuses on the use of a self-compacting, fiber reinforced cementitious composite, which can be applied as cover replacement, or in a thin layer around the perimeter of an existing column, thus providing confinement to the original core and increasing the shear strength of the structural member. Different mix designs prepared in various countries have been examined, all incorporating the use of industrial by-products, such as silica fume or fly ash. The aforementioned mixtures were replicated with the use of locally available raw materials at the laboratories of the University of Cyprus. Polyethylene (PE) fibers, with

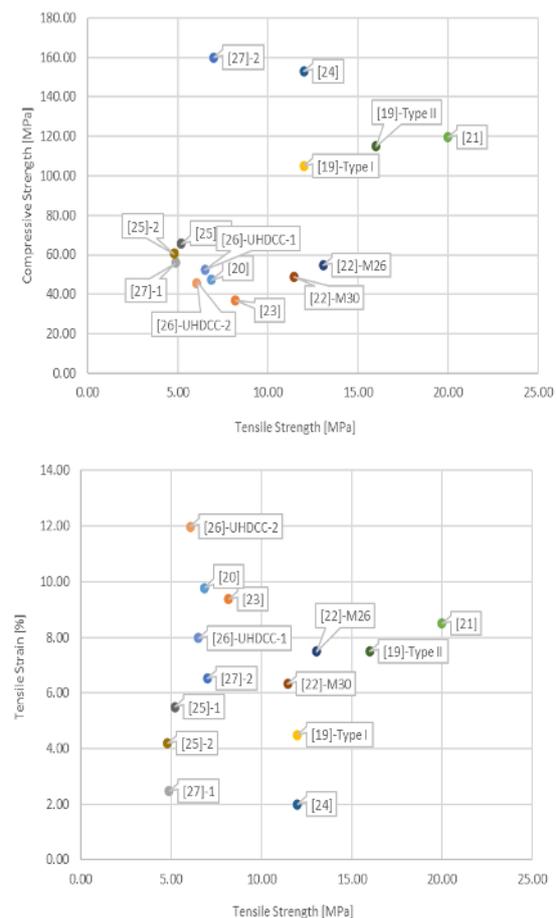
Fig. 1 Performance of SHFRCC from the literature in terms of compressive-tensile strength and ductility in tension [19],[20],[21],[22],[23],[24],[25],[26],[27]

Through an extensive literature research, a series of strain hardening fiber reinforced cementitious composites (SHFRCC), prepared with the use of PE fibers by different research groups around the world, have been identified, and their performance in terms of tensile strength, compressive strength and ductility was compared, as shown in Fig. 1. Minimum requirements in terms of performance and local availability of materials were set to select some of these mixes to be prepared at the laboratory facilities of the Department of Civil and Environmental Engineering at the University of Cyprus. The various mix designs selected were prepared with different types of cement, sand, fly ash or silica fume and PE fibers. The same aggregates were used throughout, thus facilitating a performance comparison.

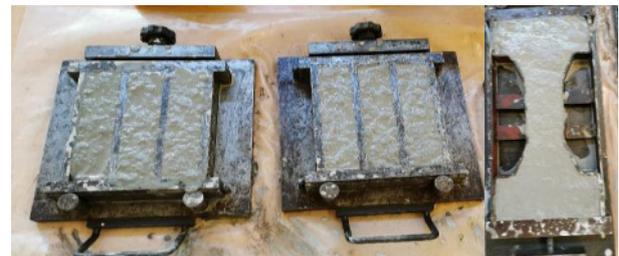
Fig. 2 Molds for compression/flexure and tension specimens

The experimental procedure had to be carefully designed to ensure proper fiber dispersion within the mixture. Initially, the dry materials, such as silica sand, fly ash and silica fume, were mixed with the cement for 5 min. Then, as the dry materials were mixing, water and HRWR were added to the mix. After the mix obtained self-compacting fluidity, the polyethylene fibers were slowly added to disperse in the entire mix. Mixing of the materials continued until a cohesive and self-compacting composite was achieved. Each mixture was cast into dogbone and small beam shape molds, as shown in Figure 2, and was kept for 24 hours at room temperature. After demolding, all specimens were cured in water for 28 days, until testing.

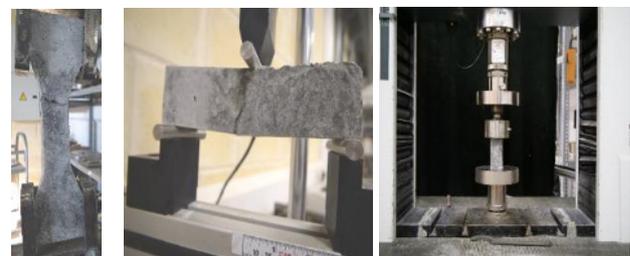
Fig. 3 Experimental setup for uniaxial tension, 3-point bending and uniaxial compression

Uniaxial compression tests were performed on 40x40x80 mm specimens, as shown in Fig. 3. The load was applied by displacement control with a speed of 0.024 mm/s, for static conditions and in order to obtain the post-peak descending branch of the behaviour of the materials.

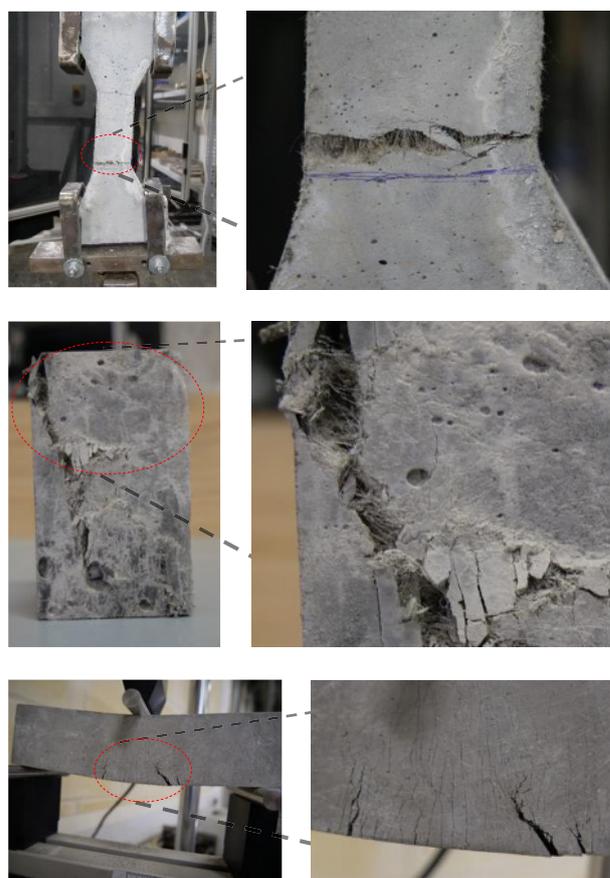
Fig. 4 (Top) Dogbone specimen after failure, (Middle) PE fibers bridging a crack, (Bottom) Multiple cracking during bending test

Polyethylene fibers used in the mixes play an important role in avoiding abrupt tensile failure and maintaining a relatively constant strength as the deformation increases. Specimens hereby tested exhibited strain hardening in tension after the first cracking, that is attributed to the tensile strength of the matrix, with the formation of multiple cracking along the critical 100 mm length. After a critical tensile strength, deformation was localized in a single crack (Fig. 4), while the tensile strength gradually reduced, with fibers pulling-out from the critical cross-section.

Figure 4 shows an example of the crack pattern of a specimen in the 3-point bending test, with multiple cracks visible at the tensile zone of the specimen. This pattern developed in all the specimens tested, albeit to a different extent in terms of width of the cracking zone, number of cracks and distance between the cracks. After a certain hardening effect with increase of the load capacity of the beams, localization of deformation was exhibited, leading evidently to failure of the specimen. Equation 1 was used to calculate the flexural stress corresponding to the load.

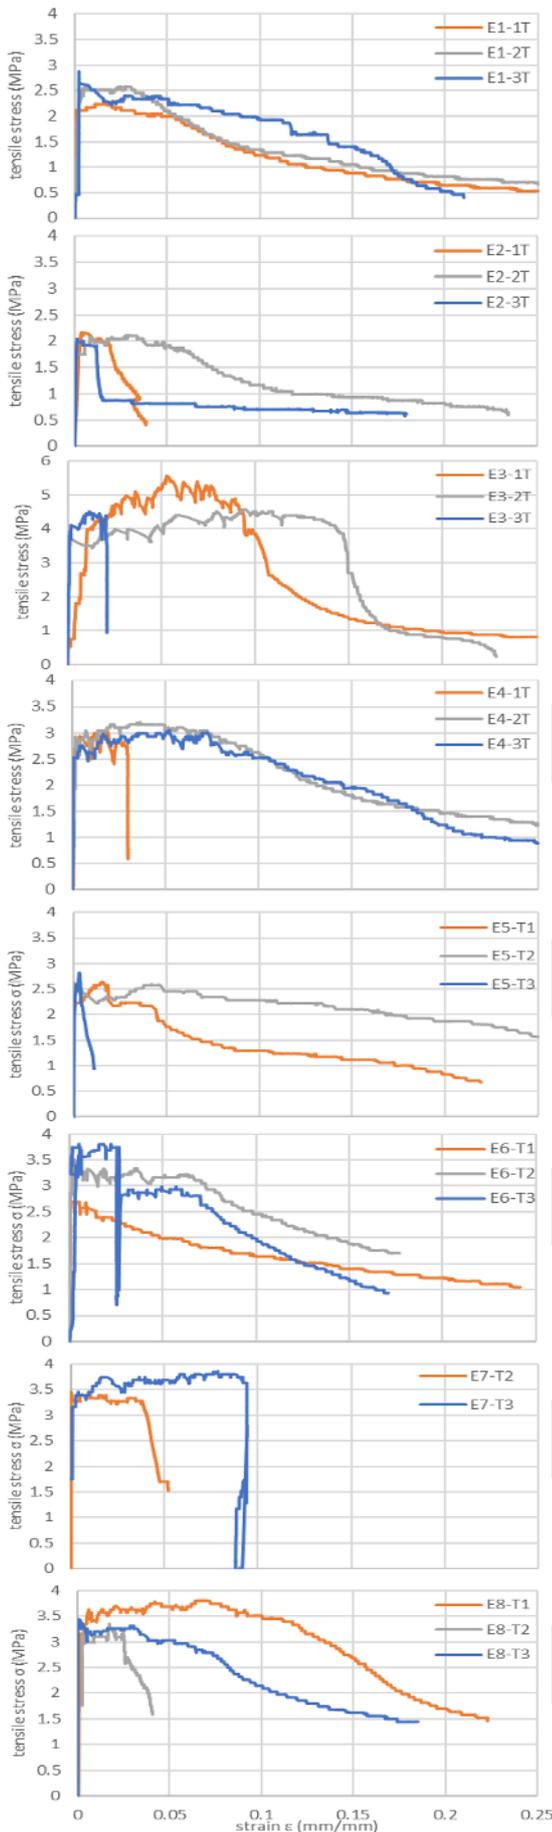
Fig. 5 Tensile stress-strain curves (28 days)

Fig. 5 shows the tensile stress - tensile strain results of all the mixes at the age of 28 days. All the specimens exhibited a strain hardening behavior of at least 5%, while, in some mixes, strain hardening developed up until a strain of 15%, a result close to the failure strain of steel reinforcement (see for example mix design E3). Additionally, the tensile strength varied from 2 to 6 MPa. The highest stress was obtained in the case of the 18 mm fibers at a ratio of 1.5% by volume, with the use of fly ash as cement replacement (mix design E3). Moreover, the tensile stress-strain curves showed a high energy dissipation even in the descending branch, where crack localization was initiated.

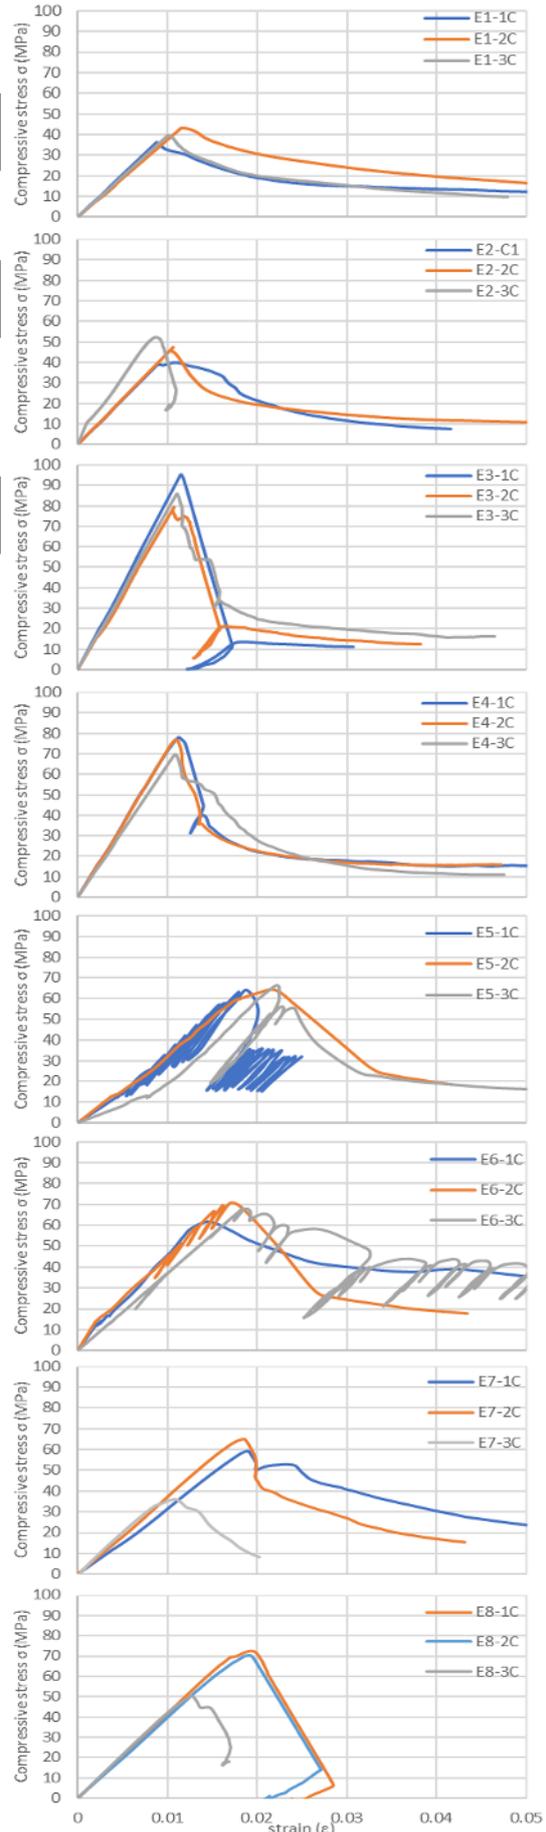
Fig. 6 Compression stress-strain curves (28 days)

The compressive strength of the mixes was derived from the testing of specimens with a width to height ratio of 1:2 (40:80 mm). The compressive behavior of all the tested specimens at 28 days, in terms of stress-strain curves, is depicted in Fig. 6. As a result of the compressive stresses, failure manifested in a diagonal crack initiating from the top of the specimen and reaching its bottom edge. Within this crack, the significant contribution of the PE fibers was evident, bridging the cracks, as shown in Fig. 4, and reducing the possibility of an abrupt failure. In all cases, the fibers provided a confining effect, by bridging the cracks and transferring lateral stresses. The formation of the usual

The peak compressive strength varied between 40 to 86.4 MPa, with the highest compressive strength obtained for mix design E₃. In addition, mix designs E₁ and E₂ had the lowest compressive strengths, 39.60 MPa and 45.90 MPa, respectively. The graphs present systematic ductile behavior in compression, with a slow strength diminishing/descending branch and a residual strength in the order of 10-20 MPa in all cases. The slope of the descending branch is increased with an increase of the compressive strength.

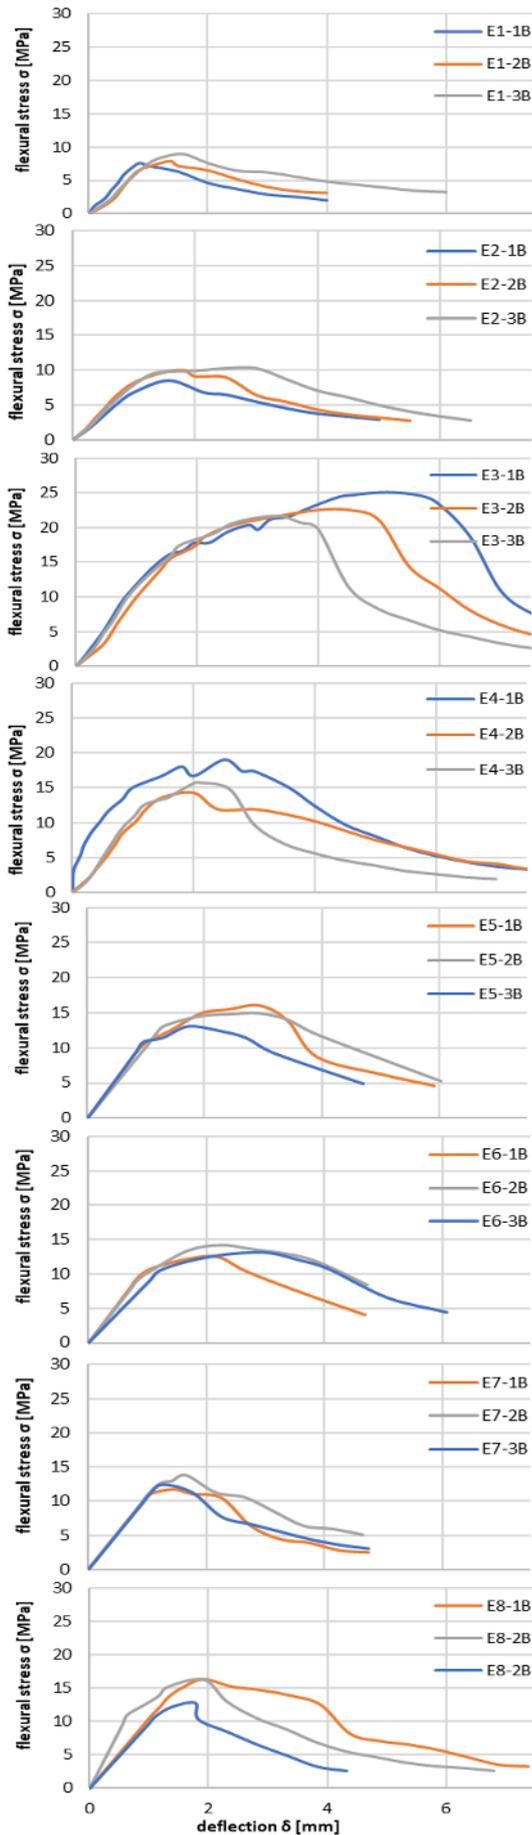
Fig. 7 3-Point Bending stress-deflection (28 days)

where P is the total load applied, L is the span length between the supports, b and d are the width and depth of the beam, respectively. It is important to note that stress calculated from Eq. 1 (engineer value) is not the actual stress developed at the extreme tensile zone of specimen, since this equation is derived from elastic analysis, where the neutral axis of the cross-section is located at the center of the beam depth. These equivalent flexural stress-center point deflection curves for each specimen, at 28 days are depicted in the graphs of Fig. 7, for comparison reasons. The results show that specimens from mix E₃ presented the highest equivalent flexural strength i.e., 23.12 MPa.

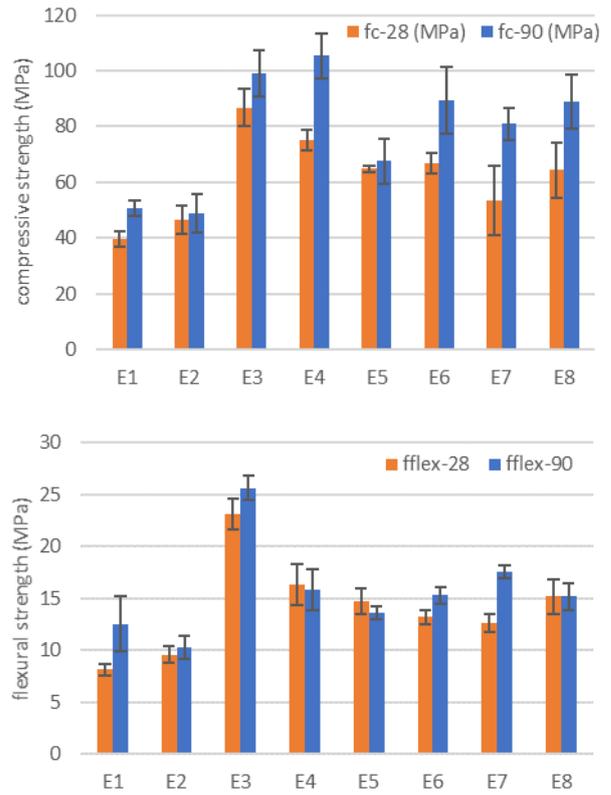
Fig. 8 Comparison of mean strength at the age of 28 and 90 days in compression (top) and flexure (bottom)

The use of industrial by-products, such as fly ash and silica fume, in concrete mix design decreases the rate of end-product strength development with age, in comparison to normal concrete. Composites with the aforementioned by-products develop their final strength after 70 days; therefore, in this study, tests were also performed at the age of 90 days for comparison reasons. Figure 8 shows the mean compressive and flexural strengths for all mixes at the age of 28 and 90 days. After 90 days, all specimens showed an increase in compressive strength, with the most extreme increase of 34% recorded for mix design E₆. The same applied in the case of flexural strength, which is related to the compressive (and tensile) strength of the material.

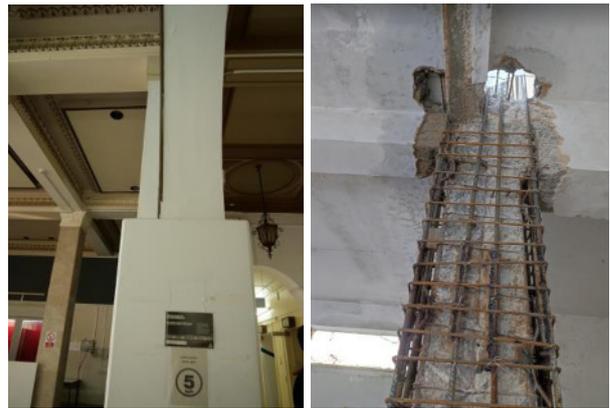
Fig. 9 Jacketing of historic concrete columns, Cyprus

In order to change this deficiency of old substandard columns, a usual practice is to increase the members cross-section, by reinforced concrete jacketing, resulting in alterations of the architectural characteristics of the heritage structure (Fig. 9). Reinforced concrete jacketing requires the addition of new longitudinal and transverse reinforcement, as well as proper cover depth, that is usually > 70 mm. In cases of old substandard columns measuring 200x200 mm in cross-section, this practice results in a jacketed member with dimensions 350x350 mm.

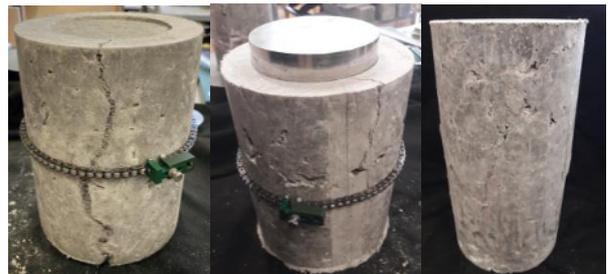
Fig. 10 HC cores confined with strain hardening composite failure patterns

A series of low strength concrete cores (HC=mean compressive strength of 10.22 MPa), with diameters of 100 and 150 mm, were confined with the use of the E6 mix design material (Fig. 10). The confinement thickness was in the order of 25 mm, equal to the depth of the uniaxial tension test coupon. The concrete cores were loaded in two different ways: compression only in the internal low strength core, and (b) compression in the full cross section of the repaired member. The first loading condition was used to derive the confinement effect of the repair material on the low strength concrete properties, while the second loading condition was used to calculate the change in the axial load that a repaired member may be able to sustain.

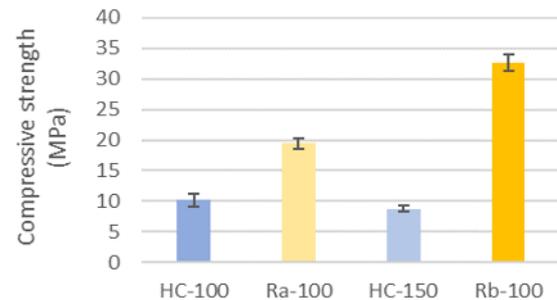
Fig. 11 Compressive strength of HC cores confined with strain hardening composite

The results indicate that the strain hardening composite acts in a two-fold way. Primarily, the repair material acts as confinement reinforcement, increasing the compressive strength of the low strength concrete of the internal core. In the case of historic concrete with low strength in the order of 10 MPa, and with a mere 25 mm repair cover, the strength is doubled to 19.5 MPa. Figure 11 shows in a graphical way this increase in strength. In the case where the full repaired cross section was loaded under compression, the repair material also contributed to the load transfer, increasing even more the compressive strength of the repaired member. This indicates that a low strength historic column measuring 150 mm diameter with an axial load capacity of 146 kN, when repaired by replacement of the 25 mm cover with the strain hardening composite hereby used, will be able to sustain three times its original load, reaching 550 kN. Assuming that the original axial load ratio, v , was 0.4, resulting in brittle compressive zone failure, the new

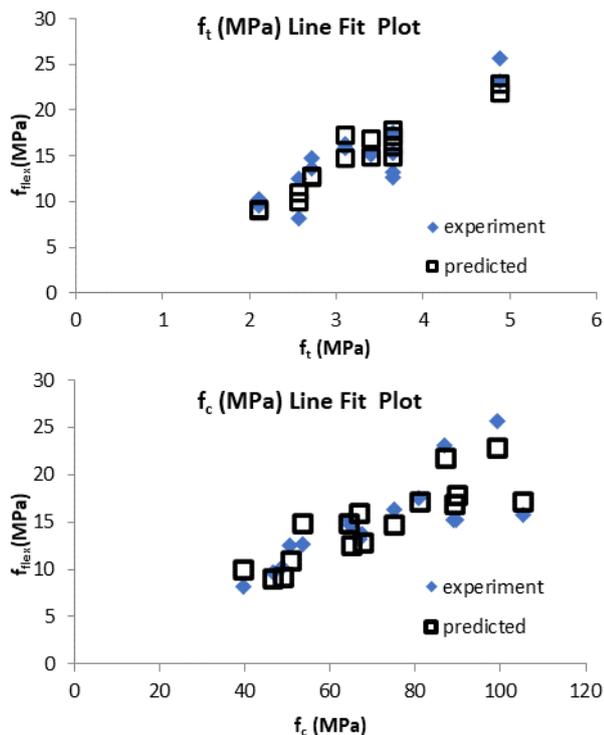
Fig. 12 Line fit plots from regression analysis

with the line fit plots for the two independent variables in relation to the experimental results presented in Fig. 12. Thus, the uniaxial tensile strength of a PE fiber reinforced cementitious composite may be derived directly from the engineered flexural strength of a three-point bending test and the compressive strength of the composites as:
