Use of a CFRP reinforcement anode for the cathodic protection of an iconic building

Abstract. This paper reports the use of a new impressed anode for the reinforcement and the cathodic protection of steel reinforced rebars in concrete beams and columns of a French historical monument. It deals with the application of a dual effect of CFRP reinforcement. The application of a DC current on a carbon fiber-reinforced-polymer used both as a structural reinforcement and as a surface anode, allowed to polarize the steel in concrete. It was then possible to combine the strengthening function with the development of a multifunctional composite allowing protecting of steel rebar from corrosion but also the monitoring of repairing function versus time. The key to success in the development of this surface anode-reinforcement was the possibility of obtaining uniform distribution of current. This innovative technique was applied to the conservation of the reinforced concrete beams and columns of an iconic building of the north of France: the Belfry of Le Touquet's city hall

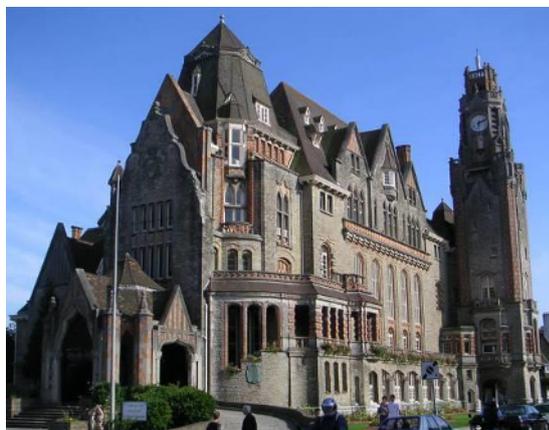
Fig. 1. City Hall and the Belfry

This innovative solution was to ensure the global reinforcement of a Belfry by the inside in the north of France. The City Hall and the Belfry, listed as a historical monument (Fig. 1), were built between 1929 and 1931. The facing is made of solid bricks and stones from North

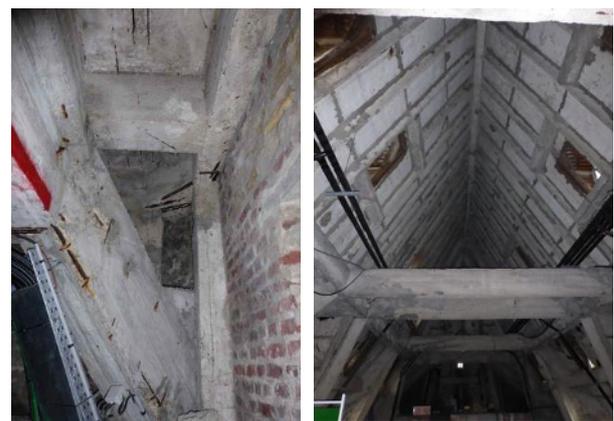
of France, on a reinforced concrete structure column-beam-slab (Fig. 1a). The roof framework is also made of reinforced concrete (Fig. 2b).

Fig. 2. a) reinforced concrete structure column-beam-slab, b) Roof reinforced concrete framework.

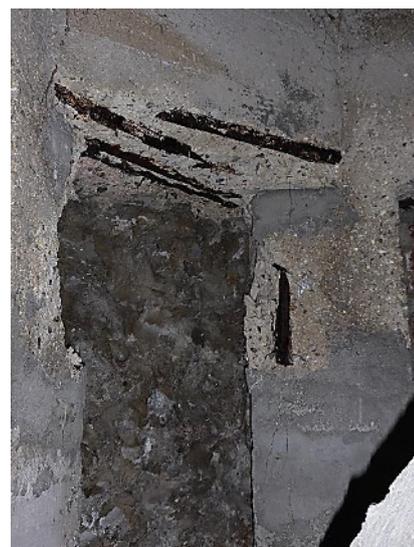
In the first step of diagnosis in the Belfry zone performed in 2011 and 2015 [4], visible decay was observed with a predominance of spalling due to intense rebar corrosion (Fig. 4) and superficial granular disaggregation associated with salt crystallization (Fig. 5). The lab analysis of the structural concrete revealed a mix of CEM I, and mainly siliceous rounded aggregates, with a water to cement ratio of 0.85, and an open porosity of 19.6%.

Fig. 4. Concrete spalling induced by intense rebars corrosion.

As the diagnosis indicated that, the concrete was affected by severe corrosion due to a combined in-depth carbonation and massive chloride pollution, with probable mechanical strength issues, it offered narrow possibilities for restoration.

Standard patch repairs [9] couldn't be durable due to the combination of carbonation and chloride pollution. Electrochemical chloride extraction would be only a temporary solution as the chloride pollution was dynamic due to the seashore location, and would anyway not address the carbonation issue durably [10]. So that the only efficient treatment for such a corrosive environment was impressed current cathodic protection. However, the implementation of such a technique remains quite invasive for a historical monument, even if miniaturization attempts were already tested on patrimonial concrete [11]. Nevertheless, in the specific case of Le Touquet Belfry, as the corrosion was very severe and mainly affecting the inner concrete structure, which is not visible from the outside and not open to

Yet, standard ICCP could not address the mechanical strength issue. Therefore, an innovative combination of ICCP and CFRP strengthening was envisaged. The final restoration protocol adopted included the following steps:

- Concrete purging,
- Reinforcement replacing,
- Structure reprofiling,
- CFRP-anode, TFC², application including all impressed current devices to energize and monitor the ICCP system for corrosion control and cathodic protection of steel in concrete,
- Coating application on structure for aesthetical purpose,
- Maintenance contract for ICCP system.

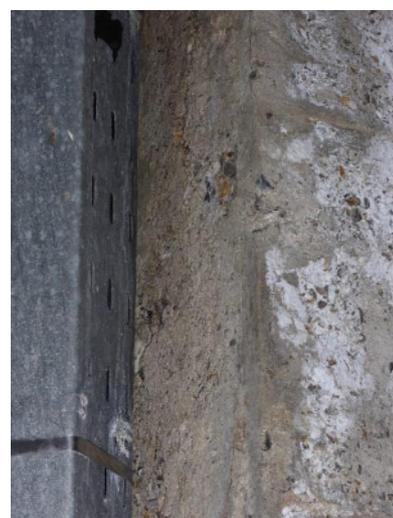
Fig. 5. Superficial granular disaggregation associated to salt crystallizations.

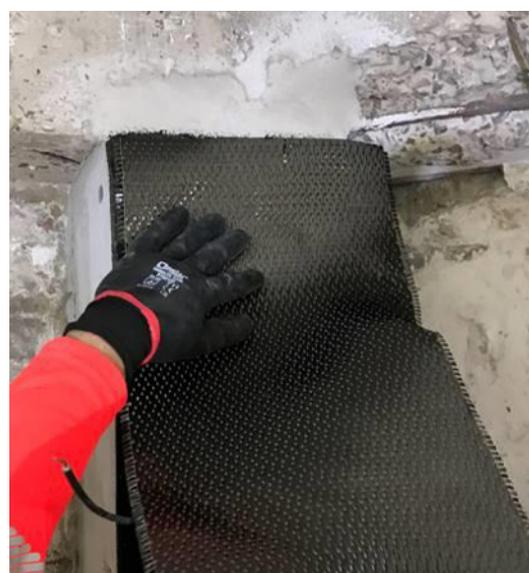
On each element, a negative connection was welded to the steel. For each monitored element, a measurement connection was added to the negative connection. The anode application is presented in Figure 8.

Fig. 8. Application of CFRP layer on a column

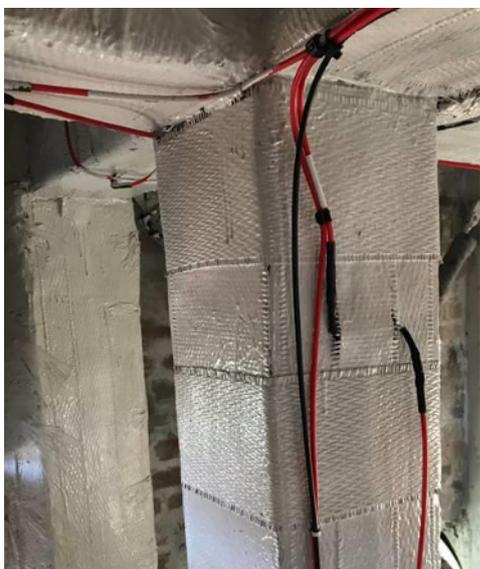
Anode wires were connected to the matrix through connectors, as per Figure 10. On each CP zone, a minimum of two ERE-20 electrodes (Mn/MnO₂) and two Titanium/MMO (Metal-Metal-Oxide) potential decay probes were embedded in the concrete to monitor performance of the CP system on different part of locations.

Fig. 10. Anode wiring

All the internal structure was painted with a white acrylic paint for aesthetic reasons but leaving access to the wiring, Figure 10

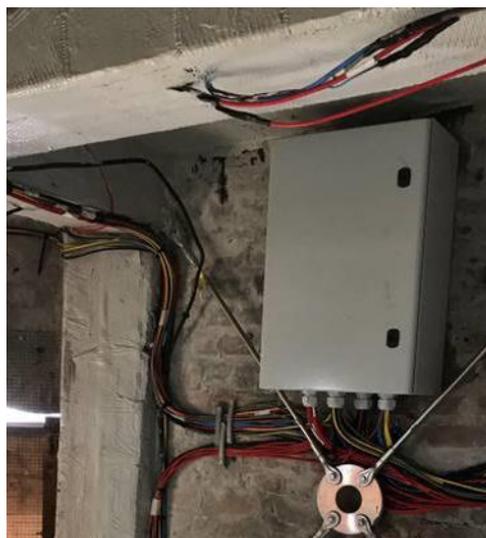
All wires were connected into a junction box located at each level, as shown in Figure 11, and then laid to the main cabinet through a cable tray. The main cabinet, as shown in Figure 12, was located at level N1.

Fig. 11. Wiring and junction box

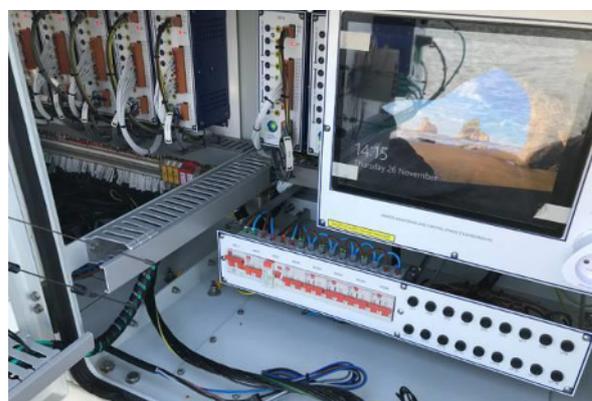
Fig. 12. Transformer-rectifier Unit and computer
