Maintenance experiences with installed CP systems in the Netherlands and their expected and unexpected maintenance needs during the past 35 years.

Abstract. This paper presents the results of a study based on practical experiences and cases with regard to the need for maintenance of installed CP systems over the past 35 years in the Netherlands. CP is a proven technique for long-term protection of steel in concrete against corrosion. Corrosion can lead to significant damage to reinforced concrete and ultimately result in a reduction in the load-bearing capacity of the structure. Correct application of CP can prevent this. Over 35 years, CP has been successfully applied in the Netherlands to all kinds of concrete structures in the industry, residential buildings, infrastructure and even monuments. CP normally distinguishes itself from other repair techniques by its long service life and durability. With careful application and professional monitoring, a service life of 15-30 years or even longer can be achieved. Nevertheless, there have been applications in which the CP system had to be maintained in the shorter or longer term or even completely replaced. Although every application

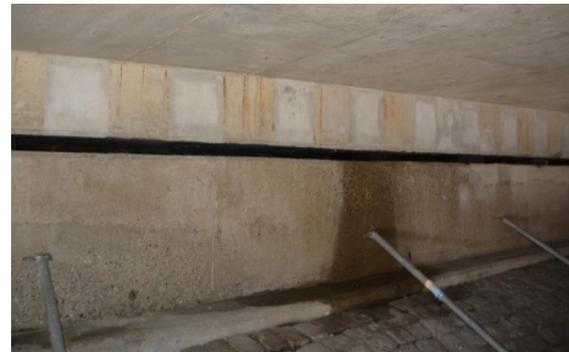
- Type of construction: prestressed abutment beams (with a support surface of approximately 1 m deep)
- Cause of the concrete damage: chloride induced corrosion due to leaking joints
- CP system type: GCP (galvanic)
- Type of anode system: Vector Galvashield XP (zinc anodes)
- Built-in in cut locations, every 0,75 m
- Only in the front surface of the beams

Fig. 1. Built-in zinc anodes, every 0,75 m

- Year of installation: 2010
- Year of maintenance: 2017
- Type of maintenance / maintenance measures:
- Extensive concrete repairs
- Replacement of the GCP system for an active (ICCP) system with 1 m long titanium anodes, in drilled holes underneath the reinforcement of the support surface of the beams

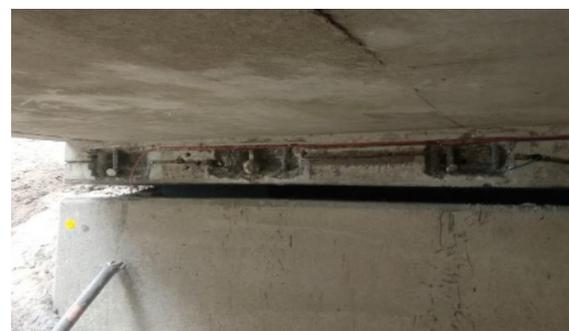
Fig. 2. Built-in zinc anodes in cut locations

- Cause of (unexpected) maintenance:
 - Zinc anodes ‘loosely’ connected to the steel with only a mechanical binding wire
 - Application of an epoxy primer on the reinforcement, for corrosion protection, acting as an electrical insulator
 - Repaired with an unsuitable mortar (resistance too high)
 - Zinc anodes applied in the wrong locations
 - Small zinc anodes applied with a spacing (0,75 m) too large for a good current distribution, resulting in a dysfunctional application
 - Maximum distance from an anode to reinforcement to be protected: over 1 m
- Typing of the error: design flaw and lack of competence and expertise with CP installation
- Consequences of the maintenance:
 - Extent: large
 - Cost: significant
 - Effects: significant

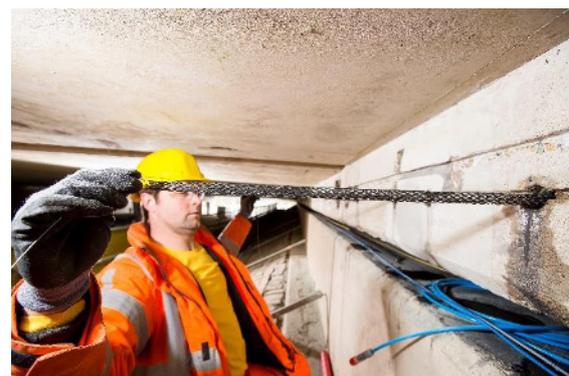
Fig. 3. Titanium anodes in 1 m deep (drilled) holes

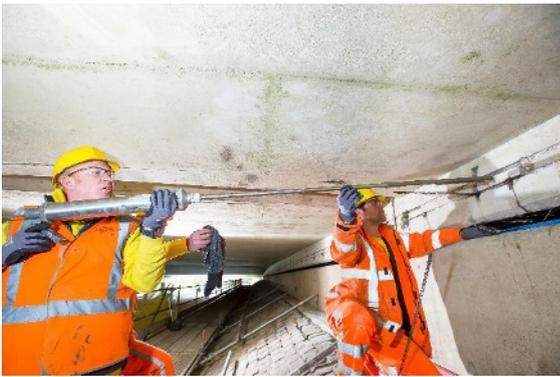
Fig. 4. Grout injection after placing the titanium anodes

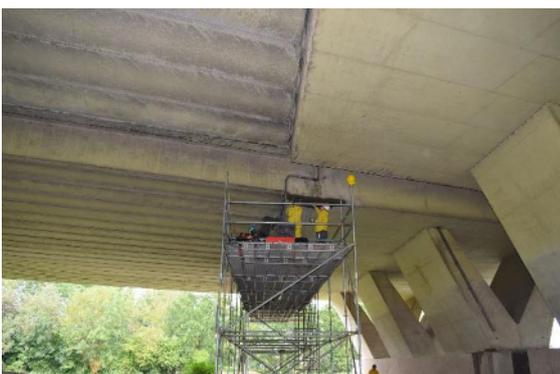
- Type of construction: prestressed table column (with a support surface of approximately 0,9 m deep)
- Cause of the concrete damage: chloride induced corrosion due to leaking joints
- CP system type: ICCP (active)
- Type of anode system: drilled in titanium anodes
 - Spacing: 0,4 m
 - Usage of a drill rig to avoid prestressing cables

Fig. 5. Prestressed support column of prestressed beams

- Year of installation: 2015
- Year of maintenance: 2017
- Type of maintenance / maintenance measures:
 - Replacement of the anode material
- Cause of (unexpected) maintenance:
 - Usage of incorrect filling mortar (with too high resistance): unfortunate mix-up of product numbers, resulting in a dysfunctional application
- Typing of the error: insufficient material verification during installation of the anodes (calamity)
- Consequences of the maintenance:
 - Extent: large
 - Cost: significant
 - Effects: small

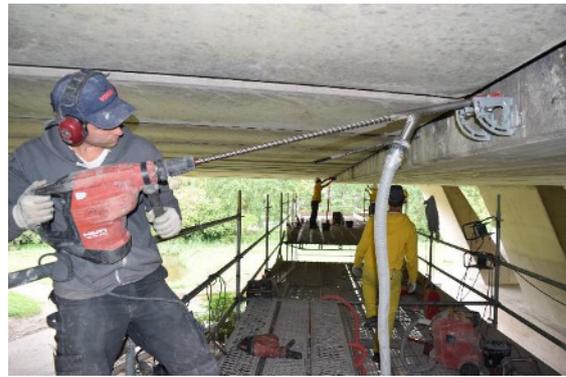
Fig. 6. Drilling holes with a rig to avoid damaging the prestressed cables

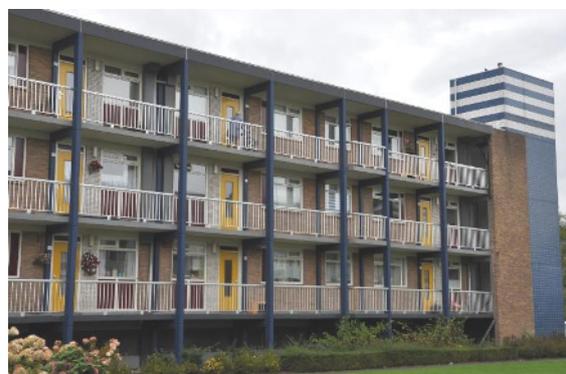
- Type of construction: gallery plates and portals
- Cause of the concrete damage: mixed in chlorides
- CP system type: ICCP (active)
- Type of anode system: Ahead[®] conductive coating
 - With primary anode of silver wire fabric strip (PDR)

Fig. 7. Front side with CP system on plates and portals

- Year of installation: 1993 / 2004
- Year of maintenance: 2021
- Type of maintenance / maintenance measures:
 - Extensive concrete repairs
 - Replacement of the anode material
- Cause of (unexpected) maintenance:
 - Limitations of the first generation of this type of anode material, with a maximum driving voltage of 2 V (versus drying concrete & increasing resistance)

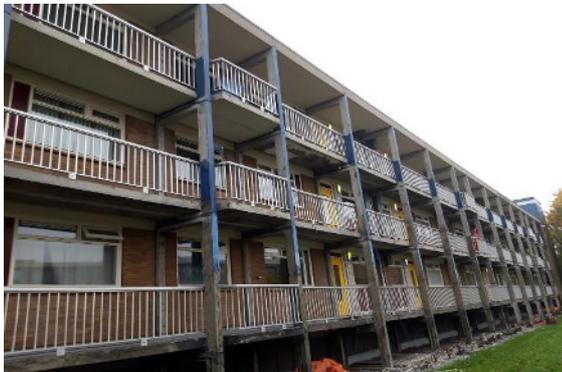
Fig. 9. Replacement of the anode material

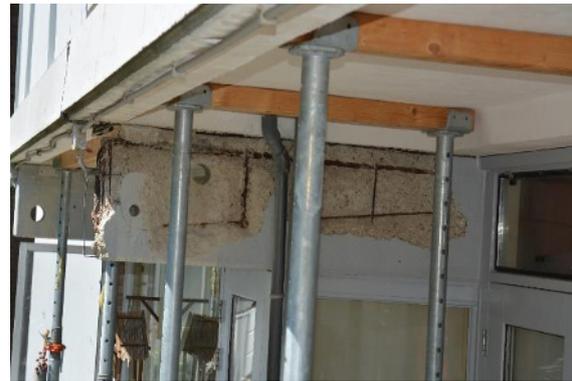
- Typing of the error: calamity, lack of competence and expertise with CP installation and inaccurate monitoring
- Consequences of the maintenance:
 - Extent: 10% of the cantilever beams were severely and dangerously damaged

Fig. 10. Severely damaged cantilever beam

- Type of maintenance / maintenance measures:
 - Replacing 10% of the cantilever beams
 - Concrete repairs
 - Replacement of the electrical installation
 - New cathode connections

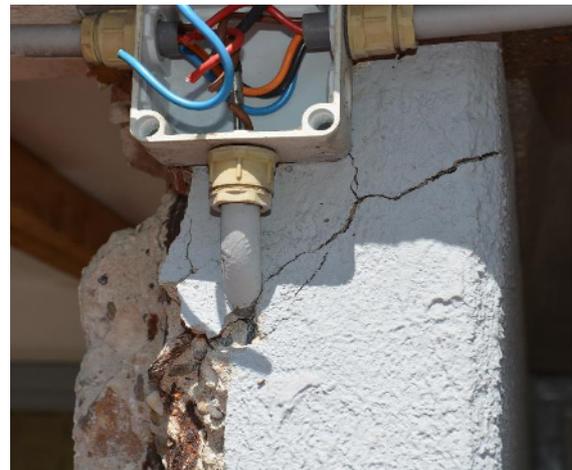
- Cause of (unexpected) maintenance:
 - Inaccurate sealing of electrical connections
 - Lost cathode connections
 - Plus and minus in the CP system reversed during the maintenance carried out in 2005 (due to confusing electrical cable colours)

Fig. 11. Damage due to reversed connections in a junction box

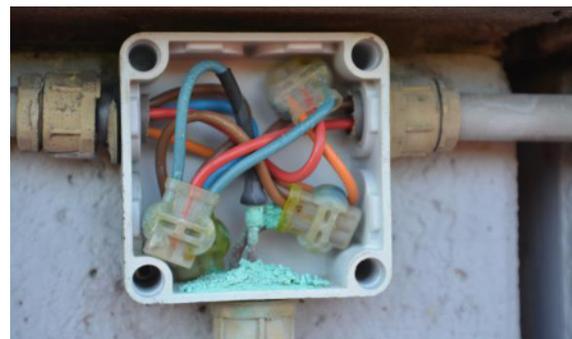
Fig. 12. Reversed connections due to confusing cable colours: red (main) anode cables are connected to a blue cable to the titanium anode (and sometimes to orange as a return cable) and brown (main) cathode cables are connected to a blue return cable (and the blue cables where sometimes switched)

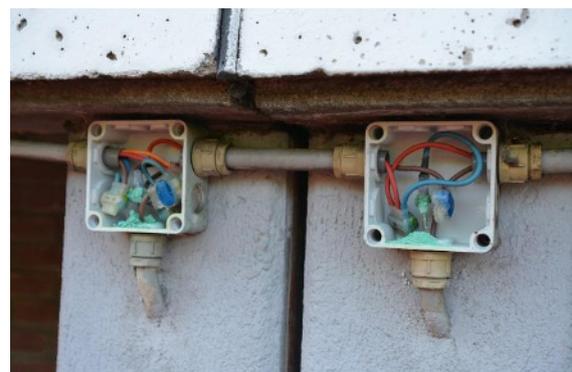
Fig. 13. Inaccurate sealing of anode connections

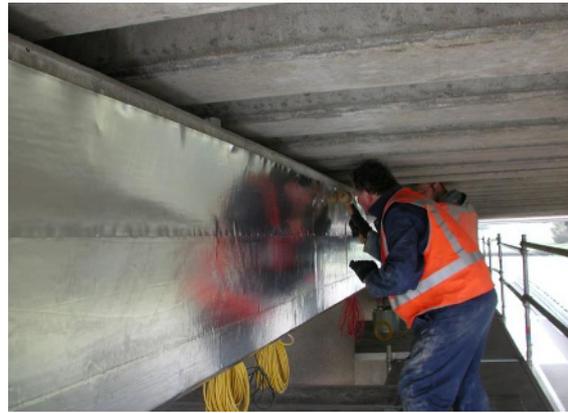
- Type of construction: prestressed support beams
- Cause of the concrete damage: chloride induced corrosion due to leaking joints
- CP system type: GCP (galvanic)
- Type of anode system: Zinc Layer Anode (ZLA)
- Year of installation: 2002
- Year of maintenance: 2013
- Type of maintenance / maintenance measures:
 - Replacement of the anode material
 - Application of ICCP system (conductive coating)
- Cause of maintenance:
 - (Sacrificial) anode material consumed
- Typing: expected
- Consequences of the maintenance:
 - Extent: large
 - Cost: high
 - Effects: significant

Fig. 15. Application of ZLA on prestressed support beam

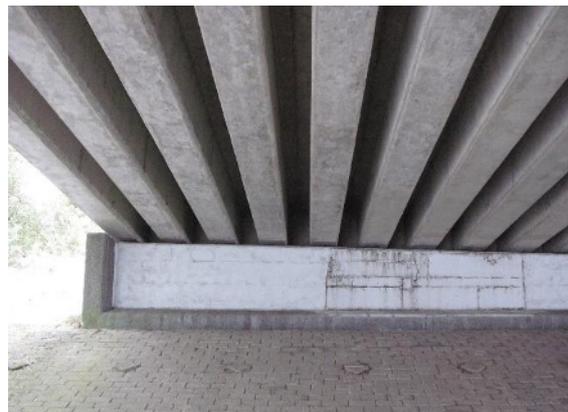
Fig. 16. ZLA after 10 years

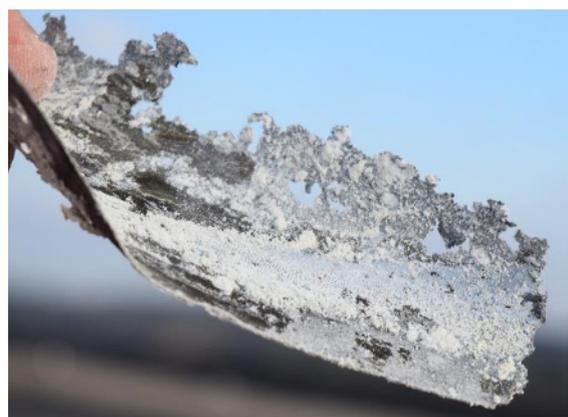
Fig. 18. Consumed zinc material

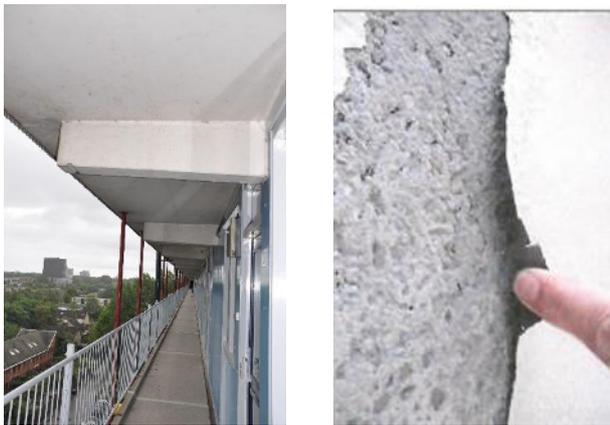
- Type of construction: roof construction and cantilever beams
 - Cause of the concrete damage: mixed in chlorides
 - CP system type: ICCP (active)
 - Type of anode system: Ahead conductive coating
 - With primary anode of silver wire fabric strip (PDR)
 - Year of installation: 1996 - 1998
 - Year of maintenance: 2019 - 2022
 - Type of maintenance / maintenance measures:
 - Replacement of the anode material
 - Replacement of the entire electrical installation
- Cause of maintenance:
- Aging
 - Wear and tear
 - Limitations of the first generation of this type of anode material, with a maximum driving voltage of 2 V (versus drying concrete & increasing resistance)

Fig. 19. Debonding of aged anode material

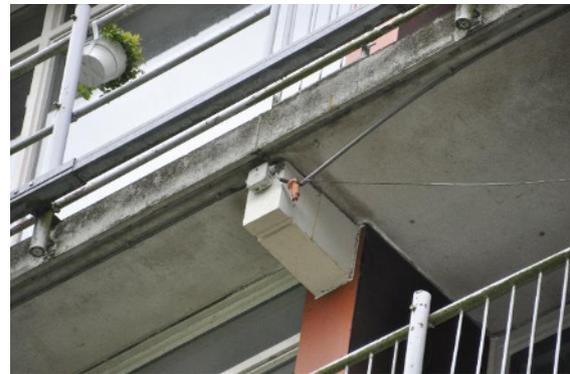
- Type of construction: cantilever beams
- Cause of the concrete damage: mixed in chlorides
- CP system type: ICCP (active)
- Type of anode system: drilled in titanium anodes
- Year of installation: 1993 / 1998
- Year of maintenance: 2020 - 2022
- Type of maintenance / maintenance measures:
 - Replacement of the entire electrical installation (power source, rectifier, modem, cabinets, cabling and connections, conduits, junction boxes)
 - Anodes in excellent condition
- Cause of maintenance:
 - Aging, UV, wear and tear
 - Moisture in the junction boxes (oxidation of copper cables at connections)

Fig. 20. Loose cabling

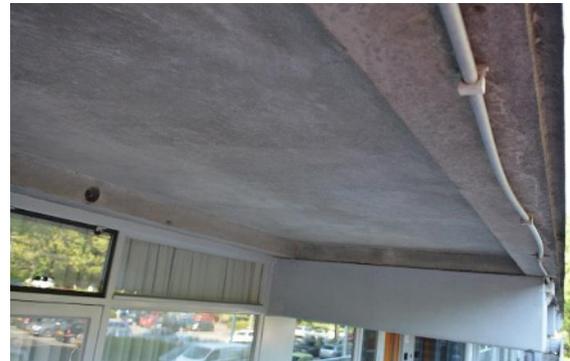
Fig. 21. Distorted conduits

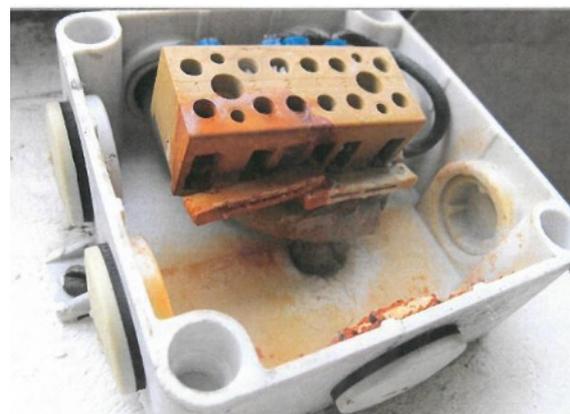
- Inaccurate cathode and anode contacts, partly no longer functional due to insufficient insulation and shielding of the connections
- Typing: expected
- Consequences of the maintenance:
 - Extent: total project
 - Cost: moderate
 - Effects: small

Fig. 22. Corroding connections

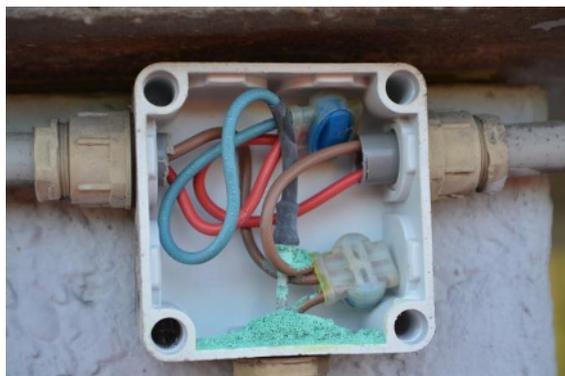
Fig. 23. Inaccurate sealing of anode connection

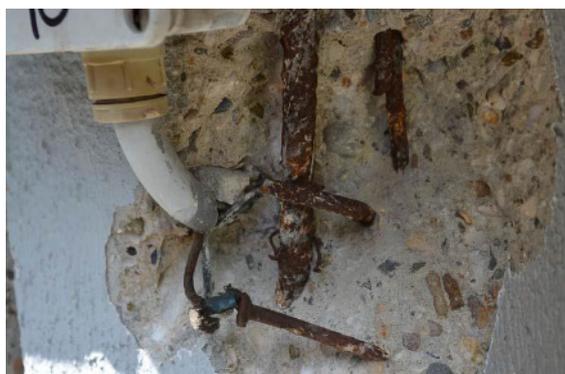
Fig. 24. Inaccurate cathode connection

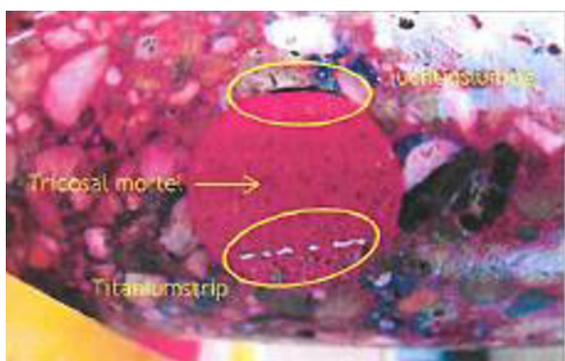
Fig. 26. Drilled core with anode material and mortar
