# Renovation of Nijkerker bridge - Innovative procurement and intensive collaboration lead to optimal approach

**Abstract.** The Nijkerker bridge (est. 1965) proved to have insufficient structural capacity to carry the current traffic loads. A contemporary way of collaboration between Rijkswaterstaat (the Dutch Highway Agency) and private parties was introduced for this project. After the design phase, renovation of the bridge was chosen instead of demolition and construction of a new bridge. Due to the collaboration between the parties involved, an optimal solution was found to increase the lifespan of the bridge by the demanded 30 years and minimize the traffic hindrance during the renovation of the bridge.

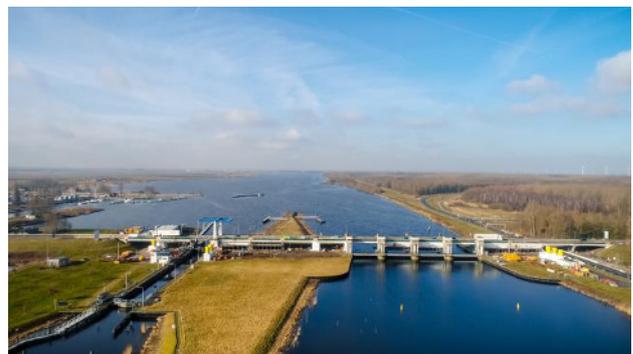
Fig. 1. Nijkerker bridge from above during execution phase

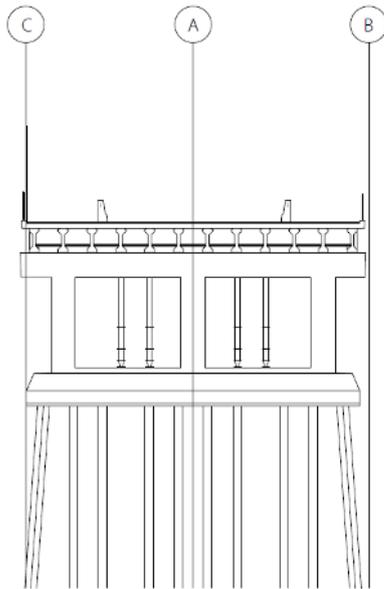
**Fig. 3.** Cross section existing situation bridge deck and pillar

The Nijkerker bridge is composed of 15 spans and has a total length of 300 meters (figure 2). Yearly 35.000 ships pass the bridge under the bascule bridge between pillar 13 and 14. The other 14 spans are 19,5 meters in length and are made up of 12 prestressed prefabricated concrete I-girders (figure 3 and 4). The I-girders are connected by an in-situ casted concrete deck. The total width of the bridge deck is 14 meters. A remarkable

property of the prestressed I-girders is the absence of shear reinforcement. The pillars of the bridge consist of a crossbeam, columns and foundation.

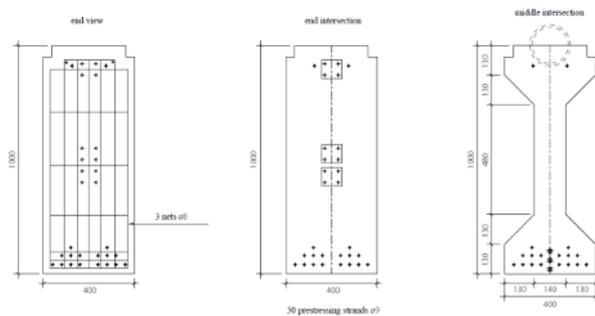
**Fig. 4.** Cross section existing situation girders

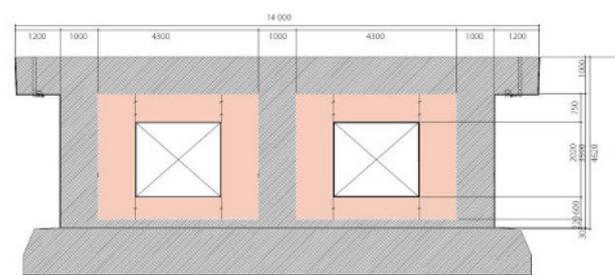
**Fig. 5.** View of the strengthening pillars with poured columns and lower and upper beams. The coloured parts refer to the new concrete strengthening

The constructive strengthening of the pillars consists of installing concrete walls by which an opening of 2.0 by 2.3 meter is maintained (figure 5). The columns and lower and upper beams provide the load transfer from the bridge deck to the foundation. The reinforcement structure is anchored with reinforcing rods to the existing structure. After placing the formwork, the reinforcement is provided with self-compacting concrete. The advantages of this reinforcement measure include the preservation of building-historical value, the positive ecological effect for flora & fauna, and social safety. For the sake of practicability, the advantage is that the temporary jack post constructions could be removed after sufficient curing (figure 6).

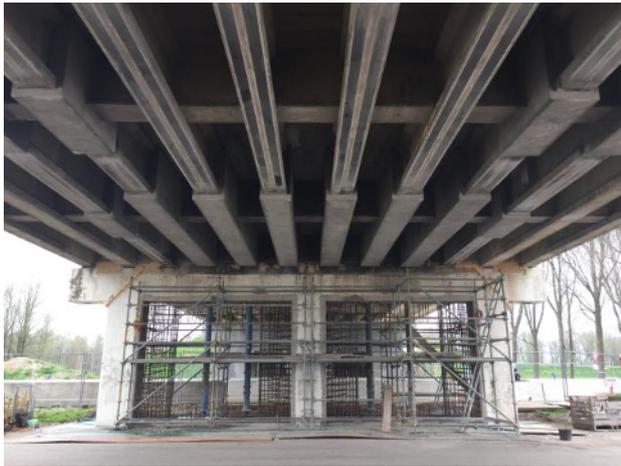
**Fig. 6.** Pillar during execution with the (temporary) jack posts to be removed.

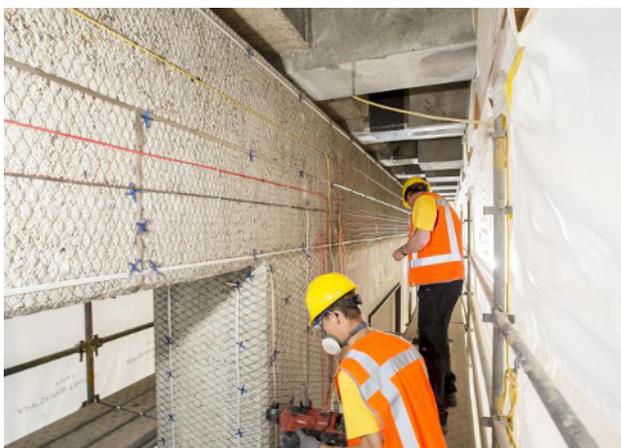
**Fig. 7.** Application of cathodic protection to preserve the concrete pillars

To prevent concrete damage due to corrosion of the existing reinforcement and to safeguard the constructive bond between existing and new concrete, the pillars are provided with an impressed current cathodic protection system which was designed according to the Dutch Recommendation [3]. For this protection technique, titanium strips have been fitted between the existing pillar and the new columns and lower and upper beams at the inner surfaces of the pillar. Titanium nets have been placed on the external concrete surfaces of the existing pillar (figure 7). The existing reinforcement is checked for electrical continuity and connected to the negative pole (cathode).

Subsequently, a low voltage of approximately 5 volts is applied between the reinforcement to be protected (cathode) and the titanium strips and nets (anode). As a result, the reinforcement receives a protective current that prevents corrosion and detachment between existing concrete and the reinforcement. The CP-system of the pillars is finished with a 25 mm layer of shotcrete. The support points are provided with a coating.

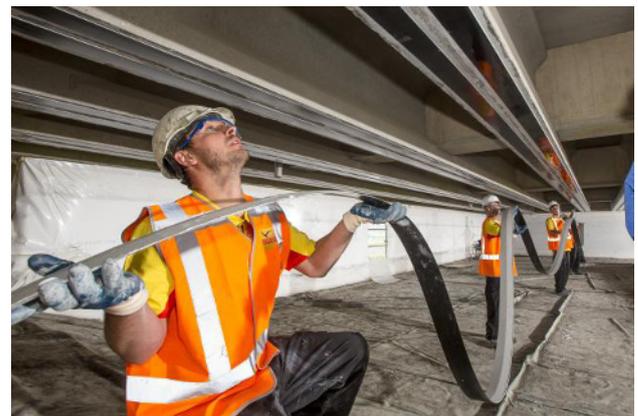
**Fig. 8.** Application of CFRP strips to the prestressed girders

The moment capacity of the prestressed I-girders under the bridge deck has been increased by applying carbon fibre (CFRP: carbon fibre reinforced polymer) strips. The design of the CFRP is based on the German DAfStb guideline 'Verstärken von Betonbauteilen mit geklebter Bewehrung' (Reinforcement of concrete members with glued reinforcement) [4], which can also be applied to prestressed structures. This directive also forms the basis for the new edition of the Eurocode 2, which includes the use of carbon adhesive reinforcement.

Depending on the span, the beams are provided with 2 or 4 strips over the entire span (figure 8). The strips are glued with epoxy and anchored at the beginning and end of the strips by means of carbon fibre sheets and CFRP fabrics. Applying carbon strengthening reinforcement on prestressed girders on this scale, while traffic continues to use the bridge, is unique in the Netherlands.

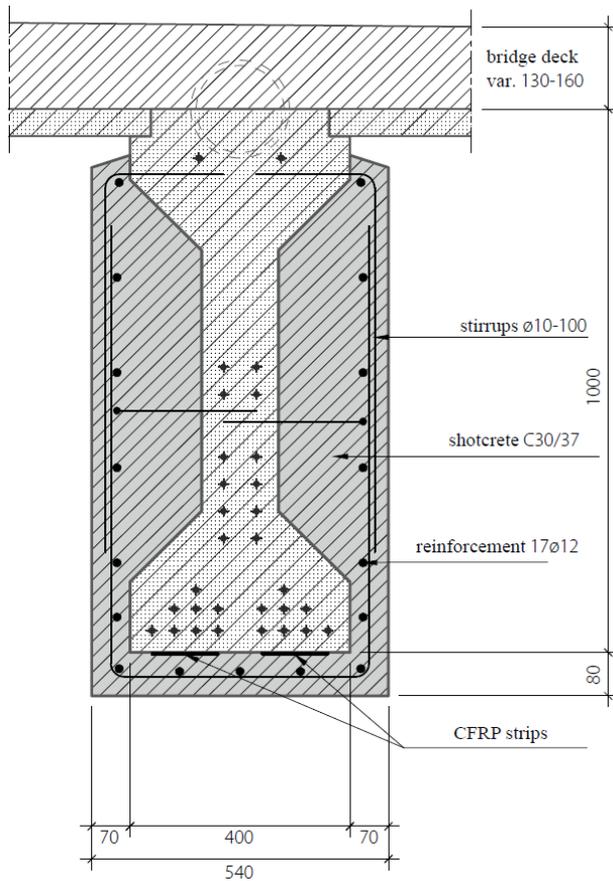
**Fig. 9.** Strengthening shear capacity

The shear capacity of the I-girders has been increased by thickening the beams all around with a reinforced shotcrete shell and steel reinforcement stirrups. The reinforcement is only applied where the shear capacity had been exceeded. Close to the support, no shear force is exceeded due to direct transfer to the support. The strengthening is installed 470 mm from the bearing over a length of 6.2 metres.

Since the strengthening does not extend above the support, it was not necessary to jack up the bridge deck construction. The girders are fitted at the top with L-shaped stirrups and at the bottom the bracket is closed by a U-shape with a diameter of 10mm (figure 9 and 10).

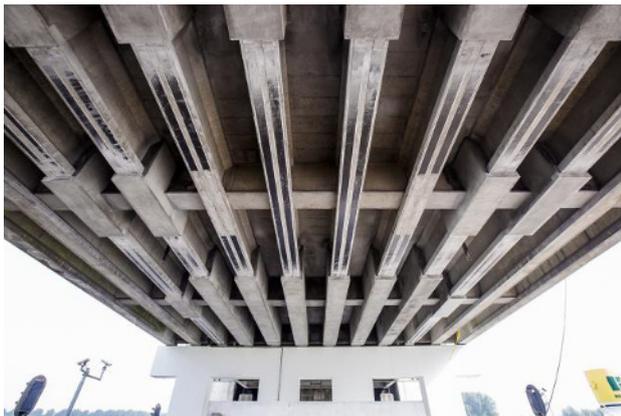
**Fig. 10.** Span after application of carbon strengthening strips and shear strengthening

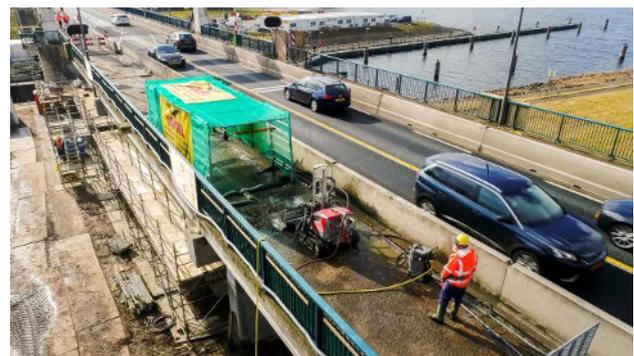
**Fig. 11.** Deployment of hydrodemolition robot

necessary and provided with cathodic protection in the form of sacrificial anodes to extend the life of the concrete repairs. For the removal of inferior concrete parts, a hydrodemolition robot was used by which the concrete is removed with high pressure while the reinforcement steel is kept intact and vibrations to the construction are prevented (figure 11). The expansion joints have been replaced by renovation joints.

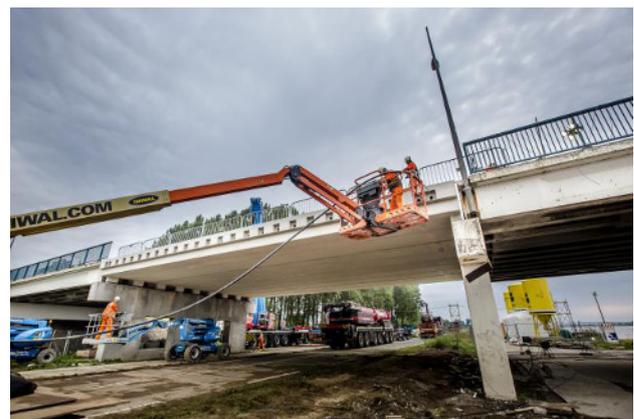
**Fig. 12.** Replacement of 1 span by a new bridge section

One out of the total of 14 concrete spans has been completely replaced by a new bridge section. This bridge section suffered significant collision damage. It has been decided to replace the girders of this field with box girders and to increase the clearance height so that it will be 4.5 meter (figure 12). As a result, the height restriction of the underlying road has been lifted and the height portals have been removed.
