# Assessing The Mechanical And Durability Performance Of Concrete Made Using Recycled Clay Masonry Rubble Bricks (CMRB) As Coarse Aggregates

**Abstract.** The South African construction industry is currently faced with mounting construction waste and overflowing landfills. Consequently, the feasibility of using of clay masonry rubble brick (CMRB) as a partial replacement for natural coarse aggregate in concrete was investigated. Three concrete mixes were made using a water-to-binder (w/b) ratios of 0.60. A control mix as well as a mix containing 50% and 100 % replacement of coarse Andesite aggregate with CMRB as coarse aggregate was tested. The compressive strength, shrinkage and durability properties (with respect to oxygen permeability, water sorptivity and chloride conductivity) were assessed. The results show that the incorporation 100% MCR brick as coarse aggregate produced the lowest compressive strength result, the highest shrinkage rate and the least resistance to gaseous ingress and chloride conductivity. The concrete mix containing 50% MCR brick exhibited the least resistance to water absorption through capillary action. The mechanical and durability properties of both c

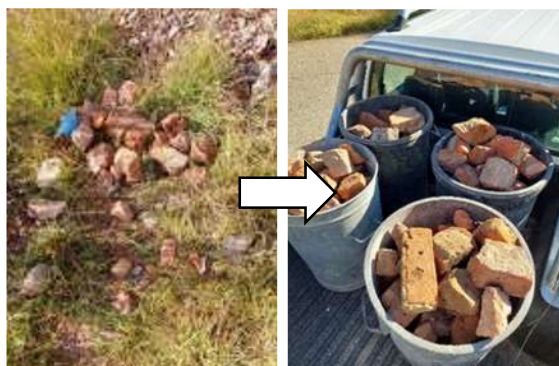
CMRB aggregates were derived from clay masonry bricks collected from an illegal dump site located in Johannesburg South, South Africa (Fig.1).

**Fig. 1** Clay masonry rubble bricks collected at an illegal dump site in Johannesburg South.

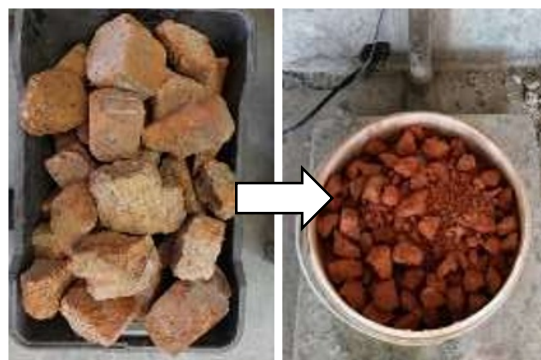
Excess mortar was removed from the CMRB (using a hammer and chisel) such that approximately less than 5% of mortar was present prior to crushing the bricks. The “cleaned” rubble shown in Fig. 2 was crushed using a hammer into sizeable pieces which classified as either fine or coarse aggregates in accordance with SANS 1083 [11]. The coarse aggregates with nominal sizes between 4.75 mm and 19 mm were selected, with the inclusion of finer particles to match the particle size fractions obtained for the 19mm Andesite coarse aggregate aggregate grading profile, in accordance with SANS 201: 2008[12].

**Fig. 2:** “Cleaned” clay masonry bricks crushed into smaller aggregate fractions.

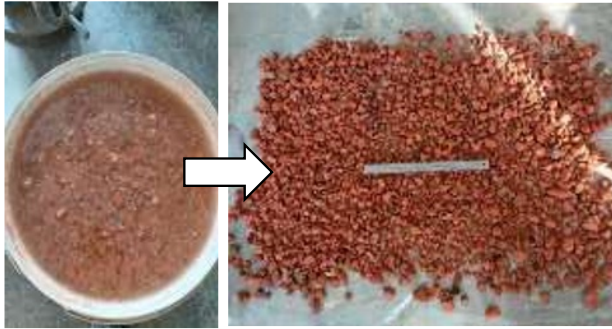
Prior to casting, the crushed CMRB aggregates were prepared according to a modified method adapted from De Venny [3]. Due to their high porosity (absorption), the crushed CMRB aggregates greater than 6.2 mm were first weighed, soaked in water for 30 minutes, removed from water, weighed once more, and set to dry for 1 hour prior to their inclusion in the concrete mix. The aggregates were further laid on a flat surface and covered in a layer of paper towel to absorb any excess moisture present on the surfaces of the aggregates (Fig.

4). This process ensured that the crushed masonry aggregates remained surface-dry when added into the concrete mix.

**Fig. 4** Crushed CMRB soaked in water and subsequently laid out to dry.
