# Durability Aspects of Chloride-Affected Cracked Concrete Structures Reinforced with 1.4003 Rebars

**Abstract.** The protection of reinforced concrete components exposed to chlorides is often ensured by coating systems, which are usually associated with high maintenance costs over the service life. A possible alternative is the use of high-alloy, stainless steel reinforcement. Through smart selection in areas subject to particularly high stresses and the possibility of using mixed reinforcement with black steel, this type of reinforcement can also be used for economical construction. In many areas, it is sufficient to use significantly cheaper chromium steel rebars instead of very expensive, highly corrosion-resistant austenitic chromium-nickel steels. An industrial research project was carried out at Munich University of Applied Sciences in which the resistance of a chromium steel reinforcement with material number 1.4003 in chloride-exposed separation cracks of RC-specimens was investigated. The results obtained formed the basis for the development of design variants for underground parking garages. Structural tests on a large number of existing structures show how a long servi

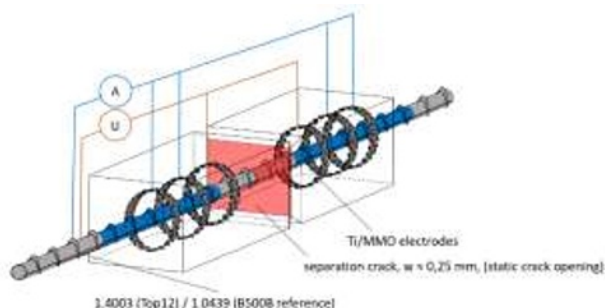
For each reinforced concrete beam, one reinforcing bar was centrally embedded in concrete. The beams were weakened with a predetermined breaking point via inserted triangular strips, through which the crack was later generated, see **Fig. 1**.

**Fig. 1.** Sketch of the investigated samples

Except for the area nearby the separation crack, the rebar was coated with a PU seal in order to exclude any falsification of the measurement results due to carbonation of the edge zone and to obtain a defined anode surface.

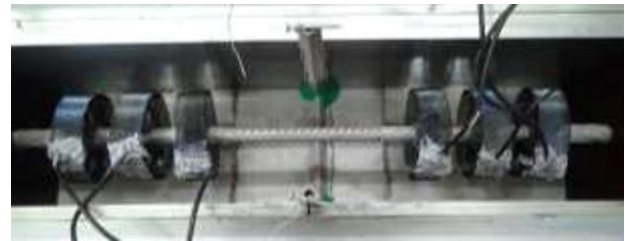
Rings made of a titanium mixed oxide strip were used as reference and counter electrodes. The distance to the reinforcement was ensured by plastic spacers, see **Fig. 2**.

**Fig. 2.** 1.4003 with Ti/MMO electrodes

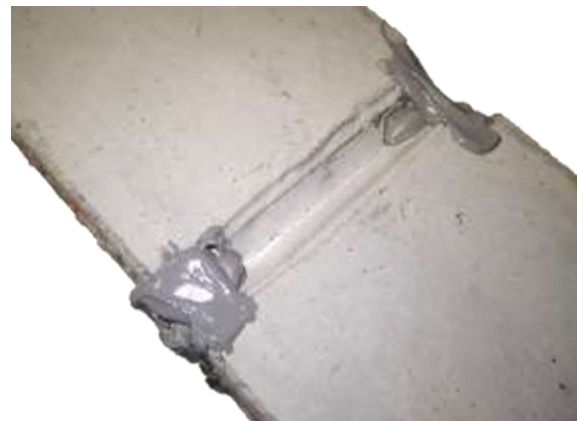
After curing of the concrete, a separation crack was created in the testing machine via double bending in a three-point bending test and held open using stainless steel plates. ( $w = 0.25$  mm), cf. **Fig. 3**.

**Fig. 3.** Sample with separation crack

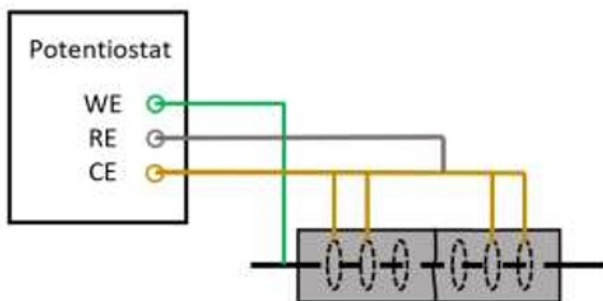
For the correct recording of the very small element current, a potentiostat was used, which was connected as a Zero-Resistance-Amperemeter (ZRA). A two-electrode arrangement is used for this measurement setup, with no separate reference electrode for potential measurement. The counter electrode is used simultaneously as a reference, see Fig. 4. At the beginning of the measurement, the rest potential of the working electrode (1.4003 or B500B) against the counter electrode (titanium mixed oxide strip) is determined. The potential difference between the working and counter electrodes is then regulated to zero and maintained. The current required for this is recorded over time. The longer the measurement takes, the more the course of the "short-circuit current" converges with the element current that would actually flow in the event of a permanent short-circuit of the working and counter electrodes.

**Fig. 4.** Measurement setup (ZRA)

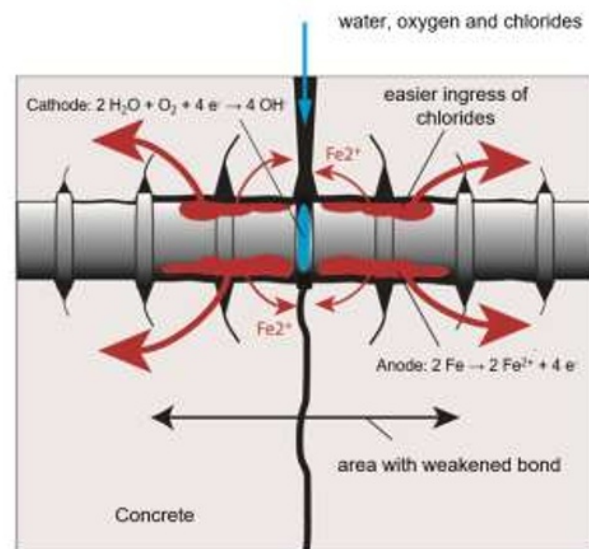
There is now an imponderability here with regard to the corrosion activity of the steel in the edge zone of the crack flanks. It is not expedient to use the steel surface in the crack, which can therefore be mathematically derived, as the anode surface. The contributing anode area depends on too many influencing factors. Overall, a correct determination of the anode surface area in the case of pitting corrosion, as investigated in the present case, is hardly possible from an experimental point of view due to the formation of scars and the associated increasing of the scar. The problems become clear from the illustration in **Fig. 5**.

**Fig. 5.** Model of corrosion in the crack area according to [10], [17]

Afterwards, the specimens were split and the pitting corrosion was photographically documented. The representation of a removed steel (B500B) with corrosion from the test series can be taken from **Fig. 7**. The representation of a 1.4003 specimen with corrosion is shown in **Fig. 8**. Here, the eccentrically offset scar to the separation crack area as shown in **Fig. 5** is clearly visible.

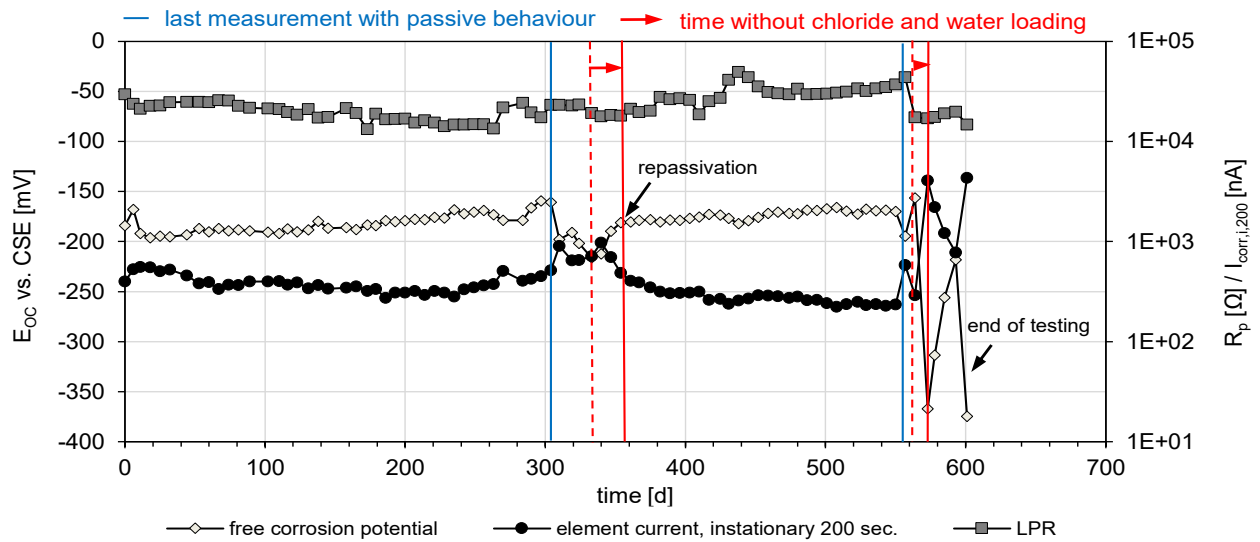
The first stable corrosion initiation without repassivation processes was chosen as the termination criterion for the tests. This is indicated by a decrease in the free corrosion potentials and a significant increase in the element currents, which do not return to their original values after two weeks of non-impact. At this point, visible corrosion was also first visible on the separated steel samples.

The exemplary course of a sample with and without corrosion initiation can be taken from **Fig. 6**.

**Fig. 6.** Curves of a sample with corrosion initiation [17]

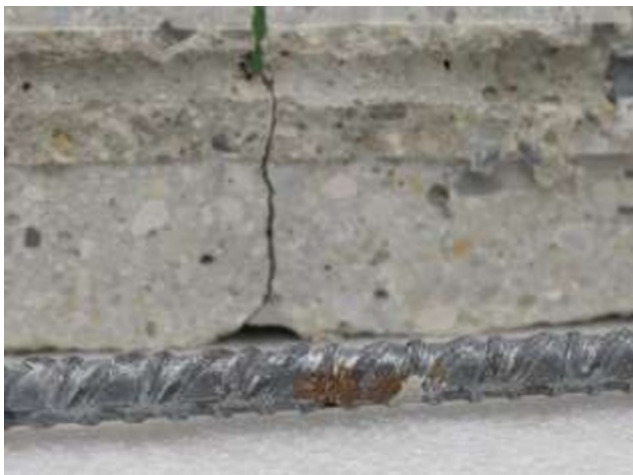
**Fig. 7.** removed black steel with corrosion in front of cracked concrete specimen

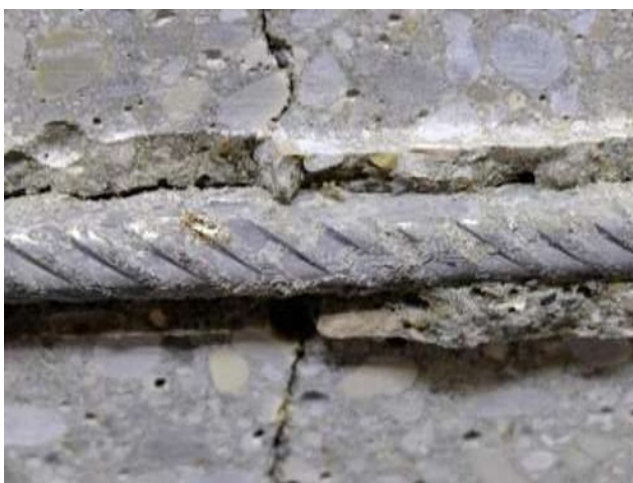
**Fig. 8.** 1.4003 Reinforcing steel in splitt concrete specimen with corrosion scar eccentric to separation crack

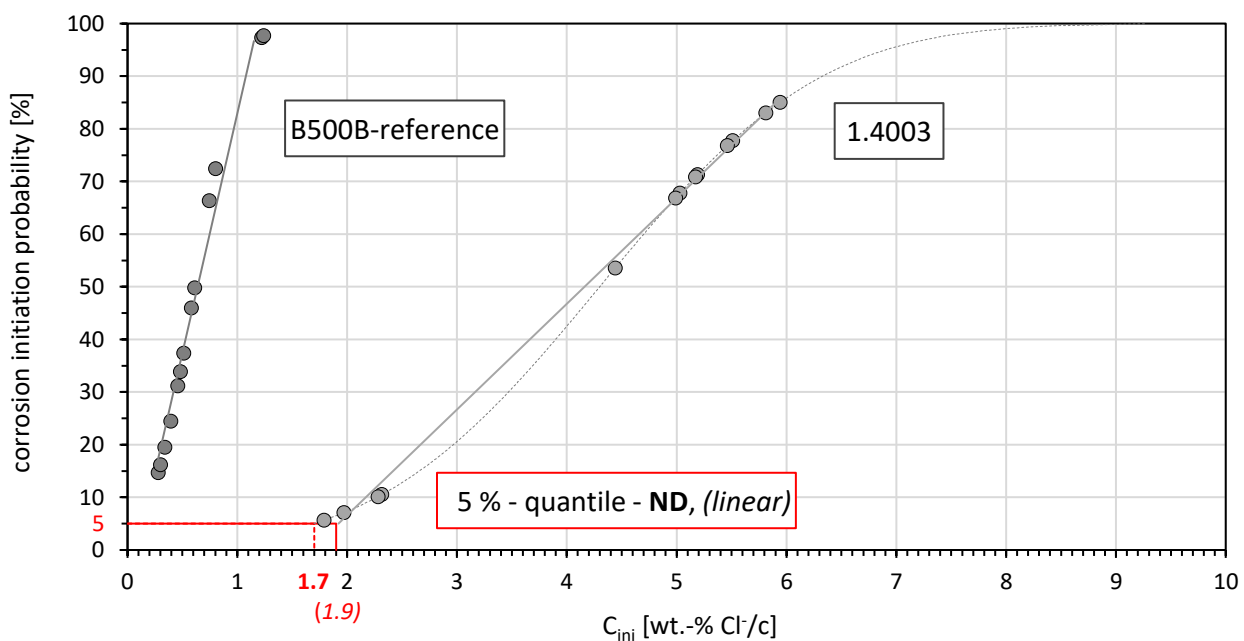
From the determined chloride contents during corrosion initiation, a distribution function was created according to the corrosion initiation probability, see **Fig. 9**.

Using a linear distribution function and a corrosion initiation probability of 5 %, the characteristic chloride content of the 1.4003 steels is 1.7 wt.-%/c. This value is below the smallest single value for the determined samples and therefore on the safe side for the tests. With a probability of 50 % for a corrosion initiation, the tests result in a chloride content of approx. 4.1 wt.-%/c. Comparing the B500B refractory steels, the value at 50 % probability of corrosion initiation is 0.6 wt.-%/c.

**Fig. 9.** summed corrosion initiation probabilities (values of stable corrosion initiation on the samples) with linear regression function and (dashed) normal distribution from [18]

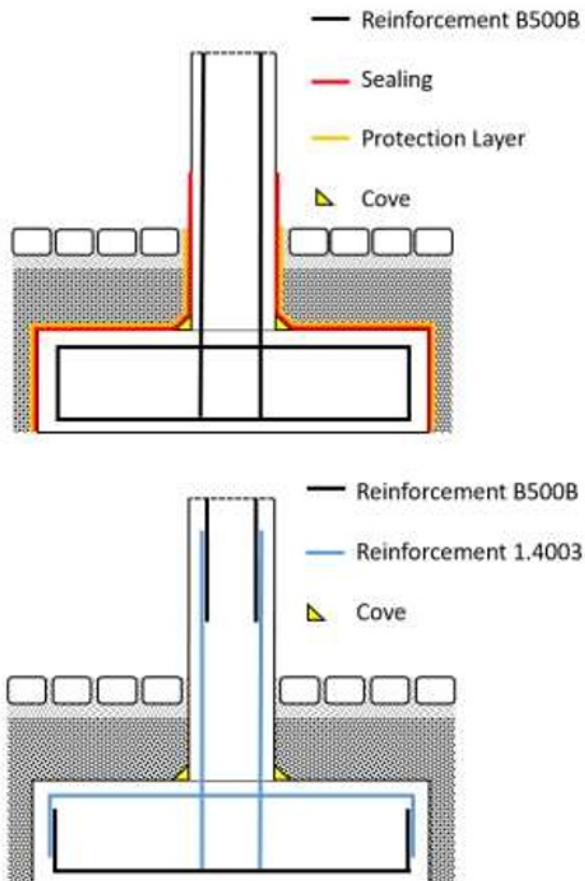
Various applications are reasonable for 1.4003. For example, its use in rising components in the base area and on foundation tops and distorting beams without further sealing is target-oriented. Here, for example, a permanent construction can be achieved with a separate protection of the construction joint between column/wall and foundation by means of a fillet, see **Fig. 10**. The advantage compared to a waterproofing according to DIN 18533 [22] is the omission of the waterproofing work at an unfavorable time of the construction phase. An exemplary

cost comparison [23] showed that for a column with a top-reinforced foundation, the manufacturing costs were almost the same as for a design with OS5b.

**Abb. 1: Comparison of column design under pavement with waterproofing (top) and 1.4003 reinforcement (bottom), principle sketch based on [23]**
