# Condition assessment of two prestressed concrete slabs after 60 years in service

**Abstract.** Two concrete deck slabs extracted from a Canadian bridge have been evaluated using non-destructive testing (NDT), followed by destructive testing. Throughout its service life, the bridge experienced harsh environmental conditions with frequent freeze-thaw cycles, hot and humid summers, and the use of de-icing salts during winters. This study presents the preliminary results of an exhaustive condition assessment of two prestressed concrete slab panels, where NDT techniques (visual assessments, electrochemical and concrete soundness tests) have been conducted prior to destructive testing. Although visual inspection did not indicate poor concrete quality, the results of the ultrasonic pulse velocity testing showed that both concrete slabs are of poor quality and may be suffering from internal defects. Chlorides may have also been introduced through the strand conduit anchor points. These findings raise concerns regarding the structural integrity of corrosion-affected members.

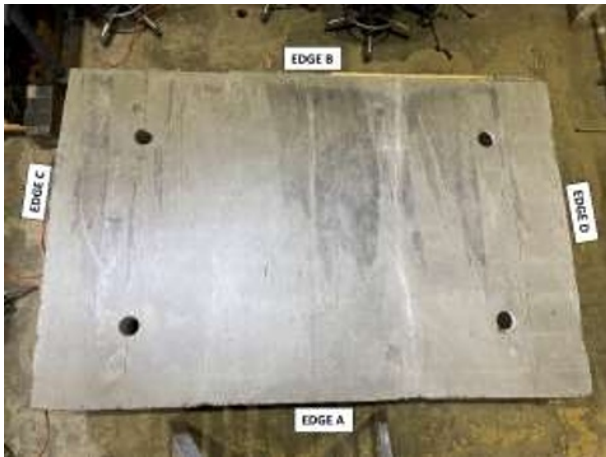
A) S1 soffit.

**Fig. 2.** Infill slabs extracted from the bridge: A) S1 and; B) S7.

As part of the highly integrated superstructure, the infill slabs (Fig. 2) play a major role in the bridge's load-transfer system. The continuous use of de-icing salts over the lifespan of the bridge, combined with the failure to incorporate appropriate mitigation measures, such as proper drainage systems, contributed to the corrosion of the slabs' post-tensioned prestressing tendons. The close proximity of the infill slabs to traffic may have increased their exposure to carbon monoxide, leading to concrete carbonation and the gradual decrease of the pH level in the concrete cover. The combined effects of their exposure to carbonation and chloride ions may have accelerated the rate of corrosion.

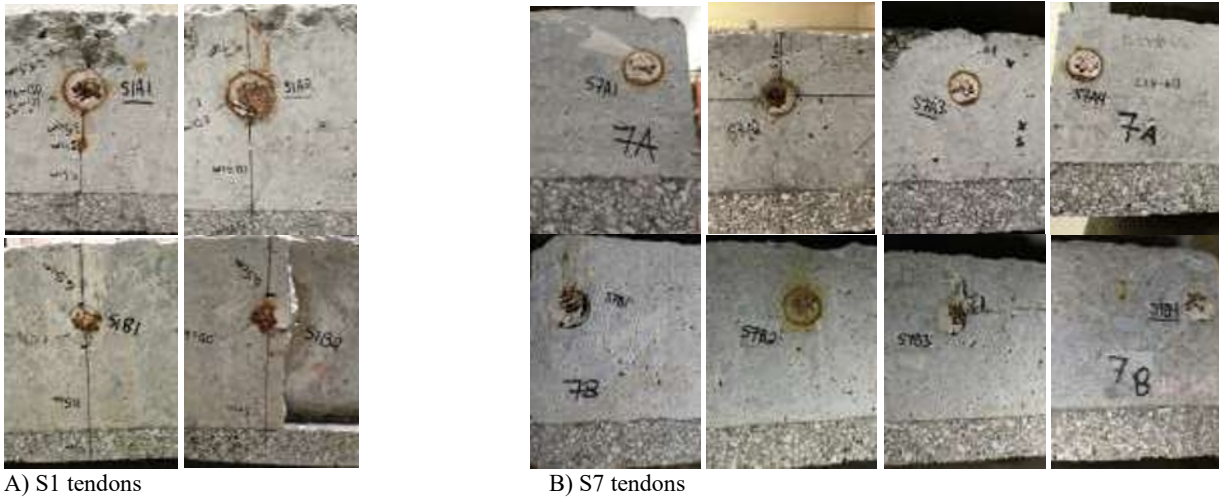
The slabs were cut from the driving surface of the bridge without removing the asphalt pavement (Fig. 3). All grouted post-tensioning tendons are composed of 12-7 mm diameter strands tightly grouped within a metal duct. The application of grout for all tendons appears successful, with limited visible empty space between the individual strands and between the tendon and duct (Fig. 4). Few strands appear to be centred within the duct, while the remaining strands have shifted to the sides. Tendon labelling refers to the slab the tendon is embedded in, the slab edge from which it is visible, and the tendon number. For example, S1A1 and S1B1 refer to tendon 1 observed from edges A and B of slab S1, respectively. Temperature reinforcement (15-mm diameter bars) is located along the longitudinal slab directions. Concrete damage along the slab edges occurred when relocating the specimens. Table 1 summarizes the main results of the visual inspection.

A) S1 tendons  
 B) S7 tendons  
**Fig. 4.** Cross-sectional view of tendons along edges A and B of: A) S1 and; B) S7.

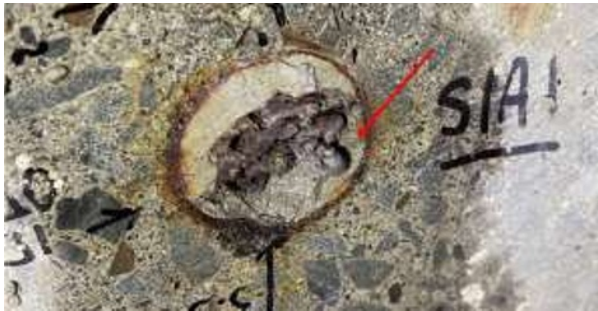
A) S1A1

Preliminary colorimetric testing for chlorides and carbonation was performed on S1 and S7. Clear silver nitrate ( $\text{AgNO}_3$ ) solution, at 0.1 mol/L concentration, was sprayed over the recently fractured concrete edges of both slabs. This technique allows the identification of chloride ions within the concrete. Silver ions ( $\text{Ag}^+$ ) react with the free chloride ions ( $\text{Cl}^-$ ) to form silver chloride ( $\text{AgCl}$ ), which results in white precipitation [12]. The results of this test indicated the presence of chlorides around S1A1 and S1B2 within the metal conduit, as well as in the concrete crack located above S1A1-S1B1 (Fig.

9). Similar observations were noted for S7B1 and the concrete crack above this strand (Fig. 10). The presence of chlorides at these locations suggests that corrosion was initiated by chlorides introduced at tendon anchor points in the deck system.

**Fig. 9.** Testing for chlorides with silver nitrate solution on S1: A) S1A1, B) S1B2 and; C) concrete cracking above S1A1-S1B1.

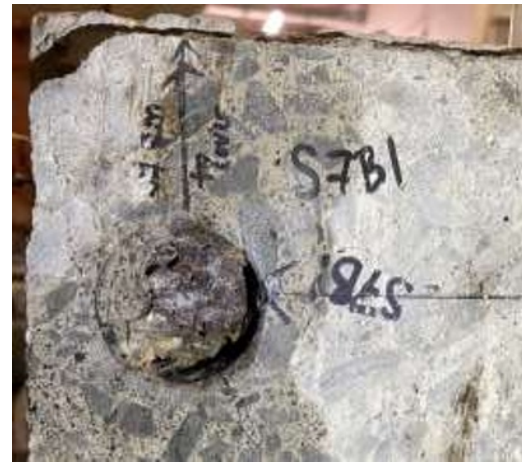
A) S7B1

**Fig. 10.** Testing for chlorides with silver nitrate solution on S7: A) S7B1, and; B) concrete cracking above S7A1-S7B1.
