Microscopic assessment of ASR-affected columns after 20 years in service

Abstract. Deterioration signs were observed on the concrete surface of the exterior columns of the SITE building located at the University of Ottawa, Ottawa (Ontario, Canada) which demonstrated the potential presence of a concrete damage mechanism, suspected to be alkali-silica reaction (ASR). To investigate the root cause of this deterioration, a visual inspection was conducted to select concrete members for coring. Damage development in the extracted cores was then evaluated through various microscopic techniques to identify the cause and extent of deterioration. First, the petrographic examination was carried out with the aim of detecting the cause of damage in the extracted core specimens through the analysis of damage features; confirming the presence of ASR in the selected elements Afterwards, the Damage Rating Index (DRI), a semi-quantitative microscopic procedure, was used to evaluate the extent of the damage. Data collected during the visual inspection and petrographic examination will be presented and analyzed. Moreover, based upon the analysis of DRI results, the induced expansion levels in affecte

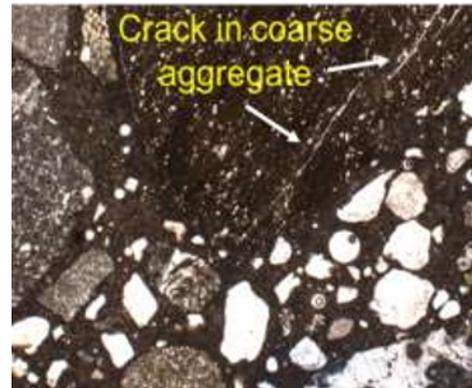
Upon the examination of the thin section specimens, various cracks were observed both in the coarse aggregate particles and cement paste of the majority of the

specimens, mostly originating from coarse aggregates (Figure 5). Furthermore, according to the results obtained through the petrographic analysis, ASR gel was found in the coarse aggregate and the cement paste cracks (Figure 6). As per the petrographic examination performed on the concrete specimens, various distress features associated with ASR including cracks in coarse aggregates, and the presence of reaction products (i.e., ASR gel) in the coarse aggregate particles, cement paste and cement paste voids clearly confirmed the presence of ASR in the SITE building.

Figure 5. Crack in the coarse aggregate, 25X, natural light.

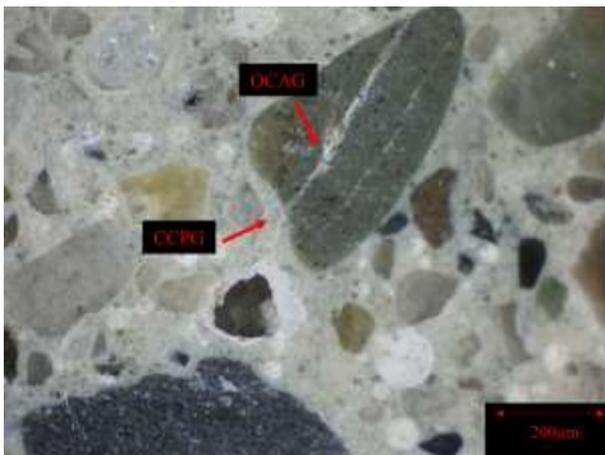
Analyzing the results gathered from the DRI, similar to the petrographic analysis, the presence of ASR could be attested through this method. As such the observation of open cracks with and without reaction product (i.e., OCAG and OCA, green and red chart in figure 7) along with the presence of cement paste cracks with reaction product (i.e., CCPG, light blue chart in figure 7) could confirm the above. Figure 8 displays the above features in examined specimens.

Figure 8. Presence of open crack in aggregate and cement paste crack with ASR reaction product.
