Emergency rehabilitation of Selby interchange on M2, in Johannesburg, South Africa

Abstract. In this paper, the retrofitting and rehabilitation of the M2 Selby interchange, on the M2 in Johannesburg, Gauteng, South Africa, is presented. After noting large shear cracks on the pier columns, the highway had to be closed down, for 10 months. The client for the project was the Johannesburg Roads Agency (JRA), the contractor was Stefanutti Stocks Civils, and the consultant was WSP. The project commenced with the design of jacking towers which were used to jack up and support the drop-in slabs. The support system was designed to be used as a kit that can be reused in future. The demolition of the piers posed some difficulties due to the small working area within the constraints of the jacked slabs, which remained in the jacked position. The piers were designed in accordance with TMH7. A key design focus was the creep calculation, due to the unique geometry of the mushroom heads. Granite aggregates were chosen to reduce the creep and the cantilever ends were precambered. The jacked slabs were lowered and aligned only at the end of the project timeline just in time for the Thorma joints an

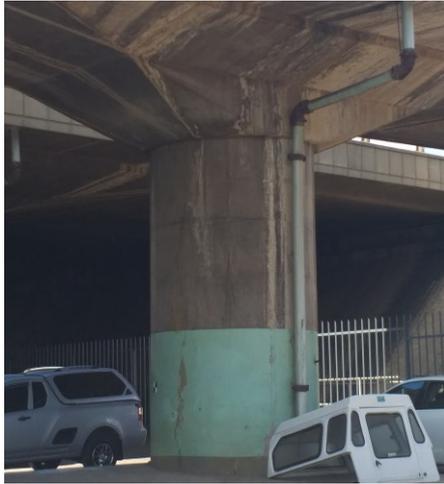
Fig. 2. Elevation of the pier

The bridges provide access to commuters in the Johannesburg (JHB) area, connecting the east and west of the JHB areas. The bridge is a multi-span simply supported structure made up of drop-in slabs supported by mushroom piers. The drop-in slabs are of reinforced concrete, and the piers are reinforced with prestressing at the top face of the mushroom heads. The repair was only required for the 4 rightmost piers next to the east abutment.

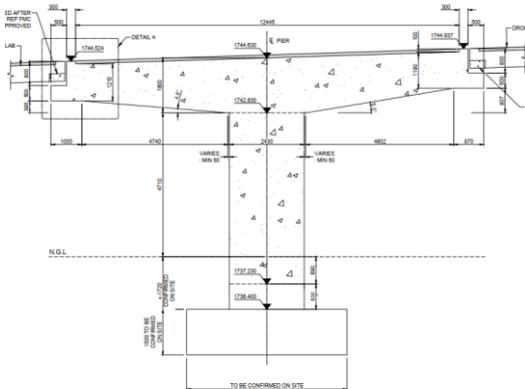
The bridge has E80 expansion joints, and the structure is found on rock with spread footings. The typical pier dimensions are 8.0m x 12.0m x 14.0m. A typical elevation of the piers is shown below in Fig. 3.

Fig. 3: Pier elevation

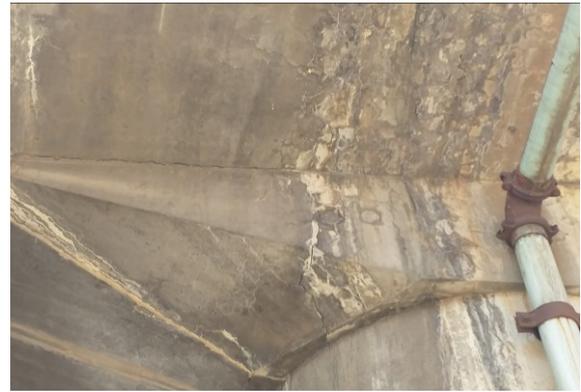
The main defects of the piers were large shear cracks as seen in Fig. 4 & Fig. 5. The cracks formed due to water entering through the top of the mushroom head and causing an alkali-silica reaction (ASR). The aggregates in the mix contain a certain form of silica which will react with alkali hydroxide in the concrete to form a gel that will swell up as it absorbs water, this will cause enough expansive pressure to damage/crack the concrete.

Fig. 4. Shear crack in the mushroom head

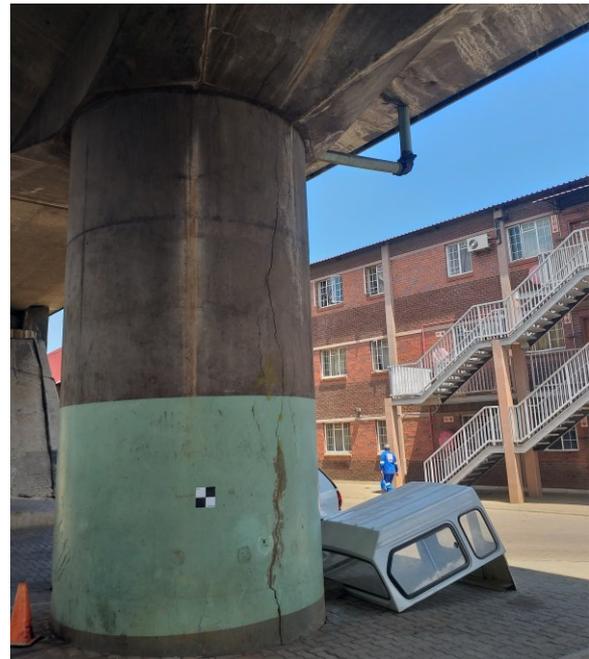
Fig. 5. Shear crack in the pier

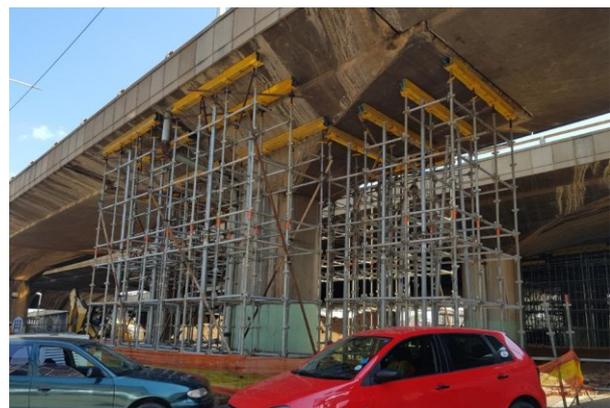
A detailed inspection was conducted on-site, and it was decided that temporary supports be put in place until the highway could be closed off to traffic. A photo of the temporary supports is provided in Fig. 6.

Fig. 6. Temporary supports

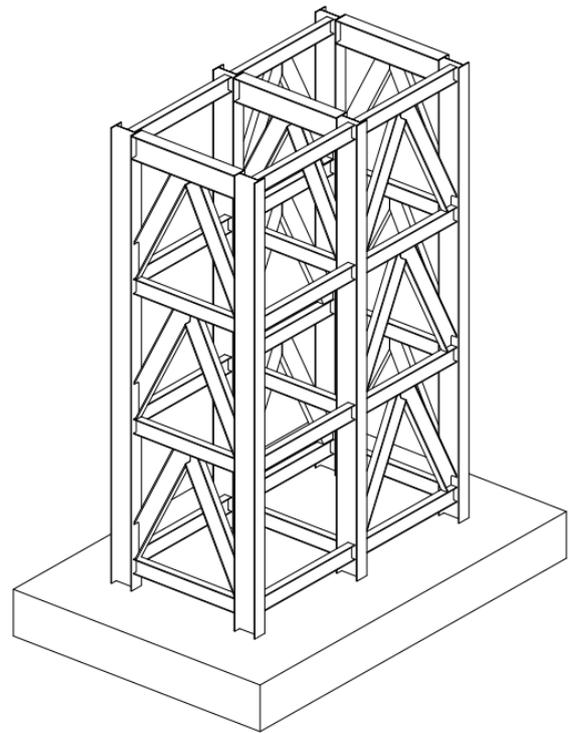
The slabs were in good condition so there was no need to demolish them, therefore it was more efficient to reuse them. Due to the lack of space in the surrounding CBD area, there was no place to remove and store them. It was found to be more cost-effective to construct jacking towers and lift the drop-in slabs out of the way. A jacking tower is shown in Fig. 7.

The jacking towers were designed using BS5400 and the project specification. Based on the geotechnical cores and analysis the bases for the structure were found on rock. The jacking towers were designed to carry the self-weight of the structure, the drop in slabs vertical weight (360tons), 10% vertical weight as a horizontal force and 0.5kPa live load.

Fig. 7. Jacking tower

The limit state design method was used to determine the member sizes for the jacking towers needed to resist the moment and shear forces in the members. The design included verification of both the serviceability limit state (SLS) and the ultimate limit state (ULS).

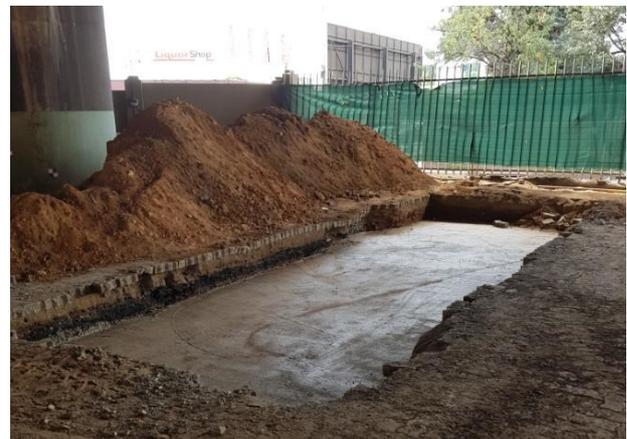
Bases were designed using the same methods as above to resist the forces coming into the bases. The bases were cast at appropriate levels so that the jacks would sit just below the drop-in slab's soffit. A typical base can be seen below in Fig. 8.

Fig. 8. Jacking tower base

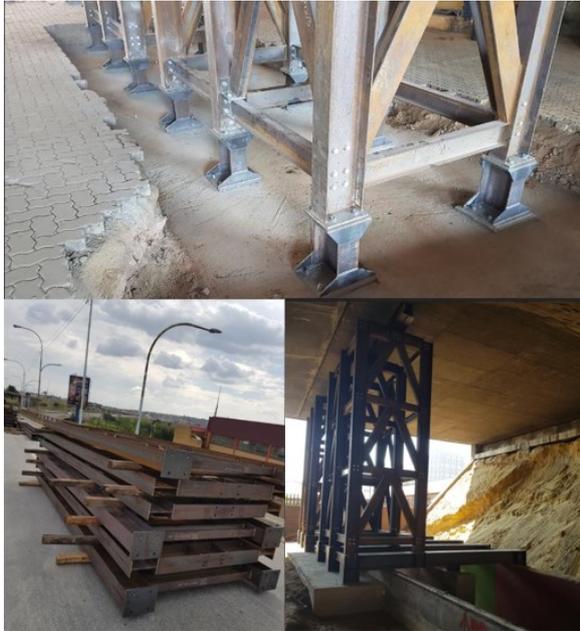
The jacking towers were designed to be modular, this allowed for one design to fit most cases with minor additions (different legs and heights), ease of transport and to allow for future reuse. The different modular applications can be seen below in Fig. 9. Elevations of the final jacked structure can be seen in Fig. 10 showing the different modular applications.

Fig. 9. Modular applications

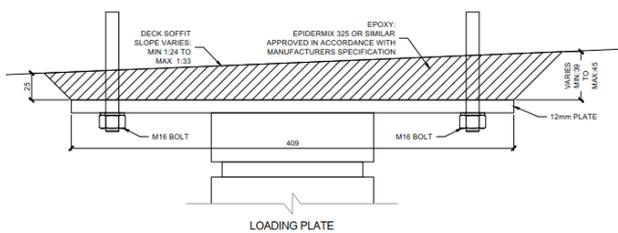
To allow for a flat jacking surface so that there would be an even distribution of the load across the jacks, 12mm steel plates were bolted to the soffit of the drop in slabs at the jack locations and the gaps were filled with epoxy. A cross-section can be seen below the loading plate in Fig. 11.

Fig. 11. Section through the loading plate

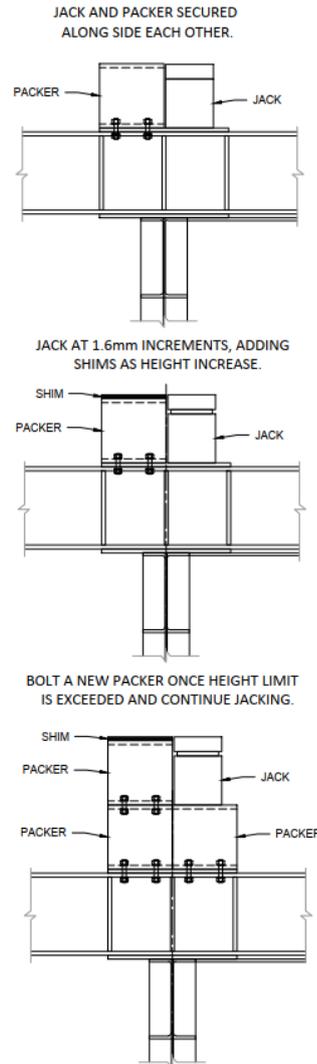
The jacking sequence was done in increments of 1.6mm with the use of packers and 1.6mm shims. A packer was placed alongside the jack and shims were added every 1.6mm, once the maximum jacking height was achieved a packer was added below the jack until the correct jacking height was achieved. The jacking process can be visualised below in Fig. 12 & Fig. 13.

Fig. 12. Jacking sequence

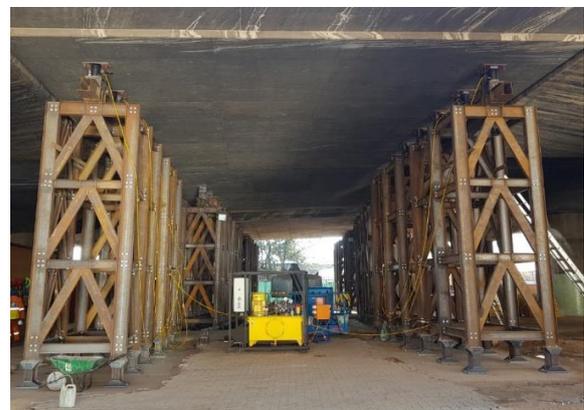
Fig. 13. Jacking towers

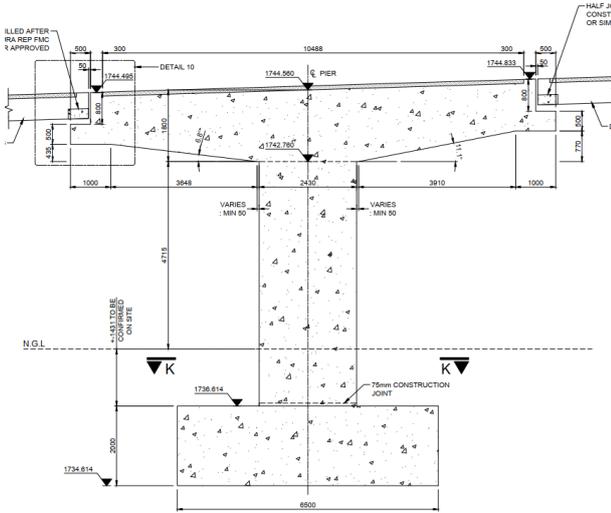
Fig. 14. Typical pier elevation

The column and mushroom head were of reinforced concrete and the mushroom head had half joints where the existing drop-in slabs would rest on. The new piers were designed to carry the self-weight of the drop in slabs vertical weight (360tons), 12kN/m SDL and TMH7 live loading.

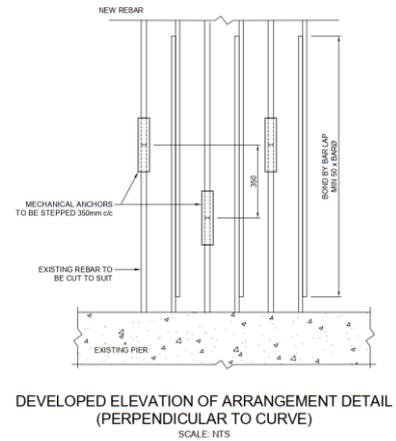
The new solution utilised the existing bases where a combination of existing starter bars, chemically anchored bars and mechanical anchors were used to dowel into the existing structure, as to not have a single plane of weakness, typical splice detail can be seen in Fig. 15.

Fig. 15. Splice sequence

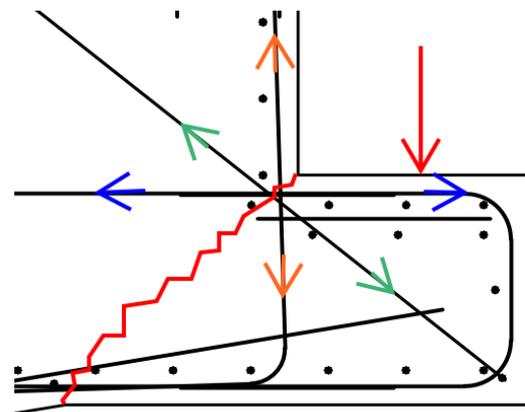
Another design aspect was the half joint. This half joint would carry the weight of the drop in slabs through the use of bearings. The design was carried out with the use of the strut and tie method, by resolving forces about a crack line and using the forces in the horizontal-vertical and diagonal bars that were greater than those applied. A graphical representation of the forces can be seen in Fig 17.

Fig 17. Half joint forces

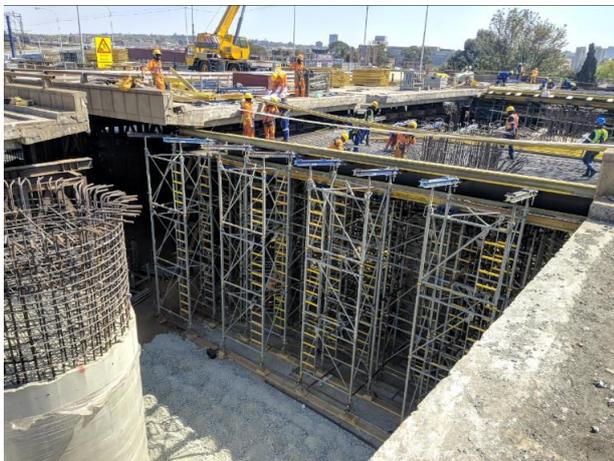
Due to the complex geometry of this structure, creep had a large effect on the mushroom head. To accurately calculate the creep at the cantilever ends the average humidity of the area, mix design of the concrete and codes of references all need to be known. Once the information was obtained the mushroom head was modelled with the data, using strap and Midas to compare the accuracy of the results. After running the analysis, it was concluded that we would pre-chamber the cantilevers linearly from 0mm to 12mm along the cantilevered edges. A photo of the precambered formwork can be seen in Fig 18.

Fig 18. Mushroom head formwork

The aggregate type used in the mix design influenced the creep. Granites were chosen over andesite and quartzite due to their superior creep properties. The creep calculation was done according to EN1992-2 and BS8110.
