Actual achievements and future challenges of HPFRC for structural rehabilitation of bridges

Adriano Reggia^{1,*}, Ivan Trabucchi¹, Alessandro Morbi² and Giovanni A. Plizzari¹

¹ University of Brescia, Brescia, Italy

² Italcementi S.p.A., Bergamo, Italy

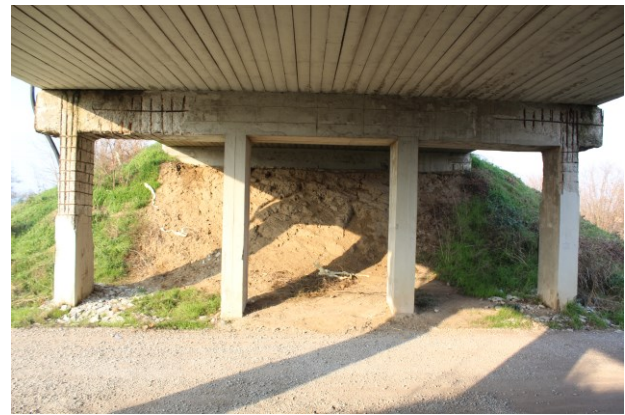
Fig. 1. Existing bridge adopted as case study for the experimental campaign.

The bridge has three spans of approximately 900 cm with multiple column piers and cap beam, Fig. 1. The abutments were built with beams resting on reinforced concrete piles, which penetrate the ground more than six meters. Each pier consists of a frame of four columns with a span of 327 cm (from the vertical axis of two consecutive columns). Each column has a rectangular cross-section 41 cm wide and 90 cm deep, and is reinforced by 14 \varnothing 16 longitudinal steel rebars and \varnothing 10 stirrups with a 20 cm spacing. The foundation is a beam 120 cm wide and 90 cm deep, reinforced with 12 \varnothing 16 longitudinal rebars. The transverse reinforcement consists of 2 \varnothing 12 deformed bars at 20 cm spacing. At the top of the pillars there is the cap beam, with a total length of 1132 cm; it extends beyond the pillars by about 55 cm. Its section is rectangular with a base of 90 cm and a height of 80 cm. The cap beam is reinforced by 7 \varnothing 22 longitudinal rebars, both at the top and the bottom, while at the middle height there are 2 \varnothing 12. Shear reinforcement consists of 2 \varnothing 16 deformed bars every 20 cm, lapped on the side of the beam (unconventional detailing). All these structural elements have a net concrete cover of about 2 cm. Steel rebars are made with FeB44k steel (yielding tension of 430 MPa), very similar to B450C steel available in Italy nowadays. Concrete has a mean cubic compressive strength of 31 MPa.

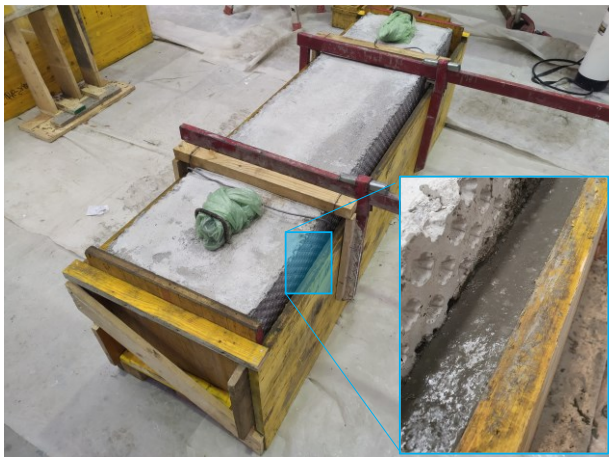
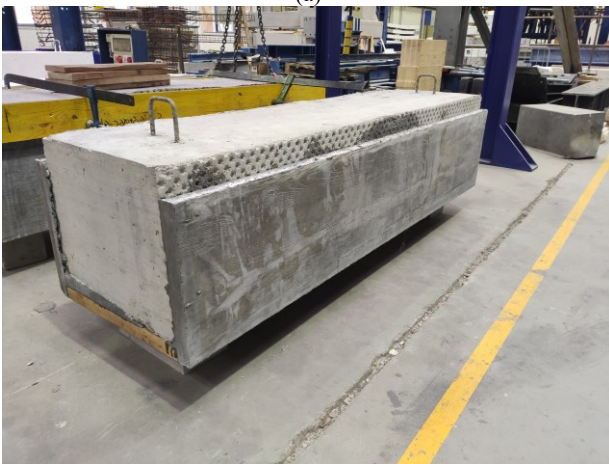
Fig. 2. Reinforced#02: (a) specimen before casting with highlighted on the right the HPFRC layer after casting and (b) reinforced specimen after demoulding.

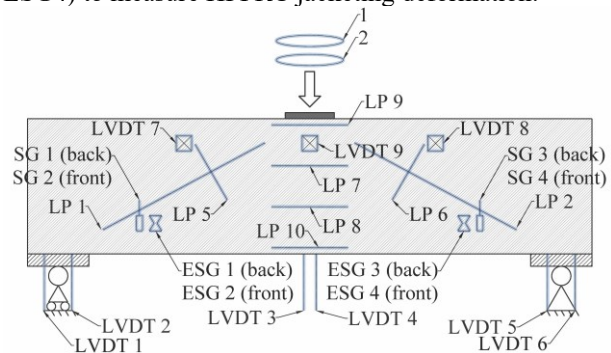
The displacement gauges are presented in Fig. 5: it includes six inductive displacement transducers (LVDTs) and eight potentiometric transducers (LPs). In particular, two LPs (LP1 and LP2) were used to measure the shortening developed along the compressed struts of the beams, considering an inclinations of about 26° ; two LPs (LP5 and LP6) were used to catch the possible formation of a major shear crack; four LPs (LP7-LP10) were used to measure longitudinal deformations at the edges of the cross-section of the beam at the mid-span. For the reinforced samples other transducers were used: three LVDTs (LVDT7-LVDT9) to measure possible detachments of HPFRC jacketing and four ESGs (ESG1-ESG4) to measure HPFRC jacketing deformation.

Fig. 5. Side view of the specimen with the adopted instrumentation.

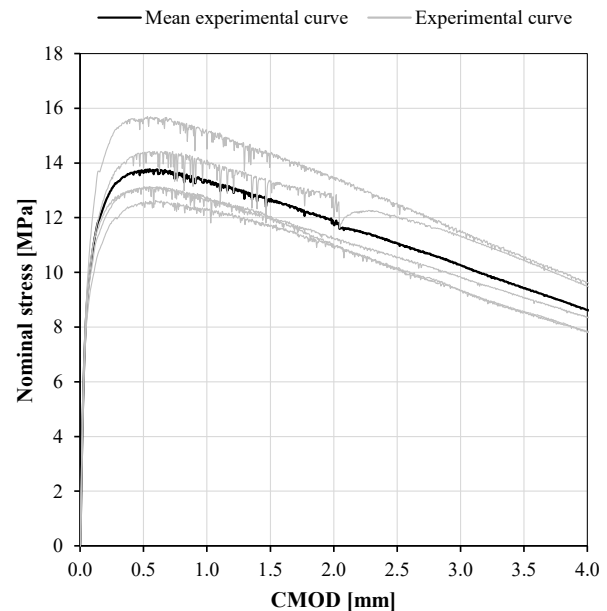
Fig. 6. Nominal stress vs. CMOD curves.

experimental curves obtained from five beams (in grey) are presented in Fig. 6 along with the mean curve (in black). The residual nominal tensile strengths of HPFRC were evaluated in accordance with EN 14651 [21]. Table 3 summarises the results obtained.

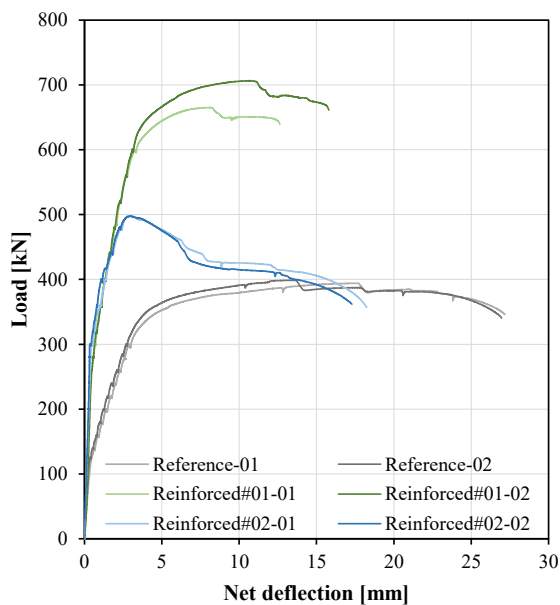
Fig. 7. Net deflection vs. load curves for the six beams tested.

The structural response of the specimens can be compared by means of the net deflection at the mid-span of the beam versus total load (see Fig. 7). At first glance, different responses in terms of stiffness, ultimate load and overall behaviour can be appreciated for Reference, Reinforced#01 and Reinforced#02 beams; details are given in Table 4.
