# Assessment of the technical conditions of Jieț waste dump in the context of its reintegration into the surrounding landscape

**Abstract.** Coal mining activity in Jiu Valley is approaching, faster than expected a few years ago, to its end and one of the main directions for transforming the area (while ensuring its sustainability) is the development of tourism. Under these conditions, a problem that has remained partially unresolved is related to the integration of the former mining perimeters, especially the waste dumps, into the surrounding landscape. Such an approach must always start from a thorough check of the technical condition of these artificial earth constructions. For this reason the stability of the dumps in the Jiu Valley is considered to be an important issue, considering that possible failures endanger both the natural and the anthropic environment. In the case of the waste dump considered as a case study, because several years have passed since the last sterile rocks were deposited and since stability studies were performed, a new such study was considered necessary (given that the deposited rocks underwent certain changes: compaction, mechanical disintegration,

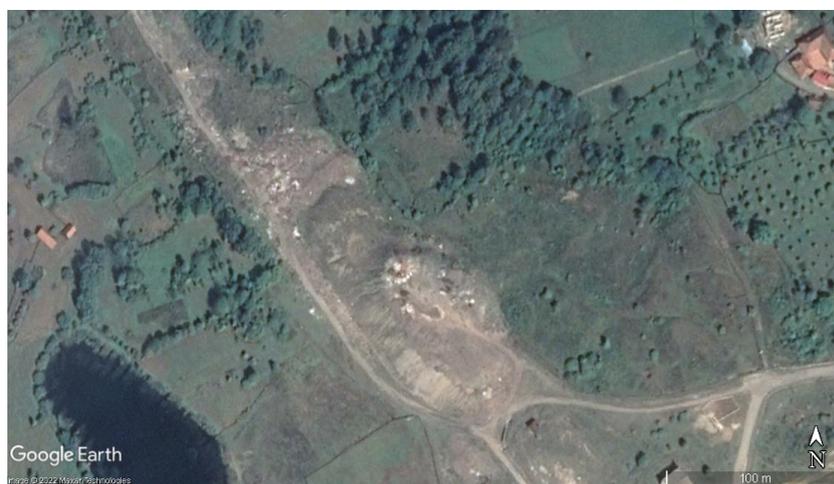
**Fig. 1.** Jieț waste dump in 2022 [4].

The dump is located near the auxiliary shaft for materials Jieț, on the former coal-shipping platform from the Jieț - Defor open pit and is oriented on the SE - NW direction. It is located on the territory of Petrila Town, on Jieț street, about 300 m from the East Jiul river and 240 m from the Lonea - Jieț road (figure 1) [3].

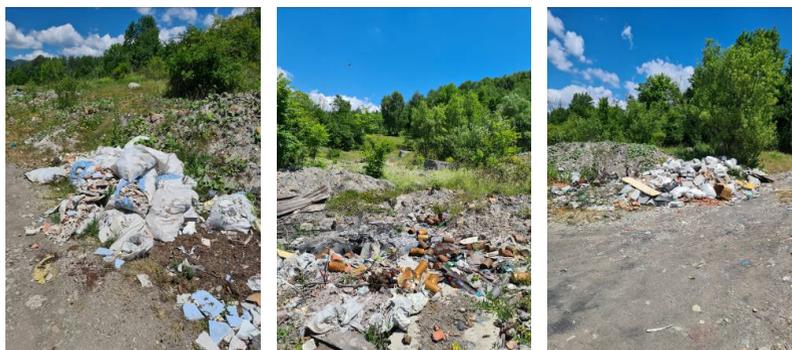
**Fig. 2.** Illegal accumulations of different types of waste materials.

The dumping activities in the Jieț perimeter is stopped for about 10 years, as well as the waste dump monitoring activities. Meanwhile, illegal accumulations of all types of waste materials have appeared on and around the mining waste dump (especially waste resulting from small demolitions) (figure 2).

Although scientific methods can be used to investigate the pedological conditions and to choose the tree species that are best suited for the reintroduction of Jieț dump into the surrounding landscape [12, 13], taking into account the above, the ecological restoration option considered optimal for Jieț dump is the one of forestation, using for this purpose endemic species [14], unpretentious to the soil conditions. Before planting the seedlings, the surface of the dump (slopes and berms) must be properly arranged, by removing the metal elements, large rock fragments and, especially, the accumulated illegal waste.

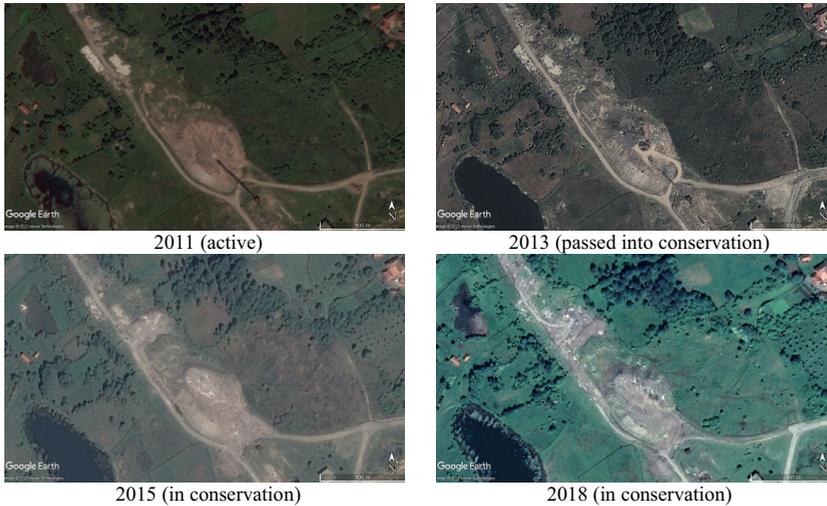
**Fig. 3.** The geometry of Jieț dump over time [4].

From a geometric point of view, the dump has undergone small changes compared to 2011 (figure 3). The geometric features refer to the configuration of the base terrain and the dump and include the slopes and the shape of their surfaces. The heights and slope angles

In the southwestern part, in order to prevent the slope of the dump from sliding, a support wall, with a height of 1.5 - 2 m, was built from prefabricated concrete beams.

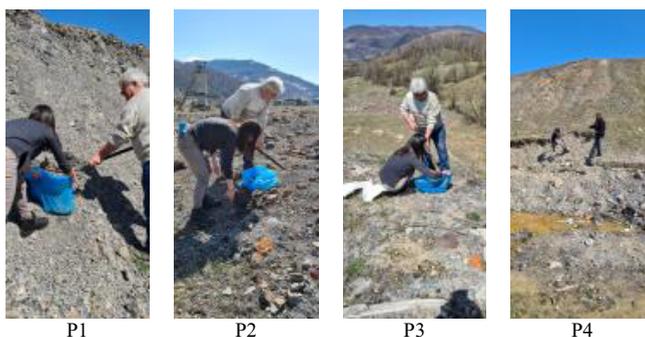
Fig. 5. Sampling campaign.

In May 2022, in situ sampling was performed from four points relevant to the geometry of the dump (figure 5) and tests were performed in the laboratories of Geotechnics and Earth Mechanics within the Mining Faculty (University of Petroșani) in order to define the physical-mechanical parameters that characterize the current state of the dumps. The results are shown in tables 2 - 4.

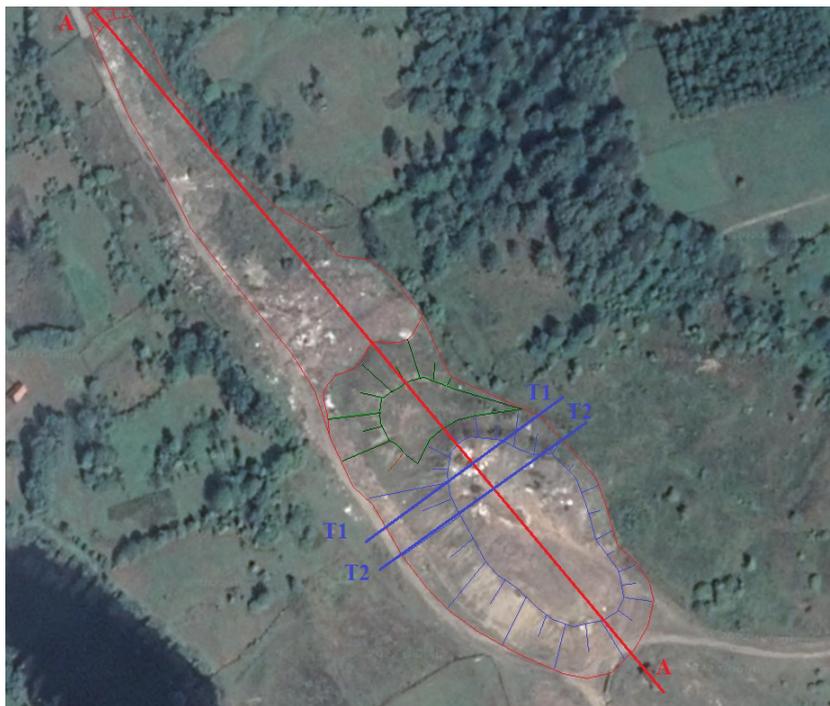
**Fig. 6.** Longitudinal and cross sections (modified after [4]).

Based on the observations and measurements made in the field, 3 sections were drawn, respectively the longitudinal section A - A and the cross sections T1 - T1 and T2 - T2 (figures 6 - 10).

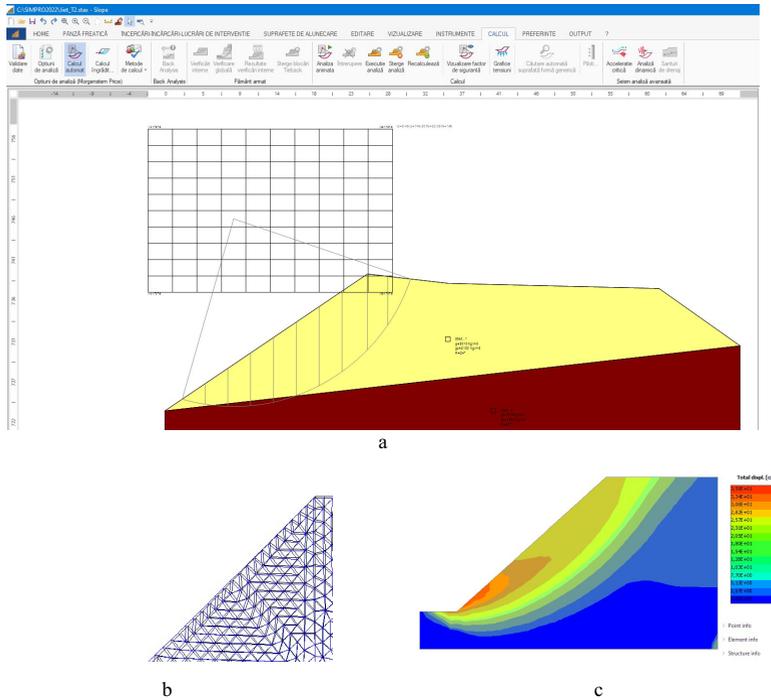
The results of the stability analyses performed for the geometric elements and the physical-mechanical characteristics presented in paragraphs 3 and 4 can be followed in table 6 and in figures 11 and 12.

**Fig. 11.** Stability analyses for a 18 m high slope at a 35° angle. a. Critical sliding surface (LEM – Morgenstern-Price); b. Deformations (FEM); c. Total displacements (FEM).

- In areas where the dump reaches the maximum height (18 m) or heights close to this value, in order to have a satisfactory stability reserve (around 30%) the value of  $40^\circ$  of the slope inclination (maximum permissible value) must not be exceeded. However, given that the aim is to ensure the long-term stability of Jieț dump, a maximum value of the slope angle of  $35^\circ$  is recommended, which leads to an average increase by approx. 15% of the stability reserve;

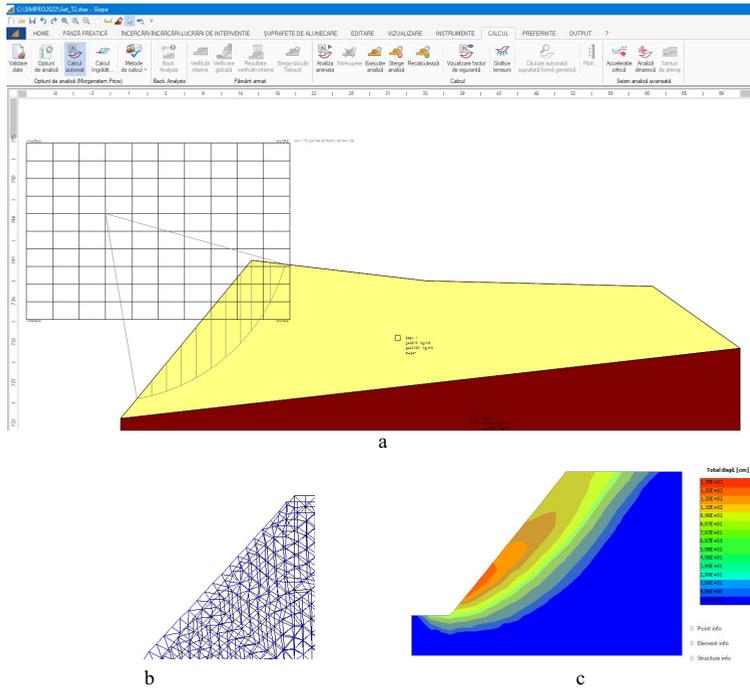
**Fig. 12.** Stability analyses for a 18 m high slope at a 50° angle. a. Critical sliding surface (LEM – Morgenstern-Price); b. Deformations (FEM); c. Total displacements (FEM).

- For slope angle values between  $40^\circ$  and  $50^\circ$ , also in conditions of a height close to the maximum, the calculated values of the stability coefficients indicate a decrease of the stability reserve below the limit of 30% recommended by the literature [5-7], dropping around 0%, ie a stability coefficient equal to 1 (equilibrium limit);

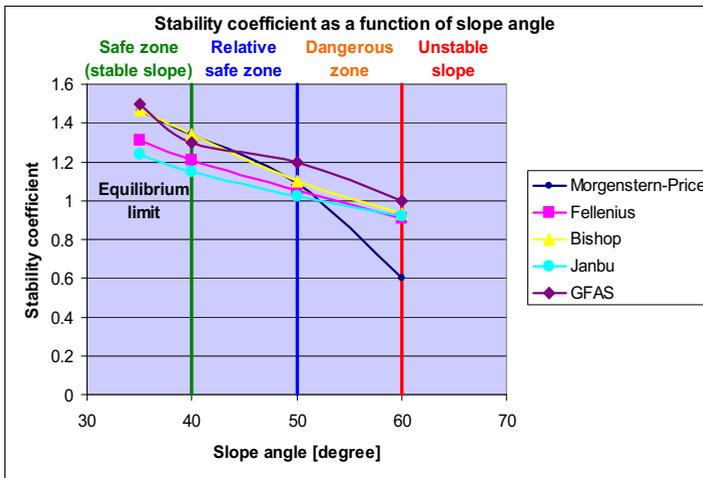
**Fig. 13.** Stability coefficient as a function of slope angle.

In order to facilitate the interpretation of the results of the stability analyses, with the help of the data from table 6, the graph from figure 13 was developed.

- For slope angle values greater than  $50^\circ$ , the value of the stability coefficient becomes less than 1 according to the analyses performed by most methods, which means that there is a real danger of landslides, even in conditions of natural moisture;
