Selected problems of maintaining the serviceability of turbochargers

Summary. To increase the filling of the cylinder in the engine, a so-called charge is applied, which consists in increasing the amount of air input under increased pressure and at an unchanged temperature. This increases the density of that air and increases the mass in the engine cylinder. In most cars, the charging is carried out by an exhaust gas turbocharger or a mechanical compressor. This paper presents the issues that concern the failure of turbochargers resulting from their balance by weight reduction method. Selected aspects concerning consequences of incorrect balancing and methods of reducing unbalanced rotor mass. A key part of the work includes a proposal to balance turbochargers of automotive vehicles using the "weight-adjustment" method. In this scope, preliminary studies were presented and conclusions observed during their implementation were described.

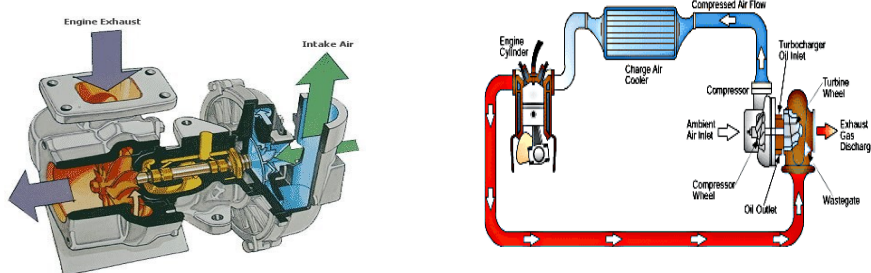
Fig. 1. Working principle of the turbocharger [2].

The turbocharger principle is based on the exhaust gas drive of the turbine rotor. The turbine is connected by a common shaft with a compression wheel, on which the air is aspirated. The compressed air is supplied to the combustion chamber of the engine cylinder under pressure - Fig. 1. To increase the efficiency of the turbocharger, an air cooler (intercooler) is used. Cooled air increases its density, which results in an increase in the mass delivered to the combustion chamber.

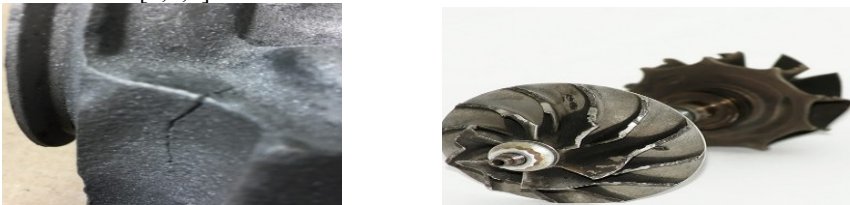
Fig. 2. Fracture of the outer part of the housing.

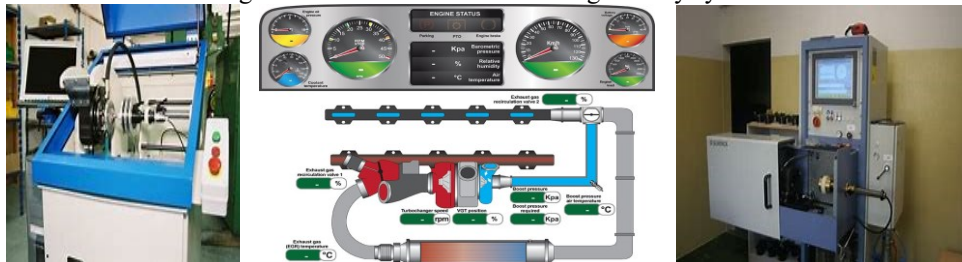
Fig. 3. DASHBOARD application in IDC5 software [5].

The color of the exhaust gas coming out of the exhaust system may also indicate the condition of turbo-charging device. The blue or black color of the exhaust gases can indicate a turbocharger failure. This defect may indicate a cracked compression wheel or a defective oil system in the turbocharger. The presented method is one of the simplest, but in case of its credibility it becomes questionable because it does not ensure accuracy and insight in its assessment [10]. The parameter that characterizes turbo-charge system and can indicate its condition is the pressure of turbocharging. The vehicle directive that has been drawn up stipulates that cars manufactured after 2000 must have 16-pin diagnostic connector. This makes it easier to diagnose any driver emissions in a vehicle and the reading of operating parameters in any time unit. The key information in the turbo-charging circuit is the actual data, which is stored by signals from sensors in the circuit. The evaluation of the above parameters is possible through additional functions, which are used as applications in diagnostic testers. The turbo-charge pressure is checked here dependent on [5]:

- rotor speed,
- compressed air pressure,
- exhaust gas temperatures,
- the blade angle of inclination in the variable geometry system.

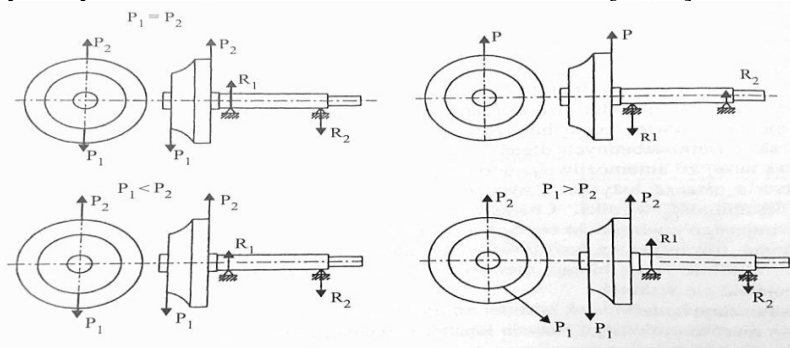
Fig.6. Illustrates the dynamic balance of the turbocharger's rotor [1].

The force pair P_1 and P_2 as shown in Fig. 6 is in the same mode of working as the axis of the rotor. On a bearing-mounted balancing station, the reactions R_1 and R_2 are generated, which are in the same position as the above forces. They have equal values but opposite directions ($R_1 = -R_2$). The location of the rotor, as well as the value of unbalanced mass, is used to verify the place and mass of the material, which must be removed for proper dynamic balancing of turbocharger rotor [1].

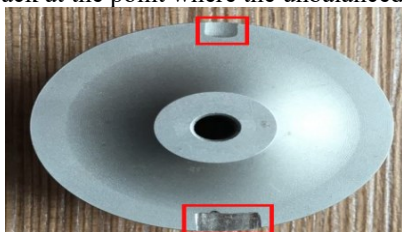
Fig.9. Mass reduction points on the compression.

This type of balancing is the result of the recommended stricter requirements imposed by companies manufacturing turbo-charging devices. Correction of unbalance of turbochargers by "reduction of mass" certainly affects the structure of the balanced element because excessive removal of material from the compression wheel or turbine wheel make them weak, which often causes cracking of these elements. The following figures (9 and 10) show the points on the compression wheel from which the mass has been reduced and the resulting wheel crack at the point where the unbalanced mass was gathered.

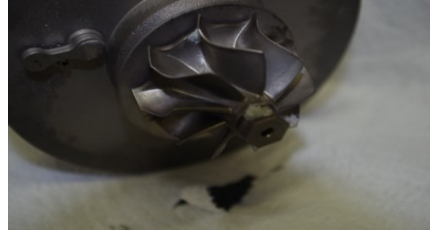
Fig.14. Ripped wheel mass.

After the process of balancing the turbine wheel had been completed, the compression wheel was verified. The procedure was the same as in the case of the turbine wheel. The unbalance of the compression wheel was reduced by overlapping the same mass as that of the turbine wheel. The procedure of balancing the turbocharger rotor was carried out in a correct way, the size of unbalance was within the tolerance limits. After the process of balancing the turbocharger's rotor, the balanced element was placed in the core of the turbocharger and mounted in the high speed Schenck MBRS110 balancing machine. During this process, the rotational speed of the rotating component exceeds 200 000 rpm. At this stage of the test, the high rotational speed strength of the mass of the rotor, which is common during the daily operation of the turbocharged drive unit, has been verified. During this test, it was observed that at a rotational speed of 200 000 rpm, the heat-resistant mass remained on the turbine wheel (Fig. 13) but broke out of the compression wheel (Fig. 14).

Further research on this issue should identify the phenomenon of the loss of added mass from the compression wheel at a rotation of 200,000 min⁻¹. In the initial analysis, this can be explained by the incorrect selection of glue for the material mass.

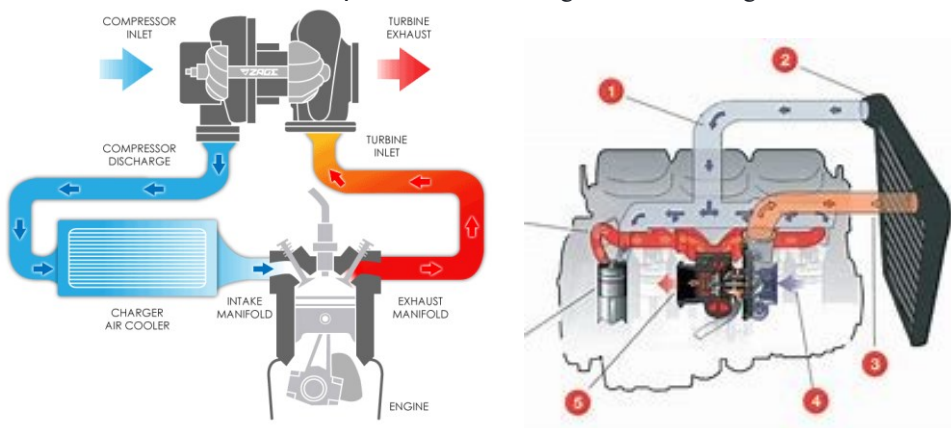
Fig.15. Diagram of turbo-diesel system [3].

Turbocharger is an exhaust-driven compressor used for turbocharging combustion engines, which is used to increase engine power by increasing the amount of oxygen supplied to the combustion chamber - Fig. 15. The construction of the turbocharger is designed in such a way that it can cooperate with it without any problems during the engine lifetime.
