Experimental study on bearing capacity of corroded angle steel members of in-service transmission towers

Abstract. The tower is the load-bearing structure of the overhead transmission line. Due to the complex operating environment and other factors, the transmission tower is prone to corrosion, which weakens the bearing capacity of the tower and affects the safe operation of the power grid. Through the investigation of the corrosion situation of the transmission towers in service, the angle steel members were removed from the in-service transmission towers, and the axial compression bearing capacity test was carried out. As the corrosion rate increases, the bearing capacity of components shows a decreasing trend, and due to the existence of corrosion, and at the same corrosion rate, due to the location of corrosion, the corrosion depth and corrosion area are different, and the axial compression bearing capacity of the components fluctuates greatly.

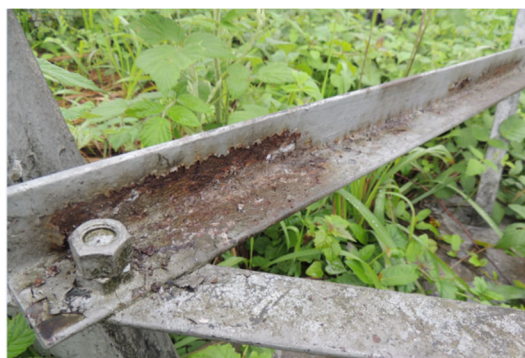
According to the corrosion status of transmission towers, it can be divided into local corrosion and uniform corrosion[3]. Local corroded iron towers have galvanized layers on the surface of most components, and some local areas or individual components are corroded, as shown in Figure 1. Local corrosion of transmission towers mostly occurs in areas with weak anti-corrosion capabilities such as tower feet, tower connections, and areas where the tower has galvanized leakage or scars. Uniform corrosion mainly occurs in coastal areas with high salt spray concentration or industrial areas with severe acid rain. The galvanized layer of the transmission tower with uniform corrosion of the entire tower is completely corroded, and the base steel has been corroded, as shown in Figure 2, where the line is Chongqing The 220kV Tiancha Line[4] has been in operation for 48 years.

The investigation of the current situation of corroded steel towers on transmission lines found that local corrosion of transmission towers mostly occurs in areas with weak anti-corrosion capabilities, such as the tower foot, the connection of tower parts, and the places where the tower has galvanized leakage or scars. The corroded components on the in-service transmission towers were sampled and the axial compression bearing capacity test was carried out. The results showed that with the increase of the corrosion rate, the bearing capacity of the components showed a decreasing trend. And under the same rust rate, due to the difference of rust position, rust

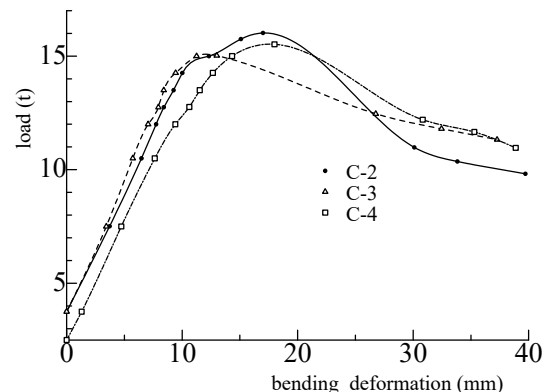
Fig.5 Load bending deformation diagram of L75×8 member

Through the axial compression bearing capacity test of angle steel with different degrees of corrosion, the load-deflection curve of the corroded angle steel specimen is obtained, as shown in Figure 5-Figure 7. It can be seen from the figure that the load-deflection curve of the component is basically similar to that of the uncorroded component, and it can be divided into an ascending section, a strengthening section and a descending section.

(a) Corrosion degree A

(b) Corrosion degree

(c) Corrosion degree C

(d) Corrosion degree D
