# Investigation on Performance of Heritage Masonry Structures

A structural assessment study on the “Humayun Palace” in Tamil Nadu, a cultural heritage structure, constructed in the early 1700’s was done. Based on the original design documentation collected through records, a static analysis model of the building was generated. This structure is a 3-storey building and details of all the provisions from the slab system to the roof tiles were made. The results developed by these models, aimed at fully understanding the original design concept of the various members, as well as at evaluating their current static and seismic safety conditions, are reported in this paper. This analysis was examined using E-TABS software, whose geometric limitations lead to minor encumbrances. Some complex geometric façade features were approximated to convenience and overcome. The results of the analyses highlight safe conditions and good performance objectives in general, but for some important exceptions. The overall satisfactory performance may be attributed to the overdesigning with excessive safety factors carried out by builders of that century, enabling the structure to withstand conditions way

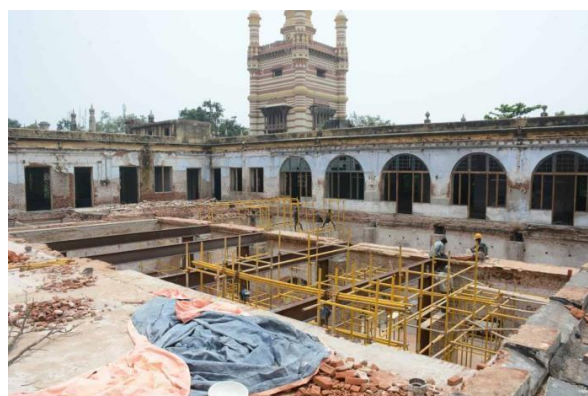
**Fig 2.** Renovation of the Structure during fire accident in 2016.

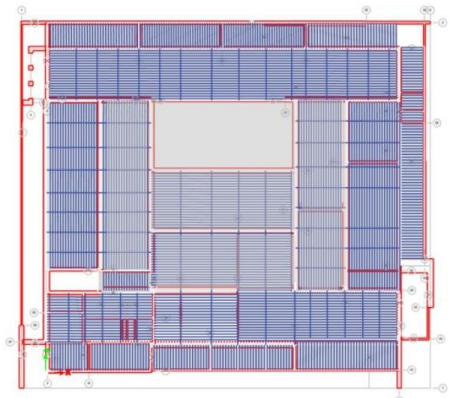
**Fig.6.d.** Modelled ground floor top view in ETABS
