# Condition of the extensive green roof of the Brno-Komín Kindergarten in winter 2 years after implementation

**Abstract.** The article describes the state of the vegetation layer of the extensive green roof on the kindergarten building in Brno-Komín. Due to the low temperatures, some plants are in a vegetative rest. On the contrary, some resistant plants are in good vegetative state even during adverse climatic conditions. The green roof was implemented in 2021 and as vegetation a pre-grown vegetation carpet was used, which was grown and transported on a coconut mat.

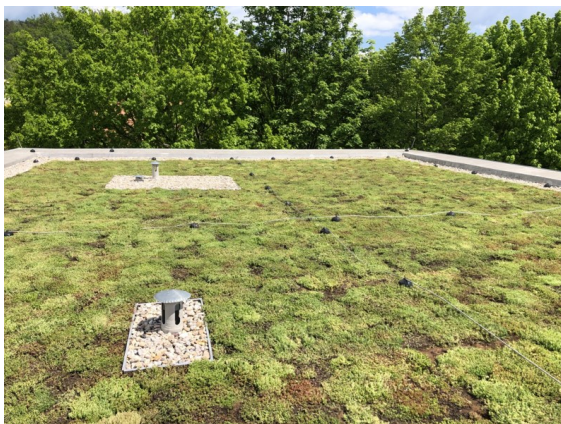
**Fig. 1.** Extensive green roof.

The article discusses the state of the extensive green roof during the period of vegetation dormancy. The roof was implemented in 2021 and since then the vegetation has already gone through the vegetation cycle and after 2 years we can see the visual result of the implementation company's work on the structure. In the pictures we can see the differences in the amount of vegetation that was green in its entire area after laying the carpet and in the vegetation boom phase (Fig.1).

The resulting appearance of the roof can be seen in Fig. 1 at the beginning of the article. The vegetation layer looks intact and the roof makes a beautiful impression.

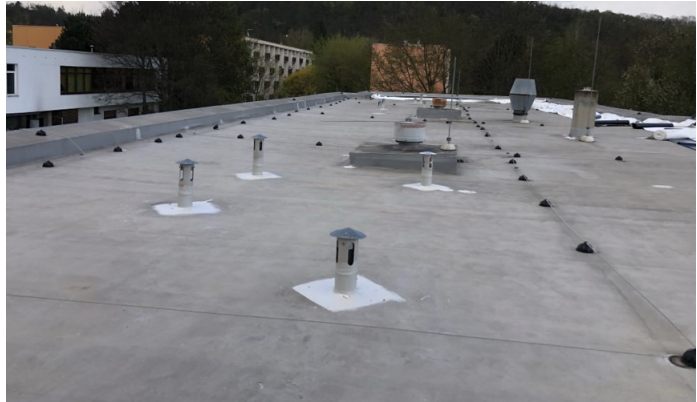
**Fig. 2.** Waterproofing control.

Before actually laying the roof structure, it was necessary to check the existing waterproofing (Fig.2). A number of control measurements were performed. One of the tests was a spark test, which locates capillary leaks in the waterproofing. A few minor bugs were found and fixed. To prevent rainwater from entering the structure.

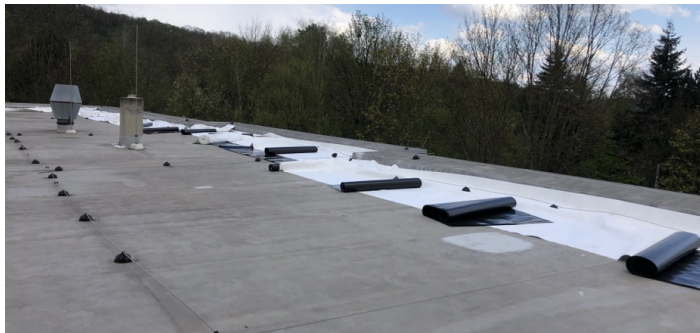
**Fig. 3.** Placement of geotextile and nop film.

When laying the geotextile, there was a problem with strong wind, and therefore it was necessary to gradually load the geotextile with rolls of nop film and bales with hydroaccumulation plates (Fig.3).

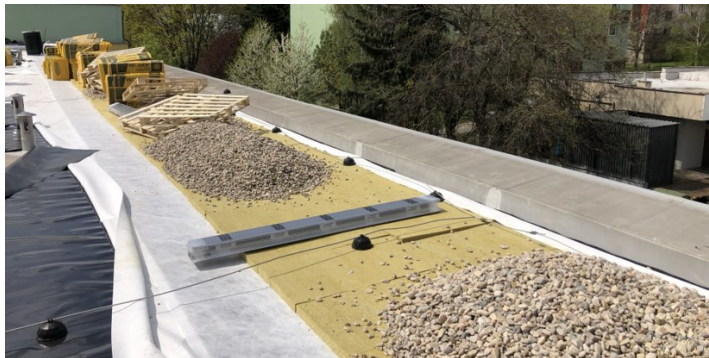
**Fig. 4.** Hydroaccumulation and gravel placement.

As part of depositing the substrate and gravel, aluminum perimeter profiles were also placed, which separated the substrate from the aggregate around the perimeter of the roof and also in the areas where the ventilation shafts and ventilation ducts penetrate.

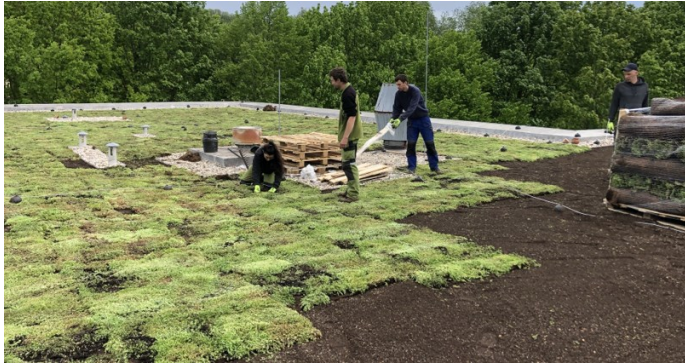
**Fig. 5.** Substrate and green vegetation carpet placement.

During the implementation, a mobile truck crane was used to transport materials to the roof of the building. A loose mixture pump was used to deposit the substrate, because manual spreading would be time-consuming on a roof area that exceeded 700m<sup>2</sup>.

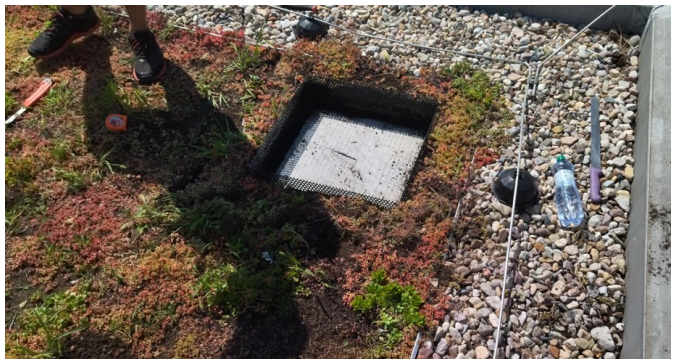
**Fig. 6.** Control segment installation.

Since its implementation, a number of work activities have been taking place on the green roof of the kindergarten. First, the roof ridge was repaired, the wiring was repaired and the control segment of the green roof was installed 1 year after reconstruction.

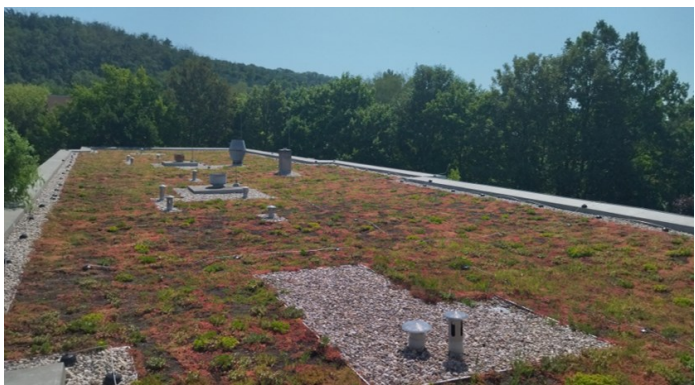
**Fig. 7.** Green roof in 07/2022.

During continuous inspections during the year, differences in the density of vegetation can be seen on the roof. The conditions for the vegetation on the green roof are different throughout the year, because the roof is not artificially irrigated, but only uses rainwater.

So we can see in Figure 7 that in the dry season in July 2022 the roof was less green and the density was lower than when the first image was taken.

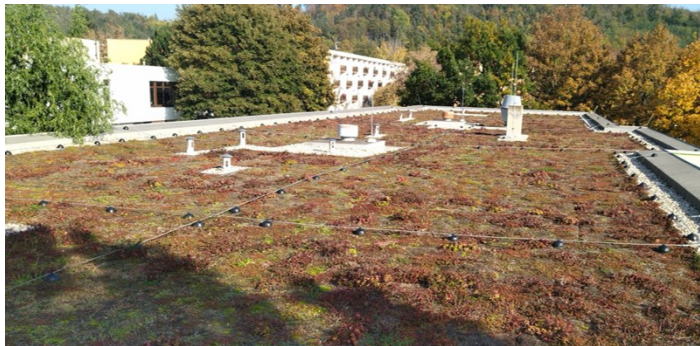
**Fig. 8.** Green roof in 10/2022.

The next imaging took place 3 months later in October 2022 (Fig.8). In the photos we can again see the reduction of the green area of the roof and small areas without vegetation. It can therefore be said that the appearance of the extensive green roof exactly copies the seasons and the dependence of the state of the vegetation.

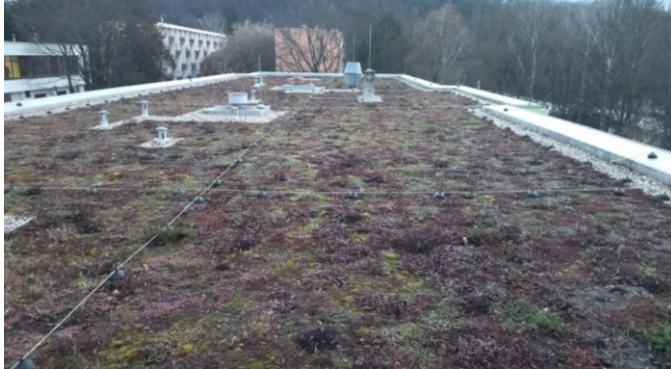
**Fig. 9.** Green roof in 02/2023.

One of the last imaging took place at the beginning of 2023. It was imaged with a thermal imaging device. The condition of the vegetation is recorded in detailed photos and we can see in them that the vegetation is dampened by the frost and especially very resistant plants and weeds are doing well.

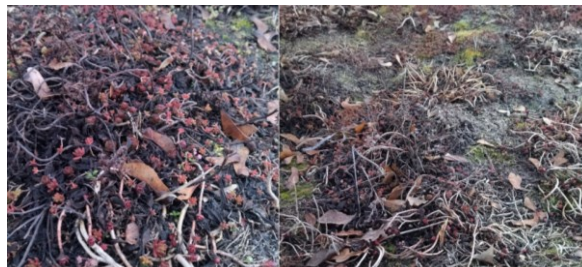
**Fig. 11.** Perennials and hardy stonecrops.

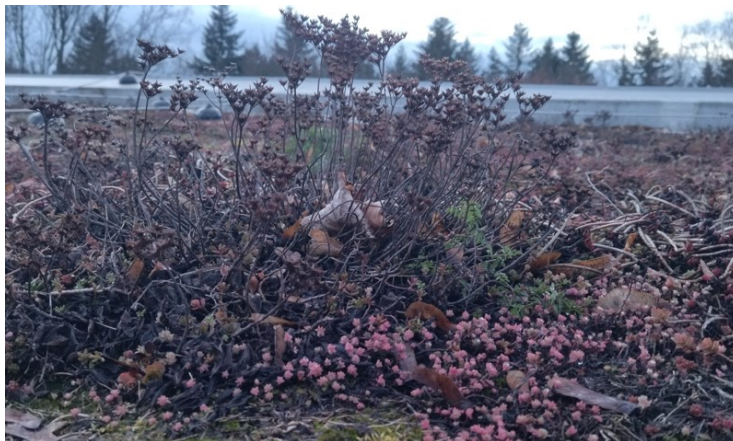
**Fig. 12.** Perennials and hardy stonecrops.

The plants, which are waiting for more favourable conditions to grow, still look wilted (Fig.12).
