Analysis of scooter engine piston damage

Abstract. The causes of operational damage to the piston of a single-cylinder two-stroke internal combustion engine (ICE) of a scooter, made of a piston aluminum-silicon alloy by mold casting, were investigated. It was found that the AK21M2.5H2.5 type alloy has a dispersed eutectic structure ($\alpha+\beta$ -Si) with a small number of primary silicon crystals of a compact shape, the size of which does not exceed 10 μm . The porosity of the cast alloy of the piston is less than the lowest 1st porosity point, as well as the quality structure, could not be the cause of its damage.

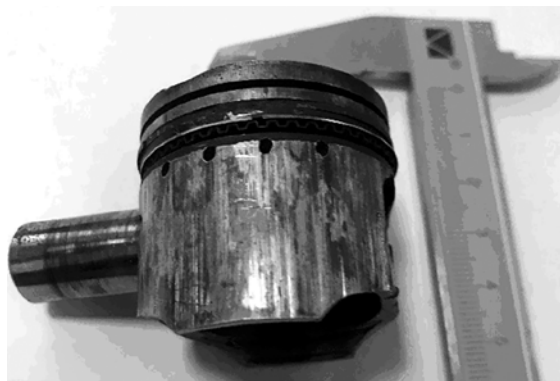
Research results. The object of the study was a piston of a single-cylinder two-stroke ICE for a scooter (Fig. 1).

Fig. 1. General view of the piston

The working volume of the ICE was 49 cm³. This piston was damaged as a result of the operation. The overall dimensions of the mold-cast piston were as follows: the diameter was 50 mm and the height was 60 mm. On the outer guide surface of the piston, so-called “the skirt”, there are traces of intense wear in the form of deep scratches and grooves

Inspection of the defective piston (Fig. 1) with the naked eye revealed damage on the guided part of the piston in the form of scratches and burrs parallel to the piston axis. Burrs occupy almost the entire area, starting from the oil removal ring and ending with the lower end of the skirt. Since the piston has no damage on the surfaces above the placement of the oil removal ring, there is a high probability that the scratches were caused by insufficient lubrication in the operating area. This, in turn, caused increased friction between the piston skirt and the cylinder surface [17]. During a detailed inspection of the surface using an MBC-9 microscope, significant damage was recorded on the outer surface (Fig. 4a) and especially in the area of the holes for the supply of antifriction fluid (Fig. 4b, c), which confirms the already existing assumption about incorrect engine operation (lack of lubrication).

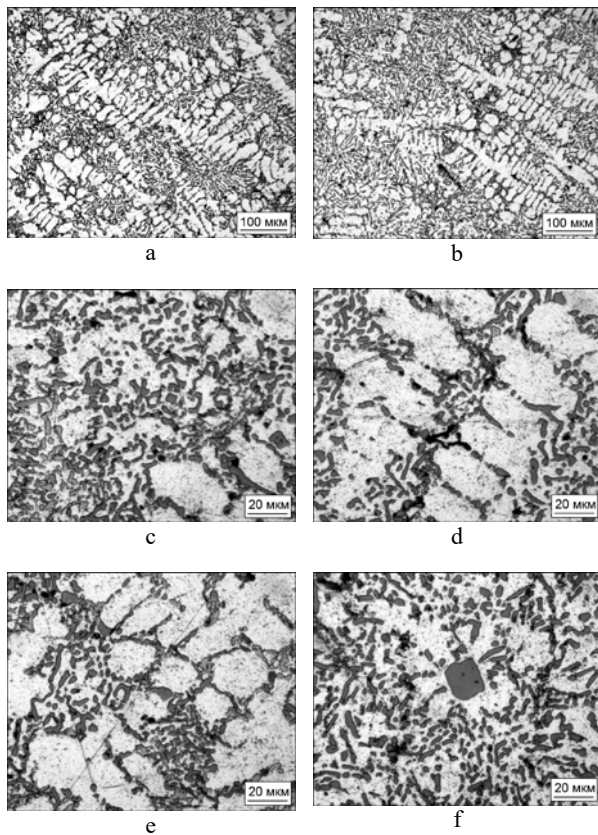
The microstructural analysis carried out in the work (Fig. 2) confirms the conclusion about phosphorus modification of the studied alloy. The structure of the cast alloy (AK21M2.5H2.5 type) consists of a small number of fine primary crystals of the silicon β -Si phase of gray color in the shape of rectangles, with the size of the sides up to 10 μm (Fig. 2d, f). In the center of some primary silicon crystals, dark inclusions of dispersed nucleators, namely, AlP_3 particles can be observed (Fig. 2f).

The main structural component of the alloy is eutectic, namely, a mechanical mixture of $\alpha + \beta - Si$. Eutectic is characterized by a different arrangement: areas of dendritic structure alternate with areas of rosette structure and areas of disordered arrangement of silicon phase

crystals. Eutectic silicon crystals are mostly elongated rod-shaped, and less often they are of a rounded or irregular shape. The length of the rods is $5\div 10\ \mu\text{m}$ and their thickness is up to several micrometers. Crystals of a rounded shape are about $1\ \mu\text{m}$ thick, whereas crystals of an irregular shape are somewhat coarser, up to $5\ \mu\text{m}$. In dendritic areas, silicon crystals are located at the boundaries of cells, which are grains of α -phase.

Summarizing the results of the microstructural analysis, it should be noted that the studied piston hypereutectic alloy has a dispersed structure of primary and eutectic crystals of the silicon phase, which was ensured by high-quality modification, most likely by a phosphorus-containing ligature. Therefore, the microstructure of the piston alloy could not be the cause of its damage.

Fig. 2 Microstructure of AK21M2.5H2.5 piston alloy after modification and mold casting

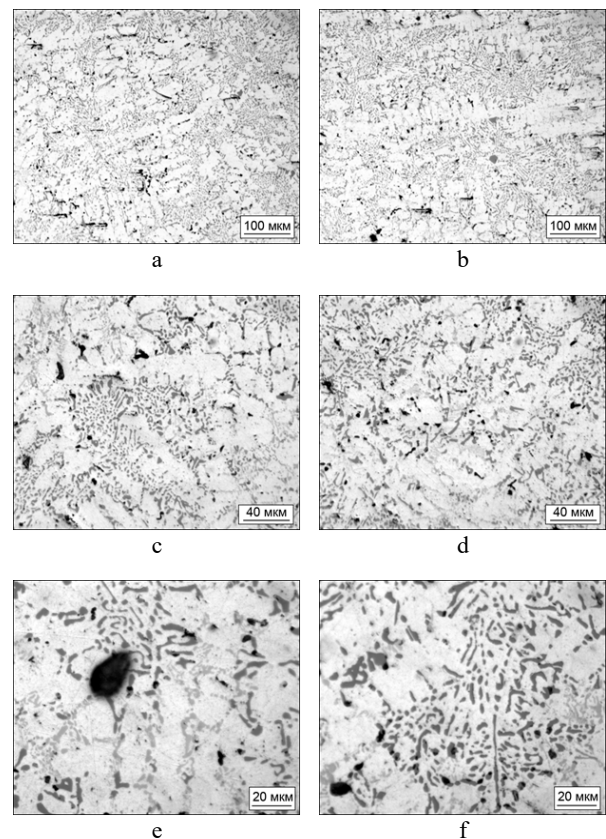
After a microscopic examination of the polished unetched samples, a slight porosity of the scooter engine piston ingot, which was cast in a metal reusable mold, was revealed (Fig. 3.5a, b). Separate coarse pores of mostly rounded or oval shapes with a size of $5\div 10\ \mu\text{m}$ are concentrated mainly in the areas of the α -phase (Fig. 3c, f). Instead, small pores are scattered in the structure of the alloy (Fig. 3c-f) and are localized at the interphase boundaries of β -phase crystals (Si) with α -phase grains. They have a globular or elongated (vermicular) shape. The size of the globular pores does not exceed $2\div 3\ \mu\text{m}$ (Fig. 3d, f). Instead, vermicular pores with a thickness of $2\div 4\ \mu\text{m}$ are bent along the interphase boundaries, reaching $5\ \mu\text{m}$, and some even $10\ \mu\text{m}$ in length (Fig. 3c, d).

Fig. 3 Microstructure of polished piston alloy samples (detected porosity)

To evaluate the porosity of the alloy of the investigated piston, the standardized method of determining the porosity of aluminum alloys by DSTU 2839 – 94 [6] was used. It was found that contrast with a reagent (10% NaOH aqueous solution, $70\ ^\circ\text{C}$) clearly outlines the existing and reveals smaller pores that were not visible during the macroscopic examination of the studied samples before contrast. Using the method of

comparison with reference scales, it was found that the average porosity of the ingot is less than the lowest 1st porosity point, which corresponds to a pore diameter of up to 0.1 mm and an allowable number of pores up to 5 pieces on a surface area of 1 cm². Therefore, such low porosity cannot threaten to reduce the tightness and mechanical strength of the scooter engine piston.

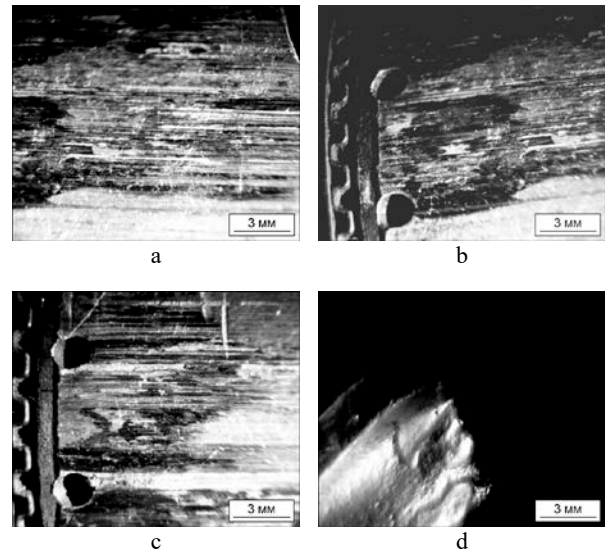
In addition to the above-mentioned defects, the macroanalysis revealed a casting defect “inflow” in the hole for the connecting rod finger (Fig. 4d). Given the place of formation, this type of defect could not be formed during injection molding, since this technology ensures the highest accuracy of the ingot surface. In addition, the use of expensive equipment for the production of such relatively small parts as a piston will

have a negative impact on the cost of the product and its subsequent sale on the market. A more likely cause of the formation of the inflow, taking into account the location of this defect, the complex shape of the ingot, and the serial production, is damage to the rod during mold casting. Mold casting is much cheaper and more efficient for this ingot [18], but the complex structure requires the installation of a rod to form a hole for the connecting rod finger.

Fig. 4 Photos of piston surface defects obtained during detailed macroanalysis

Therefore, one of the above-mentioned factors or their simultaneous action contributed to the degradation of the ICE scooter piston. If a defect is observed after production, measures should be taken to prevent it, namely, strengthen defect control of ingots, use analogs of production materials with better properties, and optimize casting parameters.
