Seismic vulnerability assessment and mechanical – based fragility analysis of a masonry clustered building in South Italy

Antonio Formisano and Giovanna Longobardi

Department of Structures for Engineering and Architecture, School of Polytechnic and Basic Sciences, University of Naples “Federico II”, Piazzale Tecchio, 80 80125 Naples (Italy).

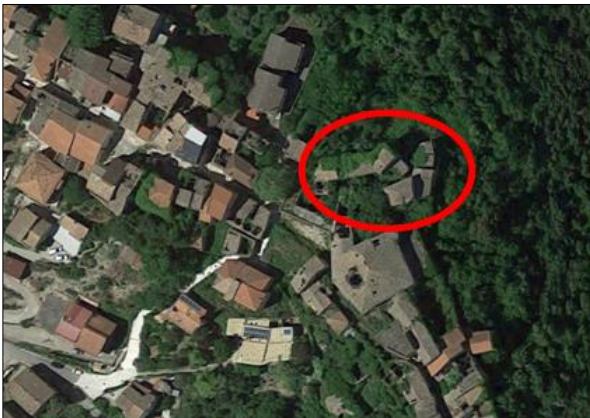
Fig. 2. Individuation of the masonry compound under study

The masonry aggregate under examination is placed in Dietro La Torre Street, slightly detached from the ancient medieval nucleus of Castelpoto. This area has been targeted by the local administration for redevelopment, aiming to revitalize the historical centre, which, thanks to the presence of the old medieval Castle, holds potential as a tourist destination.

The location of the case study is depicted in **Fig. 2**.

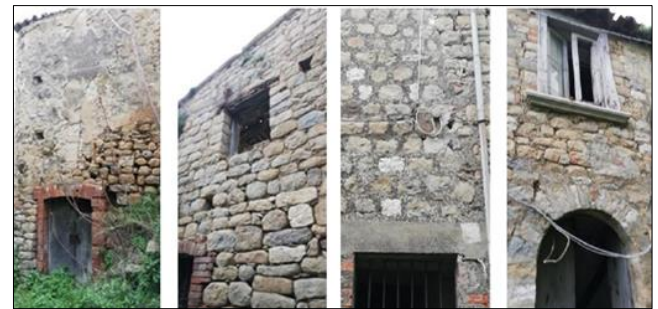
Fig. 4. Erosion phenomena on vertical masonry walls

Fig. 4 reveals erosion phenomena affecting the mortar due to exposure to environmental agents, which led to its pulverization.

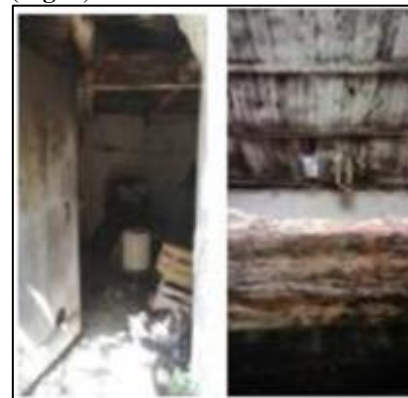
Fig. 5. Injured and deformed wooden beams

Additionally, partial collapses are evident in correspondence to wooden beams of intermediate floors (**Fig. 5**).

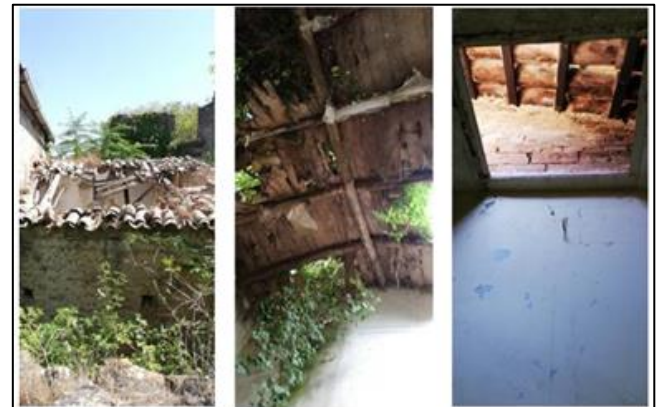
Fig. 6. Collapses of the roofs

In the end, **Fig. 6** evidences the collapse of some sections of roofs.
