Principles and technologies of historical structures consolidation, case study of Banloc castle complex

4 General presentation of the building

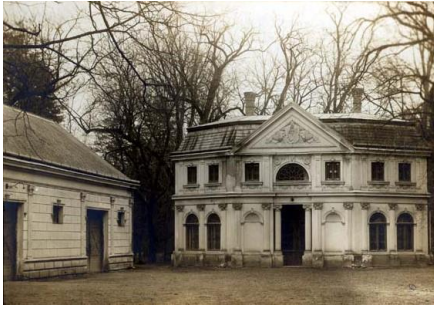
Fig. 3. Initial aspect of the Pavilion.

Initially, the Pavilion was the jewel of the Banloc ensemble. With a richly ornamented facade, it imposed itself despite its small size (Fig. 3). In present, due to multiple causes it has become a ruin (Fig. 4).

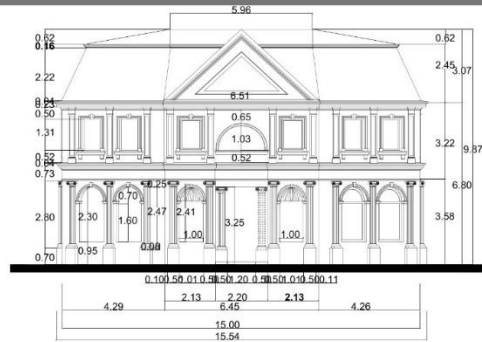
Fig. 5. Pavilion plan and west façade.

The Pavilion building has an elongated octagonal shape (Fig. 5) plan, with a masonry structure and a brick foundation; it runs vertically on two levels and has a wooden frame with sheet metal coverings. In approaching the solutions to consolidate the historical load-bearing structures, we have a coherent staged course of actions that must be carried out, respecting the order of implementation, namely:

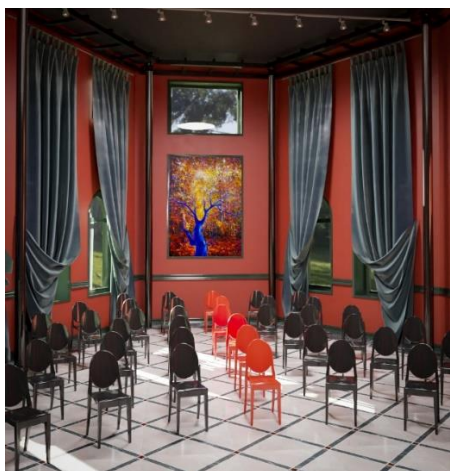
Fig. 6. Aspects of the Pavilion – Interior proposal.

The carpentry will be Chinese green, it will have frames and windowsills on both the doors and windows, with double-layer, double-paned glass, shields and bronze hinges in the classic manner, but massive, not ordinary sizes. The floor, after the installation of the heating system in the floor, supplied with caloric power from the proposed semi-buried technical building at the intersection of the extreme northern lines between the Pavilion and the Superintendent's House, will have natural stone as its material, in a classic rectangular game of marble squares Botticino (or similar), bordered by a game of Guatemala Green marble (registers 8 cm wide) - the intersections between these registers will be made in 8x8 cm squares of Rosso Verona marble (that English Red) which can go up to Red emperor. The perimeter edge on which the pillars of the metal structure are located will be treated as a horizontal border also of Guatemala Green marble, 80 cm wide; due to the elongated octagon structure, all the internal pattern of the pavement will turn at 45 degrees, compared to the N-S axis (Fig. 6).

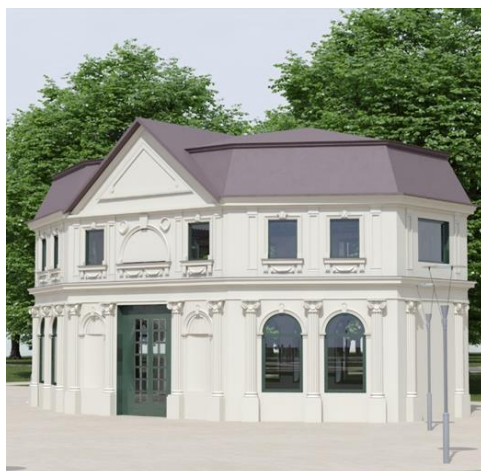
Fig. 7. Outdoor proposal Hunting Pavilion.

The exterior will be uniformly chromatically treated, in a greige-white shade, which takes over from the inside the Chinese Green carpentry, with exterior glazing beads made of Guatemala Green marble (Fig. 7).

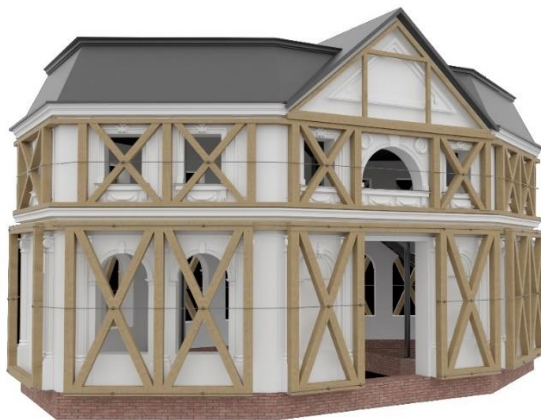
Fig. 9. The exterior cladding of the building with a wooden structure and the perimeter reinforcement by tensioned cable, on four levels.

At the Hunting Pavilion we will have mandatory masonry support. They will be rigid, so as not to deform, compressed, so as not to work in tension, and they will have to face contractions from humidity and temperature variations. A wooden structure was proposed, with different dimensions and on several layers, located outside the perimeter of the building, on all sides from ground level to under the envelope (Fig. 9) 3D.

It will have several layers because the facades are richly ornamented and we have a vertical planimetric, many volumes that come out of the building plan; this wooden structure will be tied horizontally with tensioned cable, on four levels: three cables on the first level: one at the base, one at the middle of the height of the window openings; the third at the top of the ground floor; floor, having a very low height regime, the fourth cable is made in the middle of the height of the second level. The cables on the ground floor of the building that pass through the door openings will be interrupted, to facilitate access to the building, during the construction site.

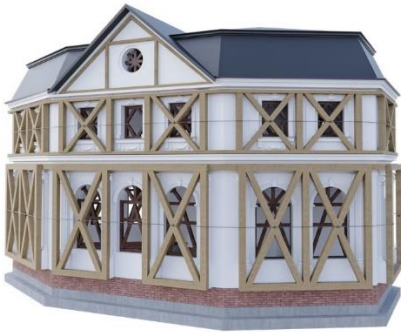
Fig. 10. Wooden reinforcements at window gaps and types of sub-foundation: a. under the base of the foundation.

Also, wooden structures will be built in the gaps of the windows and access doors, in order not to endanger the dismantling of parts of the building after the start of the consolidation works. All these structures will be temporary, and in the end, after the consolidations are done, they will be dismantled. Also at this stage, the floor supports must be made.

1. The first in which the sub-foundation is carried out, under the sole of the current foundation, in stages, in sections of 1.00 meters with a break between them also of 1.00 meters, with a depth of 0.60 m below the current level of the brick foundation (Fig. 10).
2. The second variant in which a lining is made to the inside and outside of the foundation, perimeter, starting with it 10 cm from the current ground level, downwards.

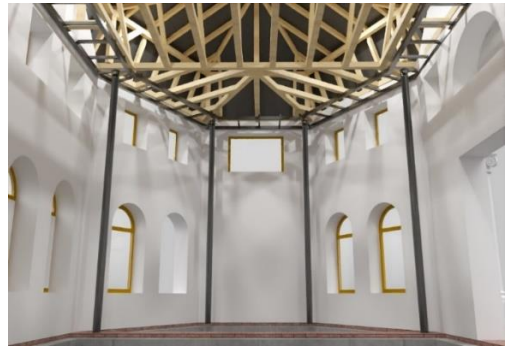
Fig. 11. The metal structure from inside.

At this moment, the interior metal structure (Fig. 11) can be mounted, which consists of pillars with a diameter of 250 millimetres, which take the form of the two pillars in the building, currently present, but which will be dismantled; the shape of the new pillars will be preserved in their memory. They will be located 40 cm towards the inside of the building (perimeter) and will be located at each change of direction of the walls. They will support at the top a perimeter structure of a rectangular, latticed pipe, 900 millimetres wide, which will reinforce the whole structure and which will be anchored in the walls, stopping the opening of the two with problems - the wall on the east facade and the wall on the facade from the west, which tend to open outwards. The building will remain empty inside, on the height of two levels, giving amplitude to the created volume, which reminds of the grandeur of the period in which it was conceived and built.

At the moment when the foundations are being consolidated, the foundation cups must also be executed for the metal structure proposed inside, which will be presented later. The concrete slab with appropriate thermal insulation will be poured over them, at a level 10 cm below the tread level.

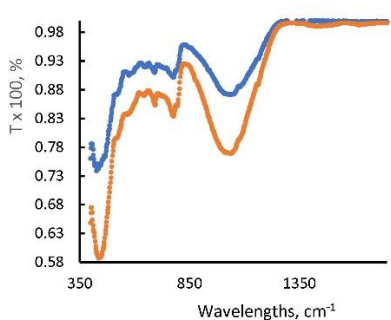
Fig. 15. FTIR Analyse of hunting pavilion sample (calcium carbonate (CaCO_3): 1409, 705 and 611 cm^{-1} , gypsum ($\text{CaSO}_4 \cdot 2\text{H}_2\text{O}$), 1109, 669 and 596 cm^{-1} and clays: 1032 cm^{-1} (Si-O-Si bond)).

Obviously, through FTIR (Fig. 15) it was possible to identify calcite (from lime), quartz (sand) and clay (albite) from the raw materials present in the area. From here it is possible to deduce that as restorations or consolidation procedures of the investigated area were made, the raw materials brought from other areas (at the first layers of mortar) were given up and raw materials from the Banloc area were used. FT-IR analysis proved the biggest band at

around 1000 cm⁻¹ representing the abundance of quartz, albite, calcite, berlinite in the studied materials.
