Sustainability in the strengthening process of the load-bearing historical structures

Marius Mosoarca^{1*}, Iasmina Onescu² and Alexandru Mosoarca³

3 Case study of the Parish House in Apos

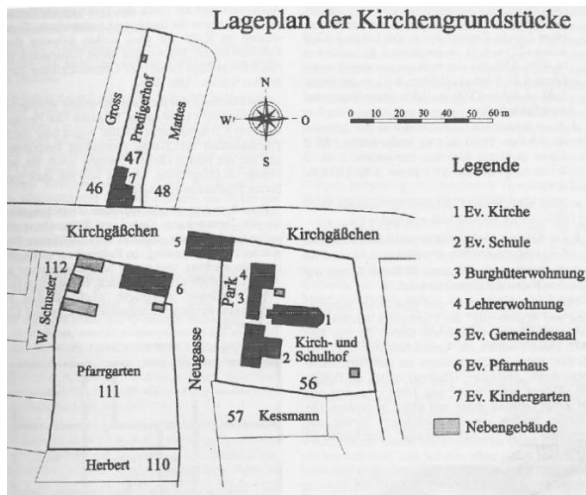
Fig. 4. Plan of the Evangelical Church Complex in Apos village: 1. Evangelical Church; 2. School; 3. Mayor’s house; 4. Teacher’s house; 5. Evangelical community hall; 6. Parish house.

The church complex is located at the north-eastern end of the settlement, strategically placed at height within the village. In the north-western part of the Evangelical Church complex of Apos was the parish house, which was a replica of the peasant house, only larger and more complex. The entire complex is illustrated in Fig. 4 [8].

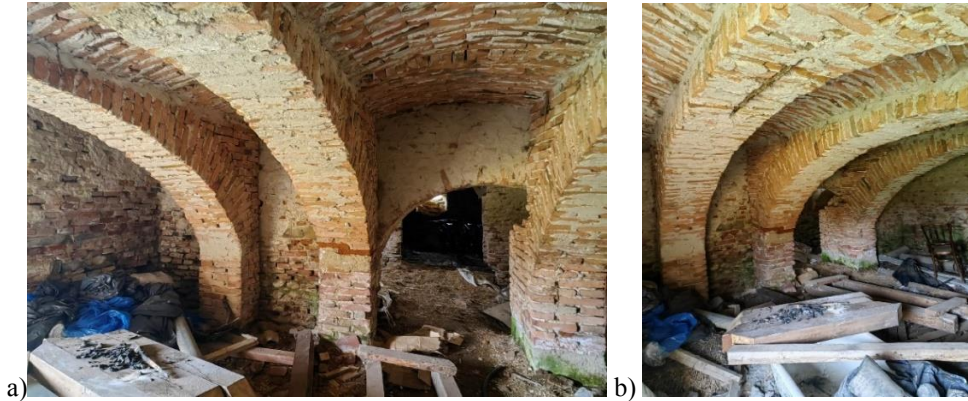
Fig. 8. Parish house: a) brick vaults over the basement; b) tie rods.

The load-bearing structure of the building is made in masonry made of brick and stone, with continuous foundations under the walls made in brick and stone masonry. The horizontal structural elements are wooden floors and brick vaults over the basement (Fig. 8a). The spatial connection between the walls is provided by metal tie rods, located also in arches (Fig. 8b), while the roof is pitched, with wooden framework (Fig. 9). The masonry arches and vaults are interventions for the consolidation of the existing building, that were made in 1955 [9].

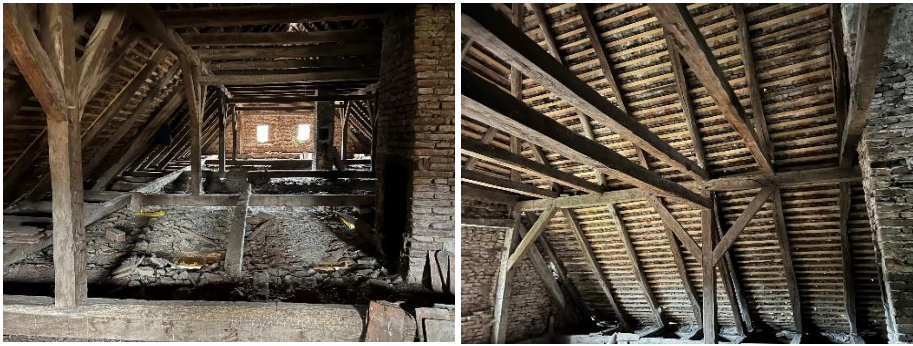
Fig. 9. Parish house – wooden framework.

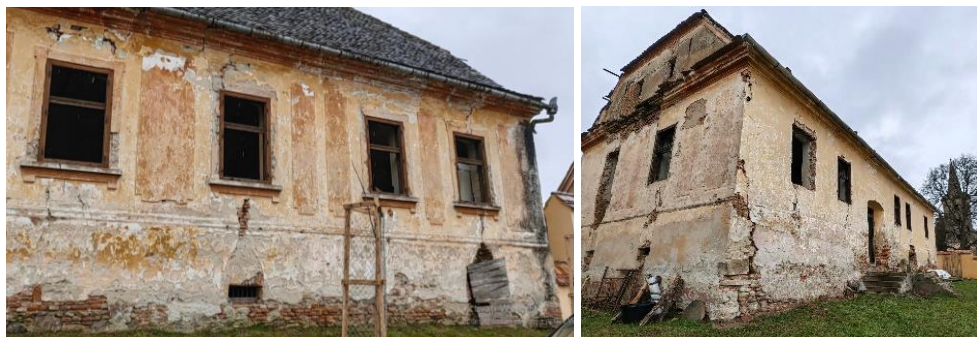
Fig. 10. Rainwater infiltration that led to the differential settlement of the foundations.

1. Lack of gutters and downspouts caused rainwater infiltration at the foundations, which reduced the bearing capacity of the foundation soil and caused differential settlement of the foundations (Fig. 10). This subsidence also caused damage to the brick basement arches and vaults (Fig. 11).

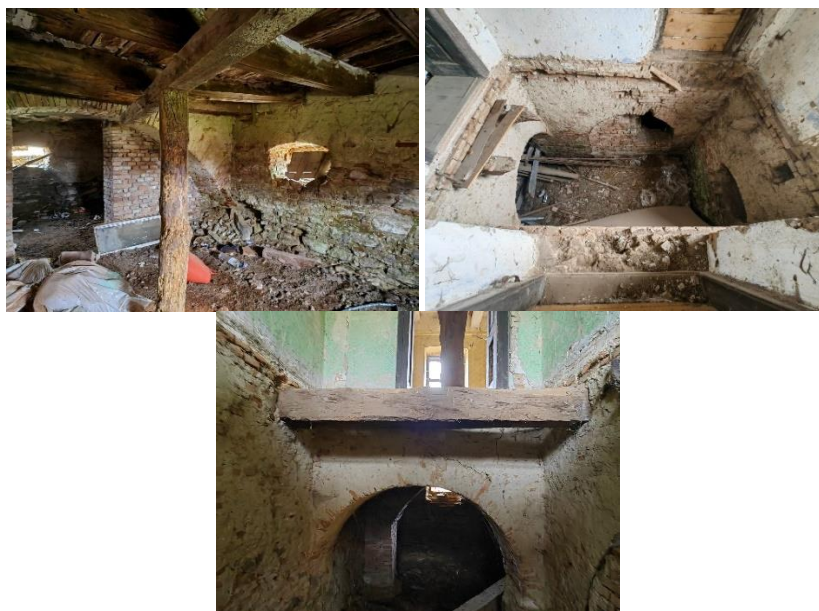
Fig. 11. Damage to the basement masonry arches and vaults.

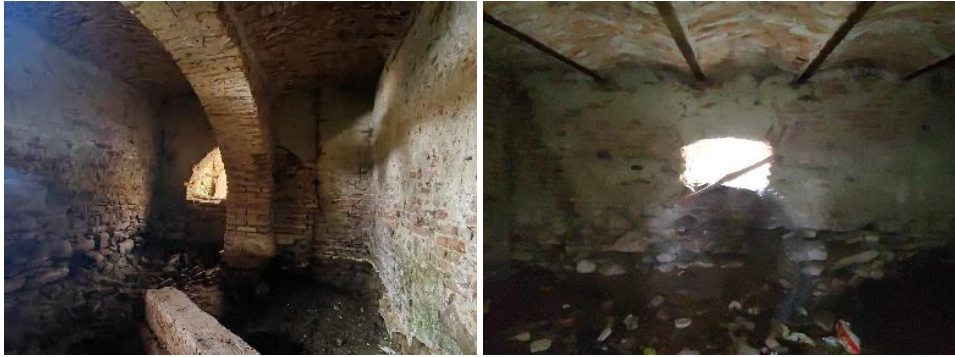
Fig. 12. Excavation of the earth from the basement.

2. Unauthorized non-compliant interventions on the foundations. Over time, attempts were made to excavate the earth from the basement to increase the height of the basement in the area of the brick arches and vaults. Because the intervention technology was wrong, damage and subsidence occurred in the foundations, arches and vaults (Fig. 12).

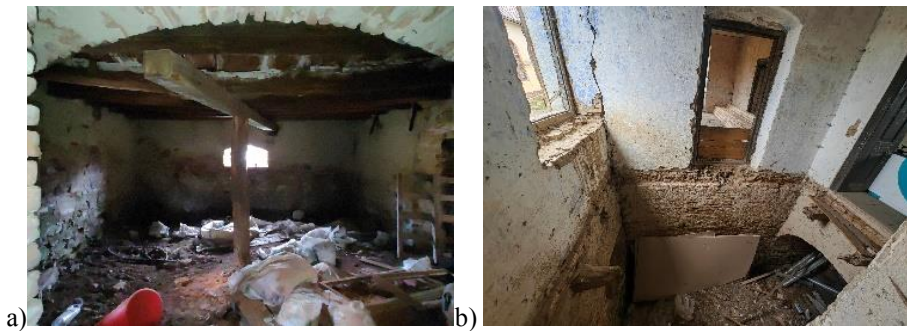
Fig. 13. Damage to the wooden elements: a) basement wooden beams; b) broken beam at the wooden floor.

3. The destruction of the tile of the roof allowed the infiltration of precipitation water, which caused physical degradation of the wood in the roof framework and wooden floor slabs. Due to the humidity, the wood rotted, reduced its cross-section, which resulted in the reduction of the load-bearing capacity of the

- beams, the reduction of stiffness and the destruction of the joints. In Fig. 13a there can be seen the deformed wooden beams of the floor over the basement and in Fig. 13b the cracked wooden beams.
4. Moisture in the walls has caused rotting of the wooden beam ends in the walls and in the rafters.
 5. Unauthorised break-ins and vandalism have increased the structural damage to the load-bearing masonry walls.
 6. Due to differential settlement of the foundations, cracks have appeared in the joints between the walls, in the lintels and in the windows parapets.
