The coating as a strategy of economic reactivation: The case of the historic center of Cuenca

Paola Alejandra Villavicencio Vicuña^{1*} and María del Cisne Aguirre Ullauri¹

¹Catholic University of Cuenca, Av. Américas y Humboldt, CP. 010101, Cuenca, Ecuador

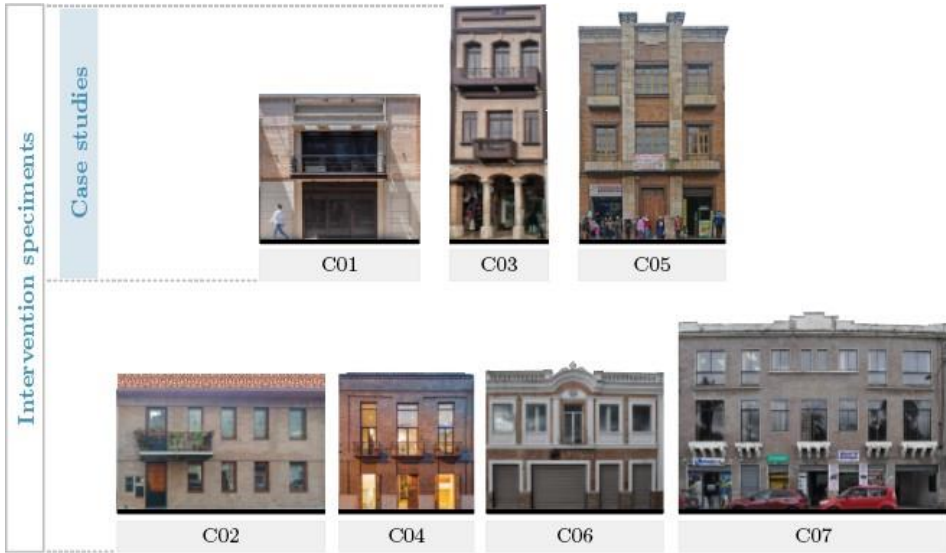
Fig. 3. CHC intervention specimens and selected case studies.

A register of buildings was generated (Fig. 3), which were assigned a name and coding (C01, C02, C03, C04, C05, C06, C07, according to the application of observation sheets characterizes the buildings considering their current state, physical appearance and intervention; the information collected was used to select three case studies (C01, C03 and C05) that, due to the intervention carried out and accessibility, are potential architectural elements that can be analyzed in detail.

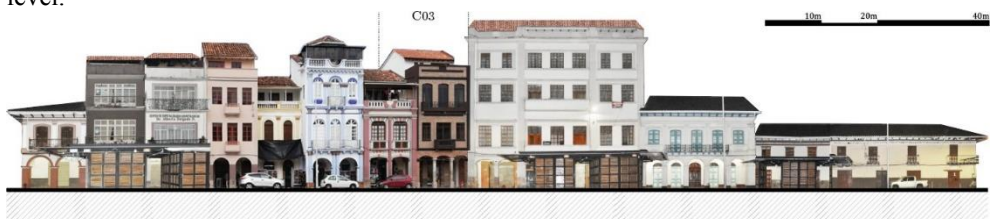
Fig. 7. Case study section C03.

Considering the section to which C03 belongs (Fig. 7), on San Francisco Street, between General Torres and Padre Aguirre in front of San Francisco square, the building is included among 12 other buildings between 2 levels and 5 continuously implanted with a portal. The existing complementary elements are public lighting, a pedestrian access road and no vegetation. The dominant use is commerce and housing; the buildings are private and have a 90% occupancy rate. In terms of the physical aspect, the sod is in good condition, and the materials used are cement, stone, travertine, brick, wood, metal, and porcelain tile. The architectural styles found in the section are colonial, neoclassical, vernacular and traditional, with colours in shades of brown, grey, blue, beige, neutral and orange. Likewise, the morphology of the buildings is of mixed character (linear and organic) with a high ornamental level.
