Investigating the role of geo-fluvial parameters on model river banks: a flume study

Abstract: This experimental investigation aimed to analyze the failure profile of a model river bank composed of sand and silty clay. A model river bank with a length of 446 cm, a depth of 32 cm, and a slope of 1V:1.5H was prepared in a flume that was 550 cm long, 150 cm wide, and 60cm deep. Froude-number-based reduced-scale distorted river modeling was considered in this study. For modeling different parameters of flume, the linear scale 1:250 and depth scale 1:20 have been taken. The study was divided into two distinct series: Series-A and Series-B, each designed to explore specific soil types and moisture content variations. In Series-A, physical model tests were conducted using cohesionless soil (sand) with an initial moisture content set at 6% and 13%. Conversely, Series-B involved model banks constructed with silty clay soil, with initial moisture contents of 10% and 15%. Both series utilized a consistent model bank slope of 1V:1.5H. The drawdown conditions, set at 50% and 80% of the model riverbank's height, were integral to the experiments in both Series-A and Series-B. The impact of moist

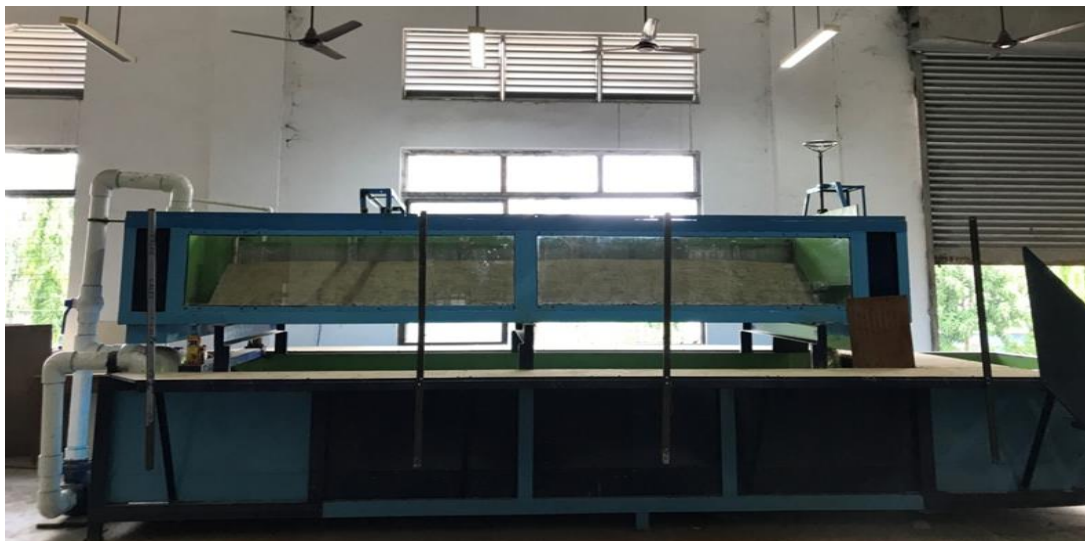
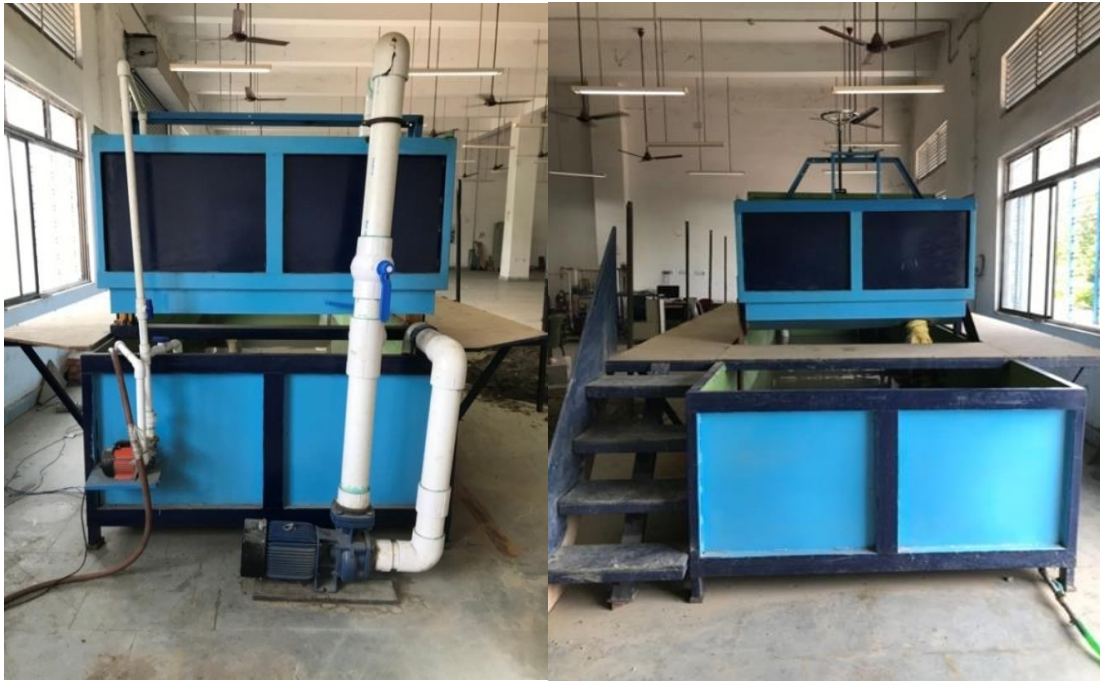
Fig.1 Photographic view of experimental flume (a) front view (b) side view

The flume dimensions measure approximately 550 cm in length, 150 cm in width, and 60 cm in depth. This experimental flume incorporates an adjoining seepage area along the sides of the bank in the longitudinal direction. Within the setup, two sets of pumps have been installed to facilitate the experimentation process. A 5L/s capacity pump is dedicated to maintaining the water level in the seepage tank, simulating the water table inside the bank. Simultaneously, a 32L/s capacity pump is employed to generate channel flow. The pump capacities were meticulously determined through trial tests, ensuring the achievement of drawdown ratios from the high flood level, essential for observing failure conditions. Notably, the configuration of the setup is designed to mimic real-world scenarios closely. A visual representation of the experimental setup is provided in the accompanying figure 1.

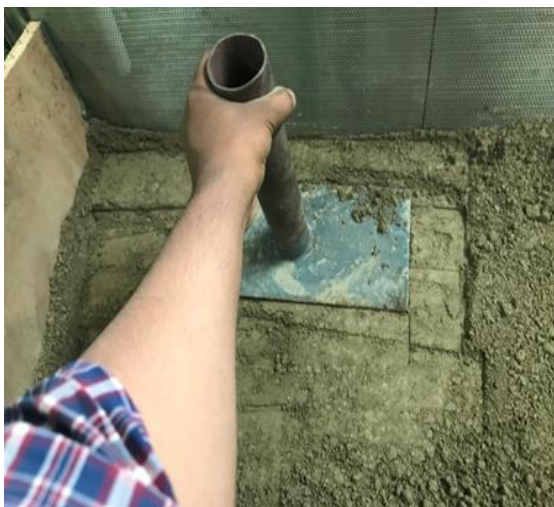
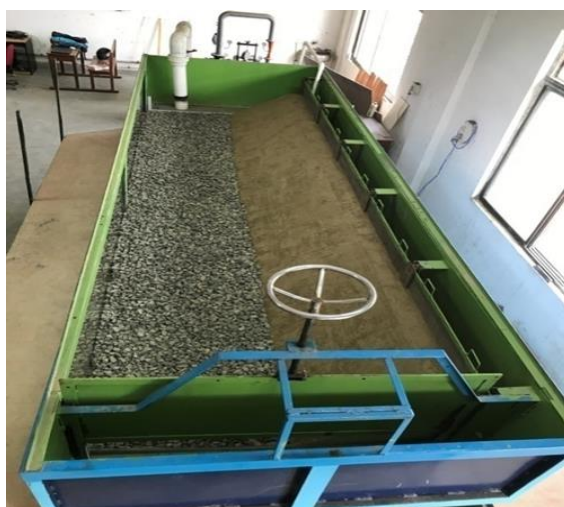
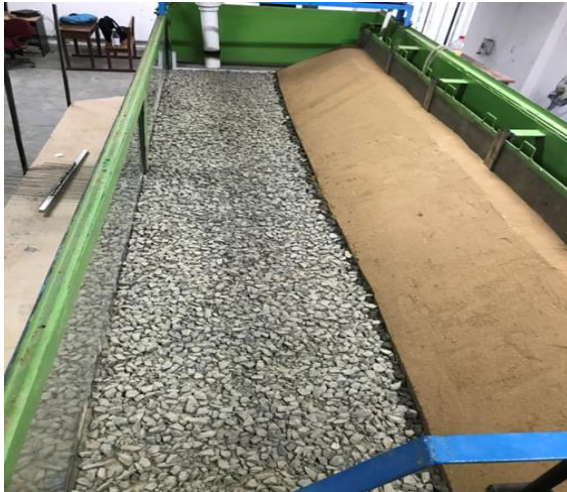
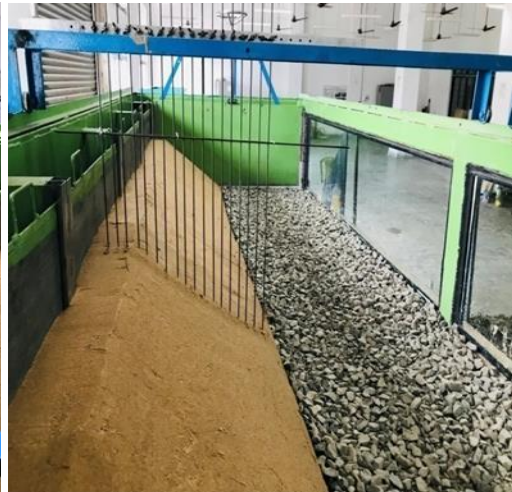
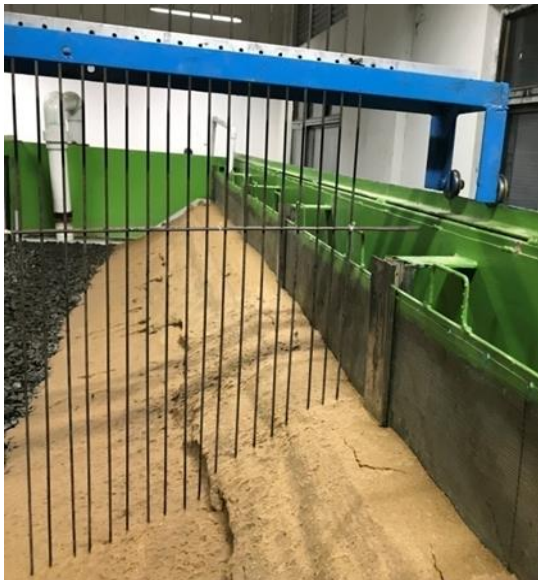
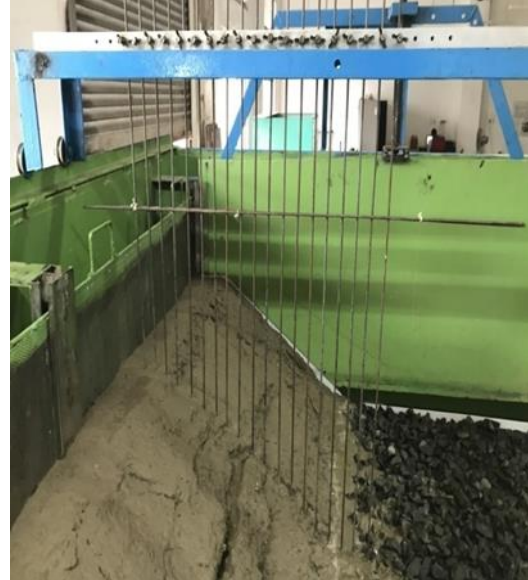
Fig. 3 model river bank (a) preparation of model bank (b) model bank prepared with silty clay (c) model bank prepared with sand (d) Initial profile of bank (e) Profile of bank after test(sand) (f) Profile of bank after test (Silty clay)

For both series-A and series-B, a meticulous approach was adopted to ensure the desired characteristics of the model banks. In series-A, cohesionless model banks were meticulously prepared with a uniform compaction energy of 0.209 kg/cm^2 . This process resulted in specific initial bulk densities tailored to moisture content (MC) levels of 13% and 6%. The banks were systematically constructed in three layers, with each layer subjected to 25 blows to achieve the targeted density. In series-B, the focus shifted to silty clay soil for the model banks. To attain the desired characteristics, an average density of 17.1 kN/m^3 and 18.3 kN/m^3 was meticulously achieved for moisture contents of 10% and 15%, respectively. The compaction energy of 0.209 kg/cm^2 was applied to each layer during the preparation process, ensuring consistency and precision in the model's construction (Fig 3). These detailed preparation methods in both series aimed to create accurate representations of riverbanks, allowing for a comprehensive exploration of the influence of various factors on the failure mechanisms and profiles in the subsequent experimental investigations.

After the preparation of the model riverbank, an initial profile reading was taken by lowering the measuring gauge onto the surface of the model bank. These measuring gauges indicate the initial readings, which have been recorded. The pump started to fill the flume with water up to 50% and 80% of the model bank's height. To maintain the water at a specific height, the outer valve was opened. The surface velocity of the flowing water was measured using the floating method, registering a velocity of 6 cm/s inside the flume. After a 30-minute run of the flume, the pump was turned off, and drawdown occurred at a rate of 1 cm/s. Two flood heights (50% H & 80% H) were selected for drawdown in this study. The detailed experimental program has been tabulated below. (Table 5, Table 6)

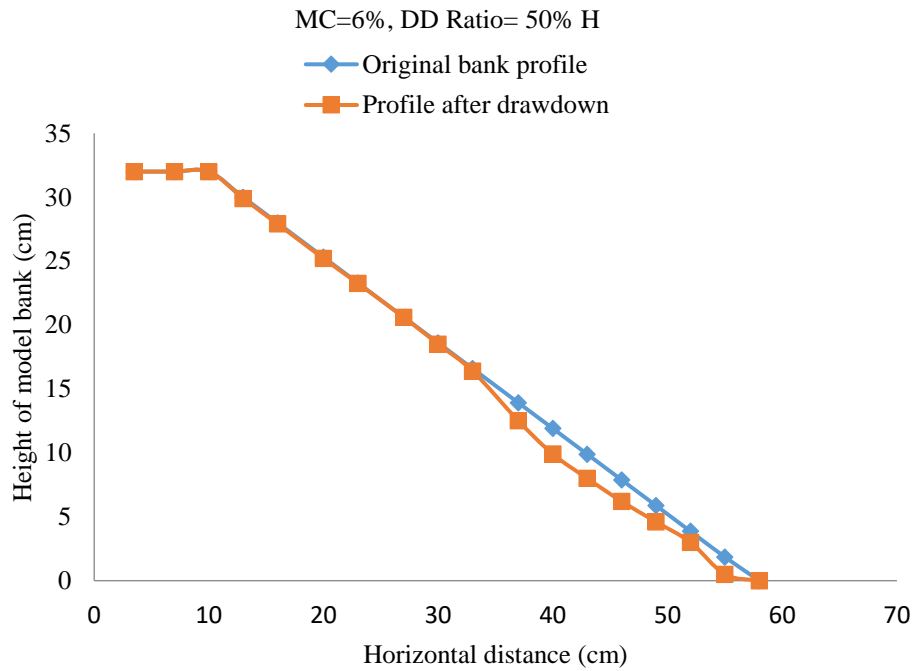
Fig. 4 Change of model riverbank profile after drawdown for 1V:1.5H slope, moisture content 6% and drawdown ratio 50% H.

Specifically, under a 50% H drawdown, failure locations were identified at distances of 21.57 cm and 10.74 cm from the bottom. The onset of failures occurred 25 seconds and 30 seconds after drawdown commencement for moisture contents of 6% and 13%, respectively. These findings challenge conventional expectations, suggesting that the immediate aftermath of drawdown does not precisely dictate the initiation of bank failure. The expulsion of pore water emerges as a pivotal factor influencing the temporal dynamics of bank stability. Expanding our scrutiny to an 80% H drawdown, failures manifested at locations 29.90 cm and 22.00 cm from the bottom. The initiation times were 25 seconds and 35 seconds after drawdown initiation for moisture contents of 6% and 13%, respectively. Remarkably, these results underscore that the 80% H drawdown, particularly with a 6% moisture content, represented the scenario with the most extensive failure pattern. This highlights the intricate interplay between drawdown levels, moisture content, and the subsequent stability of the modeled riverbank.

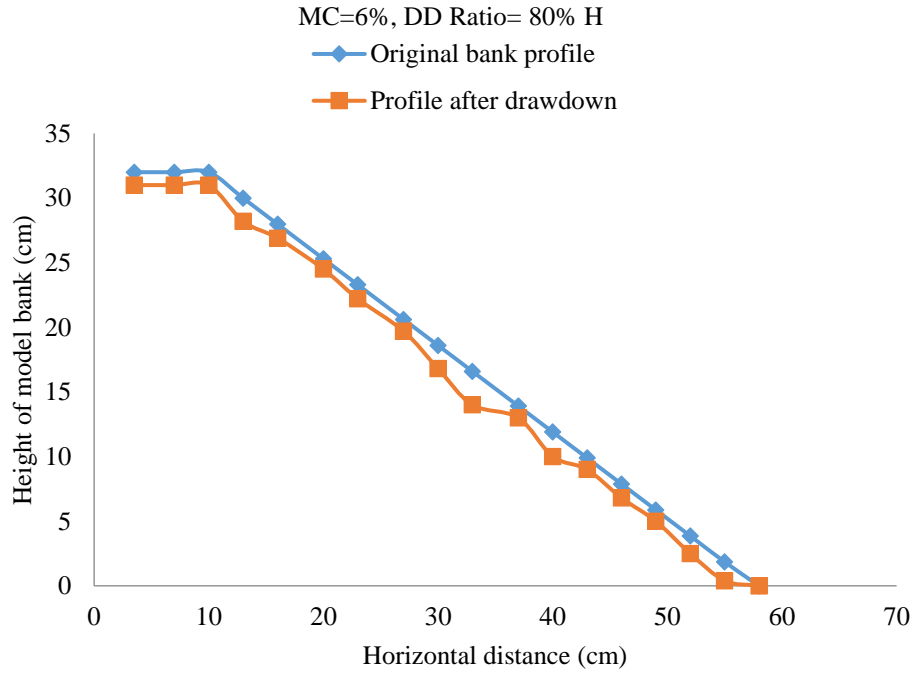
Fig.5 Change of model riverbank profile after drawdown for 1V:1.5H slope, moisture content 6% and drawdown ratio 80% H.

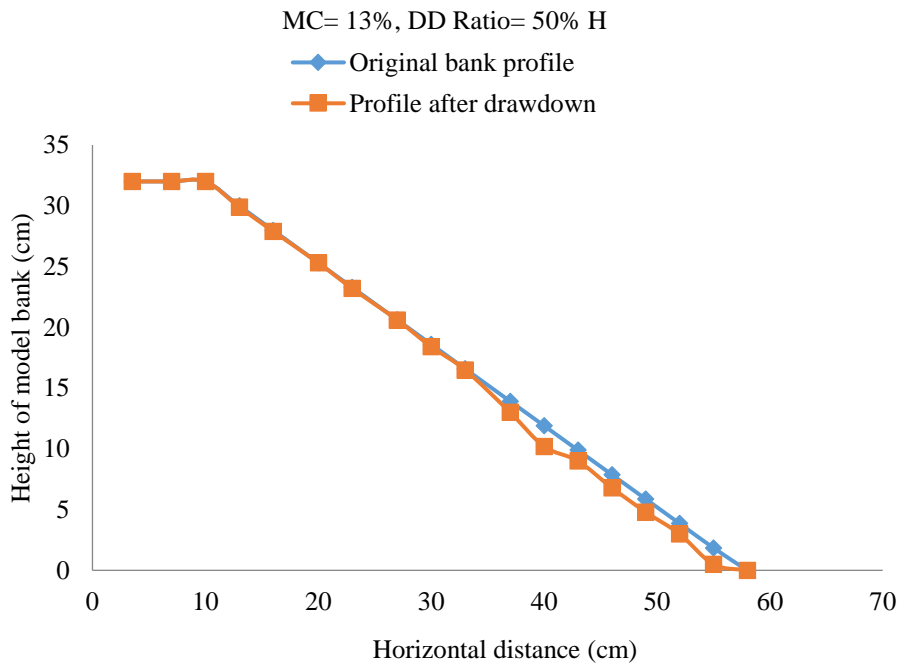
Fig. 6 Change of model riverbank profile after drawdown for 1V:1.5H slope, moisture content 13% and drawdown ratio 50% H.

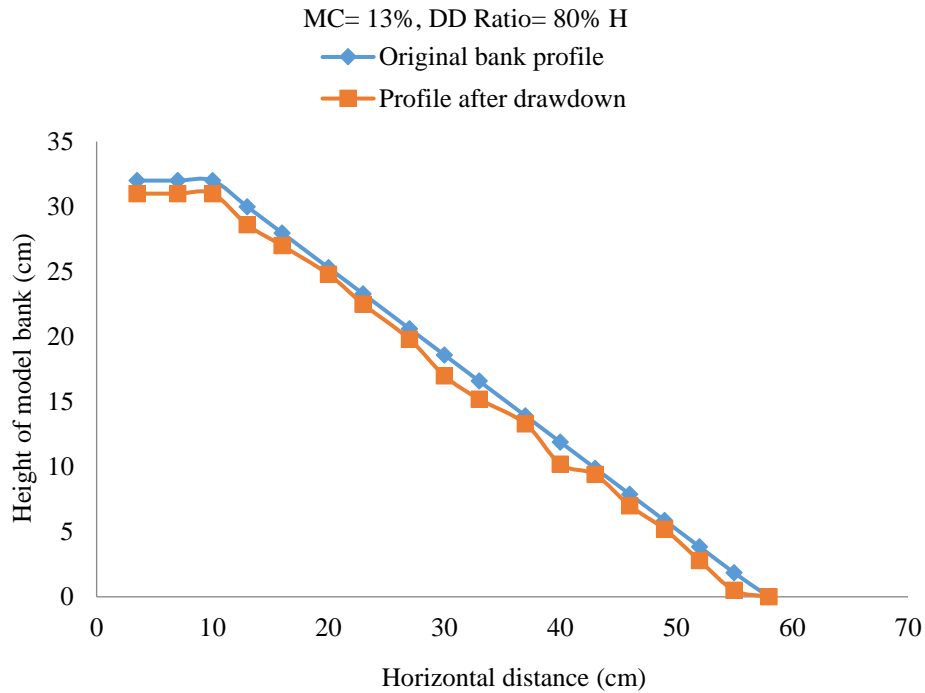
Fig. 7 Change of model riverbank profile after drawdown for 1V:1.5H slope, moisture content 13% and drawdown ratio 80% H.

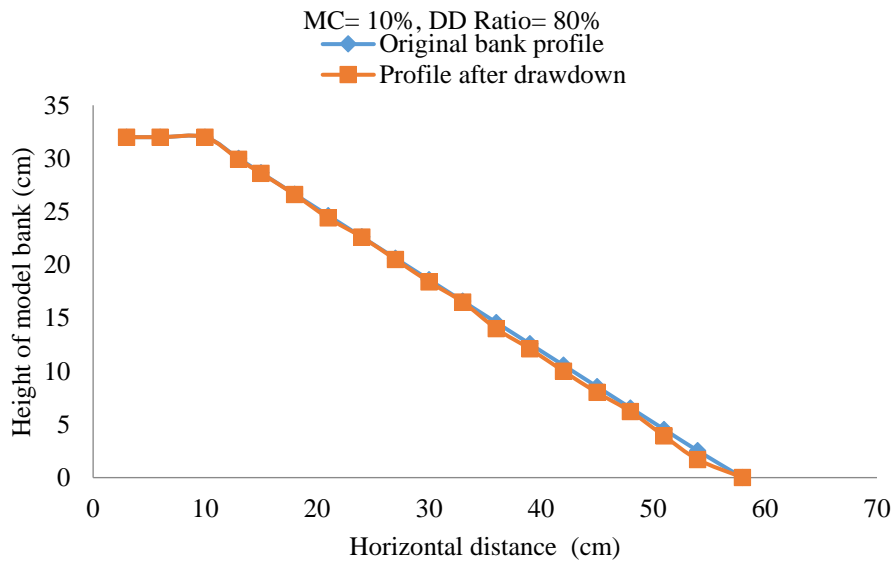
Fig. 8 Change of model riverbank profile after drawdown for 1V:1.5H slope, moisture content 10% and drawdown ratio 80% H.

At 80% flow height, there was partial erosion, and a longitudinal crack formed, as depicted in the figure 9,10. Additionally, it was observed that the failure location for an 80% drawdown initiated 15 cm and 20 cm from the bottom at times of 45 seconds and 60 seconds, respectively, as detailed in the table 8. The nature of silty clay soil is instrumental in shaping these observations. The forces propelling bank failure exhibit a diminished impact on erosion and failure in silty clay due to the internal cohesive action of the bank material effectively withstanding the seepage forces acting on the bank during water outflow after drawdown. Results shows that model bank made up of the sand shows the some what similar failure observed on the filed.

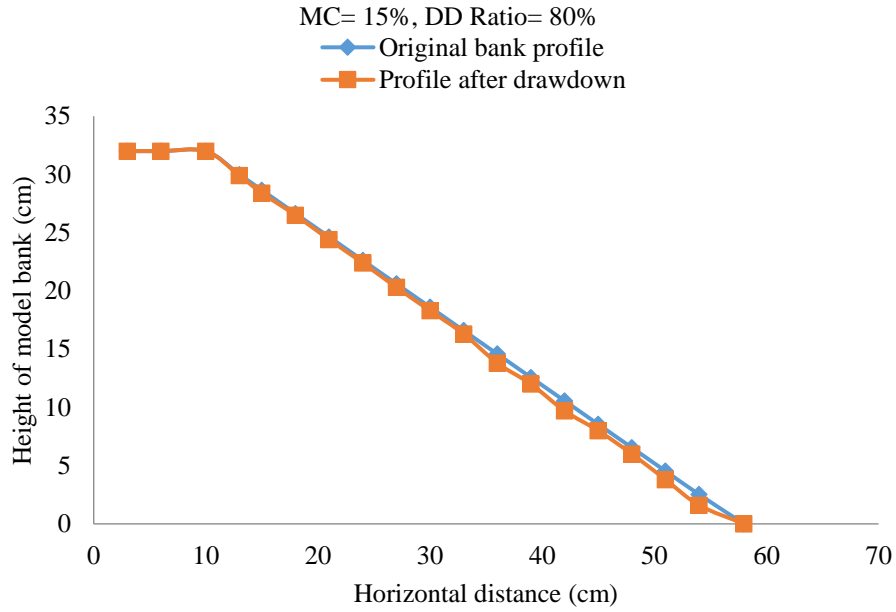
Fig.9 Change of model riverbank profile after drawdown for 1V:1.5H slope, moisture content 15% and drawdown ratio 80% H.

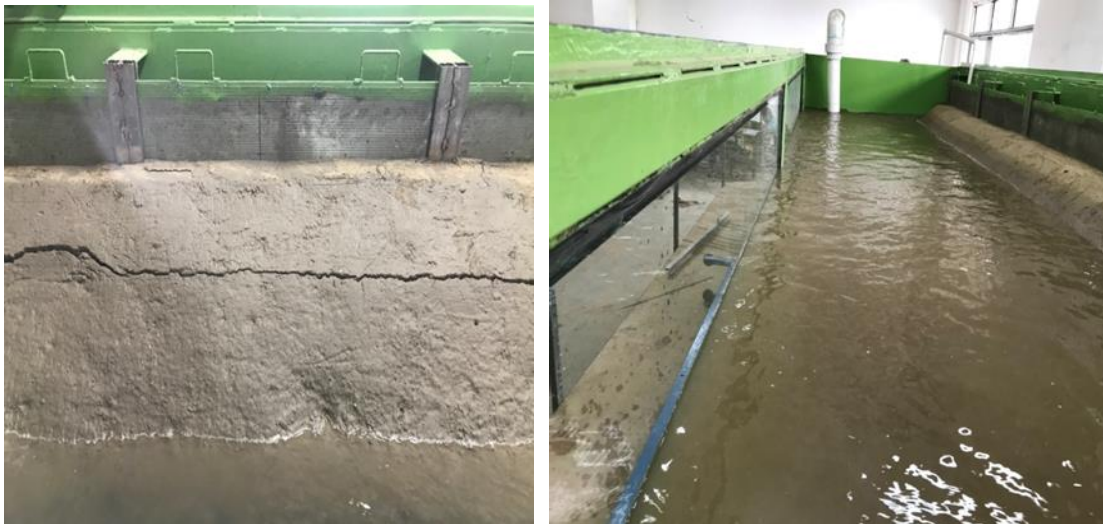
Fig.10 (a) Failure crack (b) photo during the test.
