Durable and sustainable service life extension of existing concrete structures: a holistic approach within a life cycle perspective

Abstract. Concrete structures are facing increasing aging, leading to a rising demand for maintenance, repair, strengthening and/or replacement. More than 70% of the damage to reinforced concrete structures is linked to reinforcement corrosion, which can affect the durability of the structure and the residual load-carrying capacity. Actions are required which consist of an adequate diagnosis, including the identification of damage mechanisms and causes, severity and the extent of defects, showing the cause and extent of the damage, (i) to determine the actual bearing capacity, (ii) to make an estimation of the technical durability and the residual service life and (iii) to select a durable repair technique and/or maintenance strategy (proactive vs. re-active). Furthermore, in selecting a rehabilitation strategy for preventive maintenance and curative repair, it is important to not only focus on technical requirements and initial cost, but to consider the environmental impact and financial costs over the entire life cycle and the intended service life

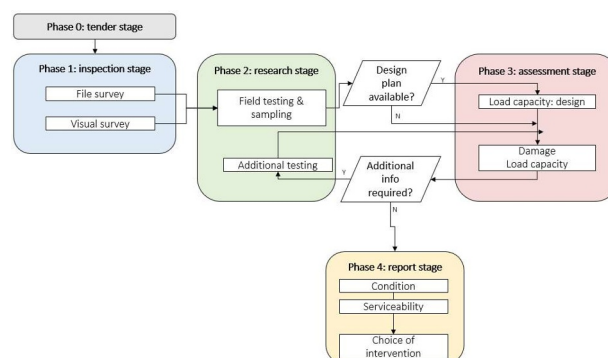
Fig. 2. Stepwise protocol for assessment of RC structures.

The need for an evaluation and assessment of the existing structure prior to repair is crucial and therefore a clear and objective method for obtaining a diagnosis is necessary. Numerous guidelines for condition assessment and evaluation of existing (concrete) structures are available in the literature but are mainly a summary of general descriptions and lack objective and/or straightforward action plans. Based on a critical review of existing standards and guidelines, integrating existing knowledge and on-site experience, a stepwise protocol to evaluate the condition and actual bearing capacity is developed (Figure 2). This protocol, which can be seen as a sum of best practices, is particularly applicable on cantilevered reinforced concrete (RC) balconies, but the framework can be generalized for all RC structures. The evaluation of (i) the actual bearing capacity and (ii) the durability (with focus on corrosion damage) are included. The protocol consists of five consecutive phases: 0) tender stage, 1) inspection stage, 2) research stage, 3) assessment stage and 4) report stage.

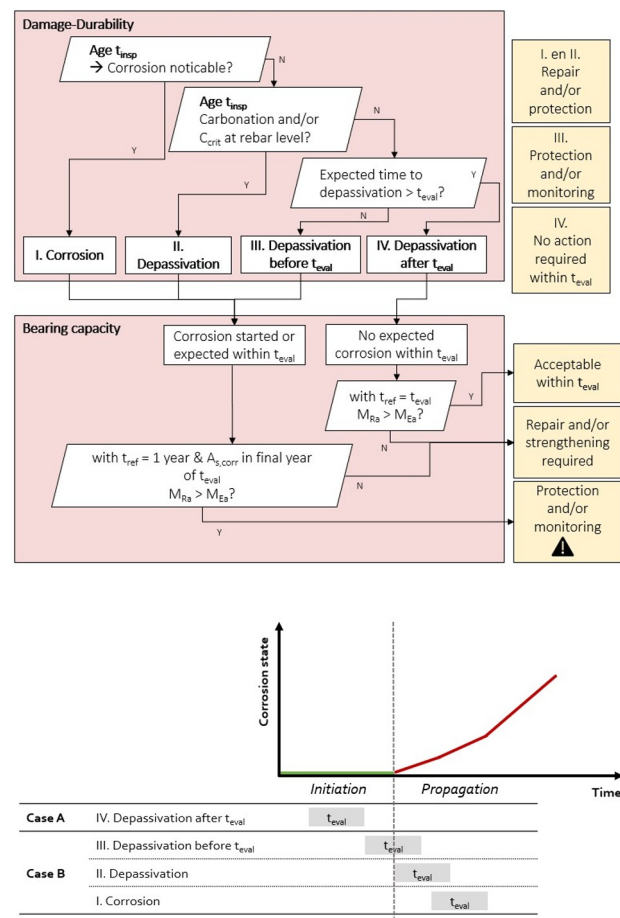
Fig. 7. Assessment protocol for damage/durability and bearing capacity of RC balconies, focus on corrosion.

Once the tender, inspection and research stage are performed and the condition score is determined, the acquired information can be used in order to come to a funded assessment of the damage (with regards to the durability of the structure) and the actual bearing capacity of the RC structure. This approach is visualized in Figure 7. Note that the protocol mainly focusses on corrosion damaged RC elements.

Preventive life-extending and curative repair techniques are directly linked to the durability related condition of the element:

- If corrosion is clearly noticeable (I) proper and durable maintenance and repair actions are required. The same actions (II) are needed in case corrosion is not yet noticeable but initiation of depassivation already occurred (carbonation at the level of the rebar or a critical chloride content C_{crit} is reached).
- If initiation of depassivation is not yet reached but is expected within t_{eval} preventive actions and/or monitoring (III) of the structure is strongly advised.
- No actions (IV) are required if initiation of depassivation is not yet reached and not expected within t_{eval} .

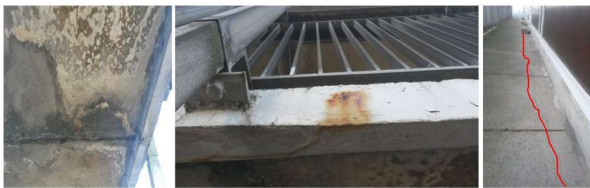
Fig. 10. Failing coating and joint + local rust stains + crack parallel to building (floor F16).

An in-depth field survey and investigation was performed on 9/17 floors of which F1, F8 and F16 are selected for the assessment demonstration of this paper. First of all, high chloride contents (exceeding the critical chloride content) were found at the level of the rebars for floors F8 and F16, most likely caused by the use of CaCl₂ as a binding accelerator (evidenced by a lack of concentration gradient). According to the protocol, it therefore can be assumed that depassivation and corrosion is most likely to be present in t_{eval}: also corrosion damage visuals are clearly noticeable. Assessment with regard to durability-related damage leads to the conclusion that repair and protection will be needed (action I and II). As

corrosion is initiated by mixed-in chlorides all floors are ranked with condition score 5, as corrosion damage has a critical severity, the process is believed to occur generally (>70%) due to the presence of mixed-in chlorides and the corrosion process is already in an advanced stage.

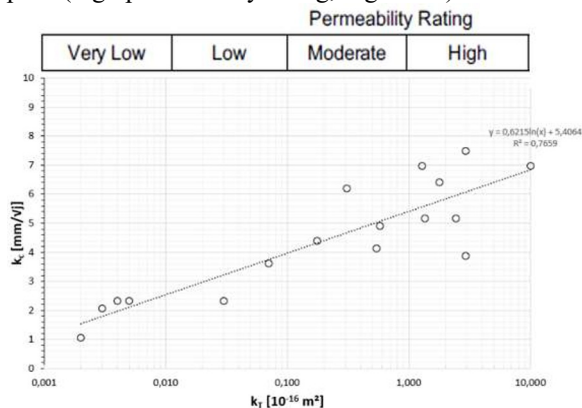
Fig. 13. Correlation between carbonation coefficient and air permeability.

However, the parts of the outer wall elements experience severe carbonation, with carbonation rates up to $5-7 \text{ mm/y}^{0.5}$ (carbonation depth of 20-28 mm), which is very high even for blast furnace slag cement based concrete. It was found that the execution of the elements in wintertime (snow, temperatures below 5°C) was performed without the application of proper insulation and heating. Poor workmanship after demoulding, with no proper curing actions, led to an inferior quality of the skincrete. According to EN 13670 a curing period of at least 7 days should have been applied. Additional testing by means of a portable air permeability tester revealed that the quality of the concrete in the outer layers was rather poor (high permeability rating, Figure 13).

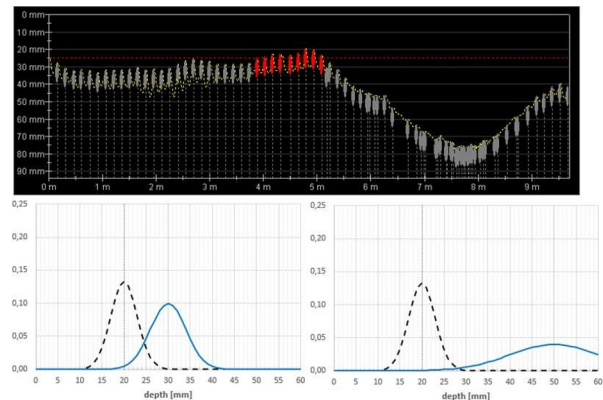
Fig. 14. High variation in concrete cover and full probabilistic Monte Carlo simulation results (dotted line: depth of carbonation front, full blue line: concrete cover).

Rebar scanning revealed high variations in concrete cover (Figure 14). According to the protocol, it can be assumed that depassivation and corrosion is most likely to occur in t_{eval} in certain areas with insufficient cover, as full probabilistic Monte Carlo simulation revealed that carbonation induced corrosion can occur within 15 years (totalling a service life lower than 30 years!) if no protection is applied. Also, it was advised to further monitor the evolution of the condition of the RC wall elements (action III).

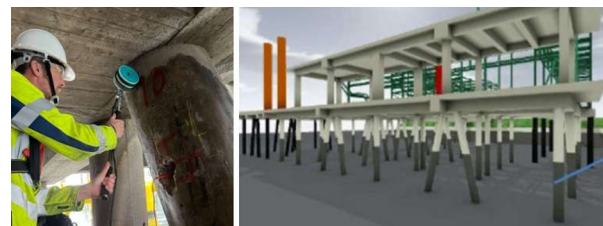
Fig. 15. Execution of potential mapping via one-wheel-electrode ($CuCuSO_4$) + schematic overview of the jetty.

A jetty in Port of Antwerp, constructed in 1970, consists of 40 hollow prefabricated cylindrical RC pillars (outer diameter 60 cm, thickness 12 cm). The distance between the water line and the top of the pillar is approximately 1.80 m. A condition assessment of the pillars was performed by means of an extensive testing program: concrete cover rebar scanning, chloride profiling on three different levels (-1.0 m below water, +0.40 m and +1.0 m above water), potential mapping and concrete resistivity testing via Wenner probe.
