# Corrosion prevention of steel frames on an iconic villa by zinc galvanic anode

**Abstract.** The renovation of a French building classified as an historic monument must meet specific requirements, in particular very precise rules within the framework of the scientific and technical control. The Villa Ephrussi de Rothschild, one of the most beautiful Renaissance-style palaces on the Côte d'Azur, was built on a summit of the St Jean Cap Ferrat peninsula between 1905 and 1912. During the restoration of the east and north facades, it was discovered that the corners of the monumental staircase were covered with an I-shaped metal frame made up of riveted angles and plates. Its advanced state of deterioration made it necessary to reconsider the initial maintenance strategy. In this context, this article discusses the results of its implementation through the partial application of an epoxy coating on the steel frame structure and to the installation of long zinc sacrificial anodes for cathodic protection.

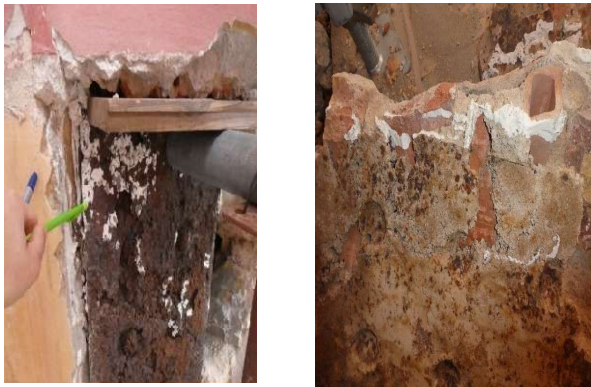
**Fig. 2.** a) Highly corroded surface, b) Materials, cement mortar and bricks with oxides

These claddings are currently coated with pink paint, while the decorations are coated with white paint. The moulded and armored decors have numerous cracks and are scattered on all facades of the building. The reinforcement is apparent, and the loss of plaster mortar can be significant.

Chloride levels are also highly variable in different areas. High levels of total chlorides were found on the south facade (0.87% mortar mass on the 15-25 mm fringe), on the east facade only in the gray support mortar (0.31% mortar mass on the 10-20 mm fringe), and on the north facade (0.08 to 0.12% mortar mass on the 0-20 mm fringe). The values are higher than the threshold of 0.06% by mass of mortar, threshold usually retained in the case of reinforced concrete. Corrosion diagnosis observations are shown below in Figures 2 to

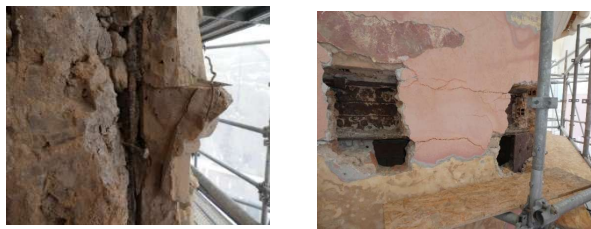
**Fig. 3.** a) Highly corroded surface of the steel column east side of the staircase, middle area, b) Corroded surface of the metal girder, near the roof east side

Following the progress of the work on the east facade and the north return of the Ephrussi de Rothschild villa, new problems have arisen. Indeed, the openings made in the metal framework of the staircase showed a significant corrosion of the posts, leading to a structural insufficiency, highlighted by a structural engineering office. In addition, water infiltrations in the roof and the terrace, which should have been stopped with the works undertaken in recent years, were still present.

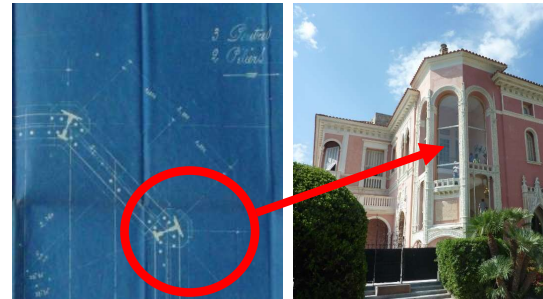
**Fig. 4.** a) Initial drawing of the Staircase, b) east and north façade of the villa

The structural reinforcement proposed by the design office for the staircase, Figure 4, consists of bracing the two pillars with a fiber-reinforced concrete "sock", after stripping and anti-corrosion treatment of the various parts making up the metal posts. The lintels are treated in the same way and covered with new materials based on hydraulic binder.

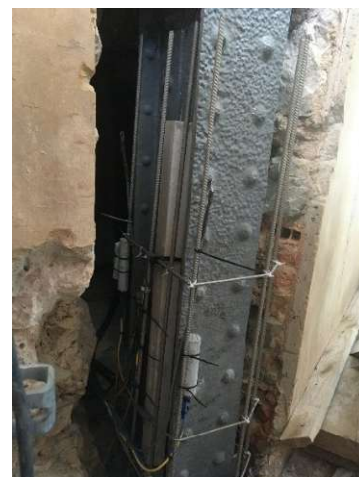
**Fig. 5.** Anode and RE placed along the steel column

The measurement points consist of a reference electrode and an activated Titanium/MMO depolarisation probe, which makes the system more robust over time and minimises long-term maintenance work by avoiding the replacement of reference electrodes when they have become polarised, as shown in Figures 5 and 6.
