Rehabilitation of a Vehicle Impact Damaged Concrete Bridge Girder with GFRP Rebars

Nur Yazdani[1*], *Maria* Montero[2]

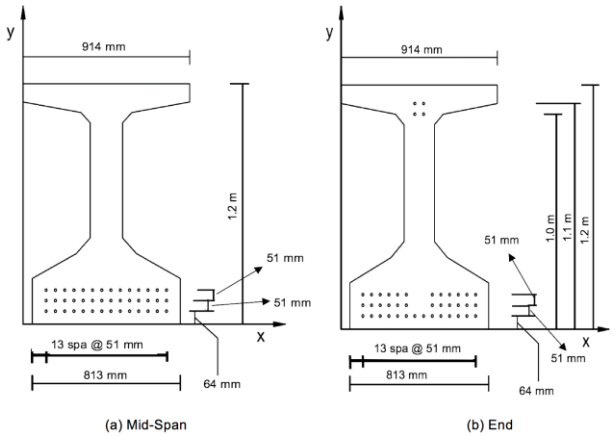
Fig. 2 Pre-stressing Strand Patterns

The damaged girder had 42 low-lax prestressing strands (with 12.7 mm diameter each and 1861 MPa ultimate strength) placed according to the patterns shown in Fig. 2, with no debonding and four harped strands.

The corresponding eccentricities were 396 mm at mid span and 309 mm at the end. The girder concrete compressive strength in service was 58.6 MPa. The non-prestressed mild steel had a yield strength of 414 MPa.

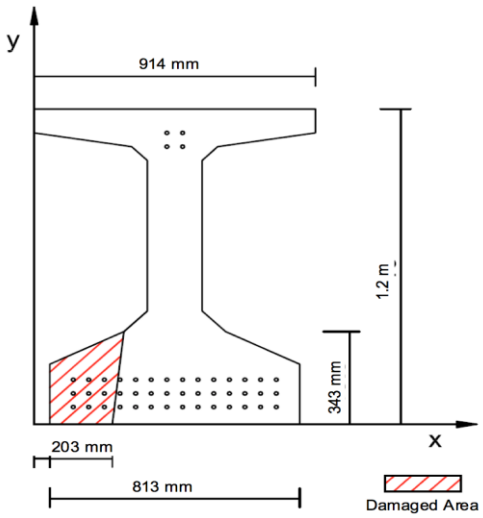
Fig. 4 Schematic of Damaged Section

It caused a 4.3 m long damage along the bottom flange with spalled concrete and three rows of exposed but undamaged strands (total of nine strands exposed). The center of the damaged area was at 6.7 m from the left support. A sketch of the damaged section is presented in Fig. 4.

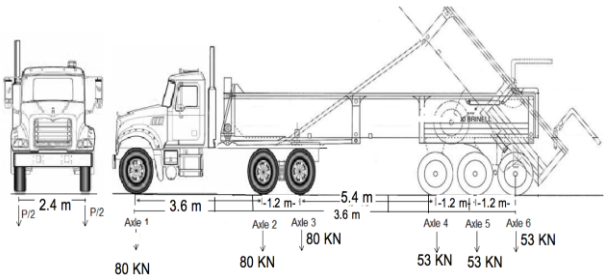
Fig. 6 Test Truck Characteristics

The load testing consisted of placing a loaded truck on the damaged span before and after the repair and monitoring the corresponding strains. The test protocol followed the AASHTO guidelines (AASHTO 2011). The test truck weighed 400 kN over six axles, as compared to the AASHTO HL-93 truck weight of 320 kN (Fig. 6).

The truck length and width were 12.8 m and 2.4 m, respectively. It was placed at two different positions on the span. Phases 1 and 2 corresponded to load testing on the damaged and the repaired bridge, respectively. For Phase 1, as shown in Fig. 7, in truck position 1.

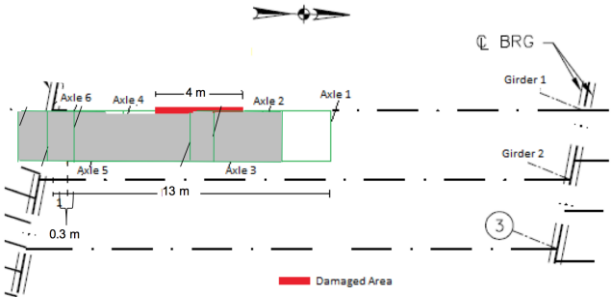
Fig. 7 Truck Position 1, Phase 1

The truck was centered on the damage (1.1 m from the barrier) for 650 sec. Thereafter, in position 2, the truck was moved to the adjacent undamaged girder for 200 sec, 3.34 m from the barrier (Fig. 8).

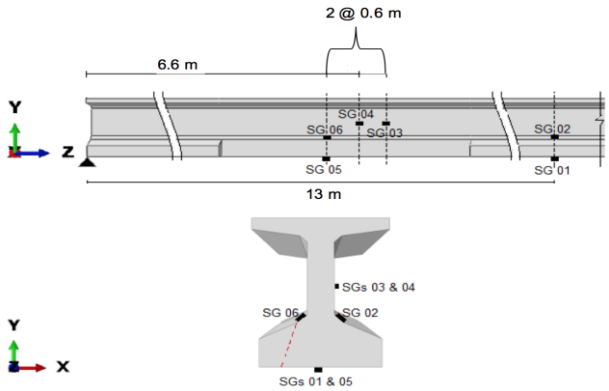
Fig. 9 Strain Gage Locations, Phase 1 Damaged Girder

The same truck locations were used in Phase 2, creating truck positions 3 and 4 for the repaired girder. Six strain gages were utilized in Phase 1, while a seventh gage was added at the bottom of the repaired girder for Phase 2 (Figs. 9 and 10).

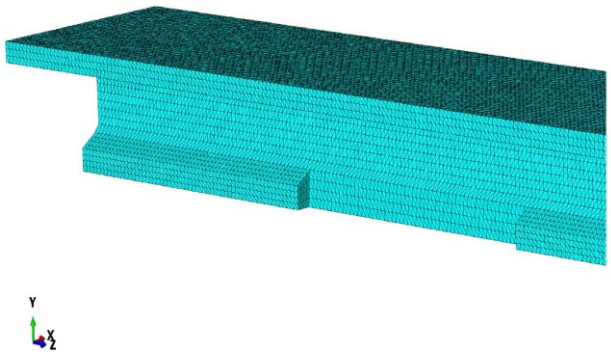
Fig. 14 Damaged Girder FEM with 76 mm Mesh Size

The computation was performed first using 381 mm mesh size and then gradually reduced to 76 mm. Mesh sizes smaller than 76 mm resulted in very long computational times. Therefore, a 76 mm mesh size was used herein (Fig. 14).

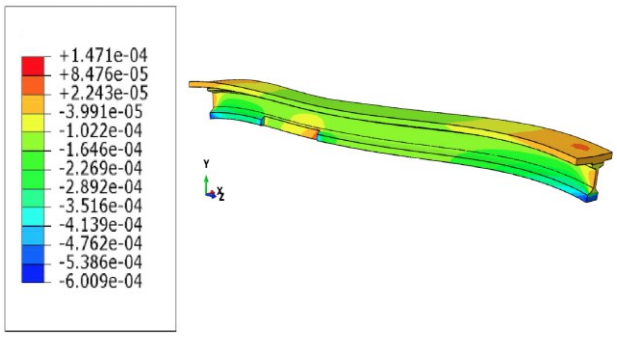
Fig. 15 FEM Model Strains, Phase 1, Truck Position 1

To compare the FEM strains to the average strains measured from load testing, the FEM strains from the closest nodes to each strain gage were used herein. Figure 15 presents the FEM strains for Phase 1 loading and truck position 1.

The deformed shape of the girder and the stress concentration around the damaged area are evident. The time variation of the measured strains for Phase 1 truck position 1 is shown in Fig. 16.

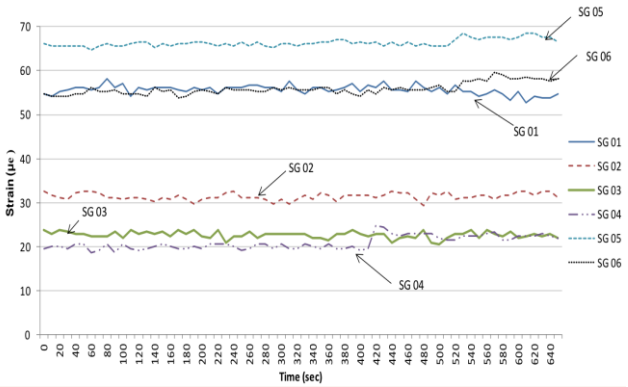
Fig. 16 Phase 1, Truck Position 1 Strain Measurements

The strains for each gage remained about constant with time with minor fluctuations. This trend was demonstrated in results from other gages and truck positions.

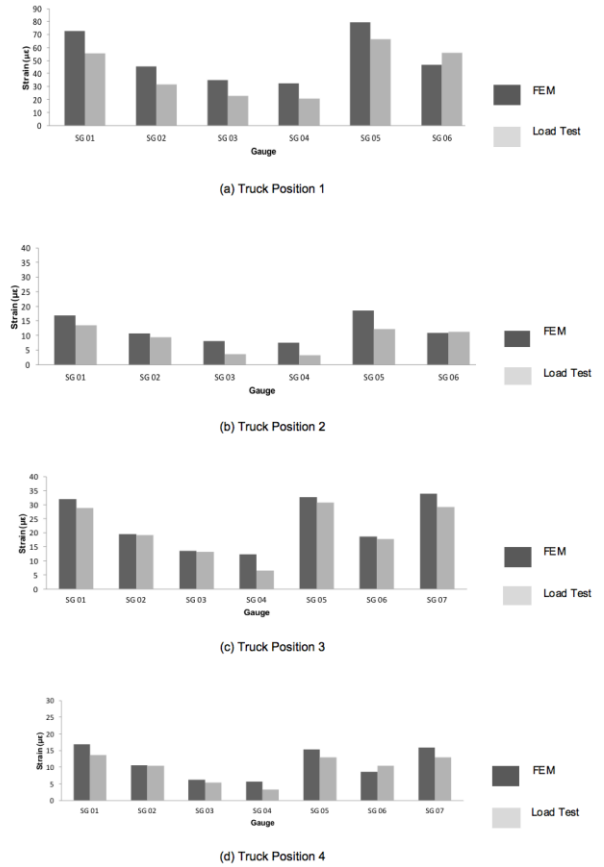
Fig. 17 Theoretical and Measured Strains

The strains from the model and the load testing are presented in Fig. 17.

Most of the FEM strains were slightly higher than those from the load testing for truck position 1. For position 2, the live loads applied on the girder were lower than those from position 1, resulting in decreased strains (Figure 17b). The model prediction was more accurate for truck position 2 than position 1. The difference between the strains from the model and the testing are small; the greatest difference was about 6.3 micron. This validates the Phase 1 FEM model. In Phase 2 repaired girder, truck position 3, the strains (Fig. 17c) decreased from those for truck position 1 by about 50%. The greatest difference between the FEM and actual strains was for gage number 4. Gages 3 and 4 were located at the same height in the girder cross section and separated 0.61 m longitudinally. Therefore, the measured

strains in the gages should have been similar. The FEM strains for these two gages were close. It may be inferred that gage 4 was not placed appropriately or did not work properly during load testing.

Because the loads applied to the girder for truck position 4 were lower than those for position 3, the strains values were relatively lower as well, with a maximum strain of about 17 micron. Figure 17d shows that the differences between the theoretical and actual strains were small. ›

5. The repair scheme drastically increased the stiffness of the damaged girder, resulting in about 50% reduction in the bottom strains, as evidenced in the theoretical and actual values.

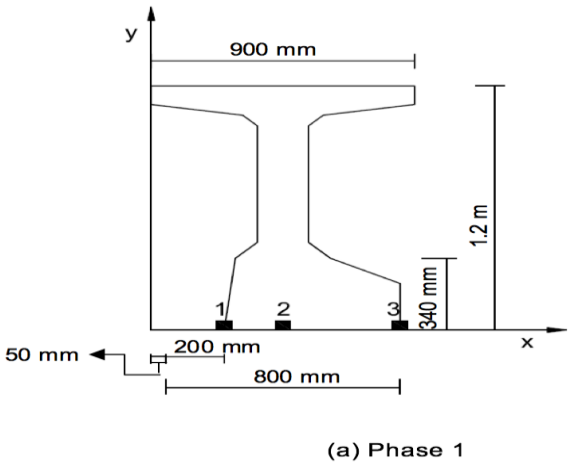
Fig. 18a. Analyzed Stress Points

The repair procedure was expected to recover the damaged section capacity by primarily increasing its moment of inertia, through which the gravity tensile stresses would be reduced. This should result in increased compressive stresses at the bottom fiber of the repaired girder. To demonstrate this, FEM stresses at the girder bottom fiber at the center of the damage (located at 6.7 m from the left support), were reviewed herein. For Phase 1, stresses from FEM nodes closest to points 1, 2 and 3, shown in Fig. 18a, were considered.

The corresponding FEM stresses are presented in Table 4. For the damaged girder, the maximum compression occurred at point 3 for both truck positions, while the minimum compression occurred at point 1 which was closest to the damage.

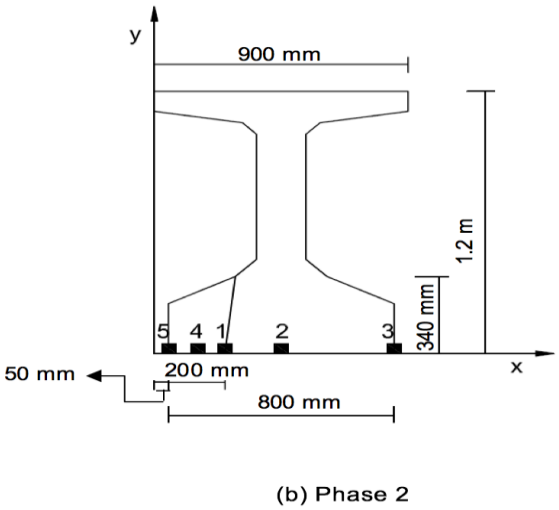
Fig. 18b. Analyzed Stress Points

For Phase 2, in addition to the three points, two additional points 4 and 5 were considered (Fig. 18b).

As expected, for the repaired girder, the compressive stress values are quite a bit greater than those obtained for the damaged girder. At point 1, the compressive stress after repair is nearly three times that from before repair. At point 2, the increase is almost 50%. The increase in the moment of inertia for the repaired girder and corresponding decrease in the tensile stresses from gravity loads are evident. For both phases, the stress values obtained indicated that the girder was under elastic behavior. The maximum compressive stress for the repaired girder concrete was 8.93 MPa, well below the assumed concrete compressive elastic limit of 29.3 MPa.
