Study of the Use of Lime Plaster on Heritage Buildings' in Malaysia: A Case Study in George Town, Penang

A.A. Mohamed Sabri¹, M.Z. Suleiman^{2,a}

^{1,2}School of Housing, Building and Planning, Universiti Sains Malaysia, 11800, Penang, Malaysia

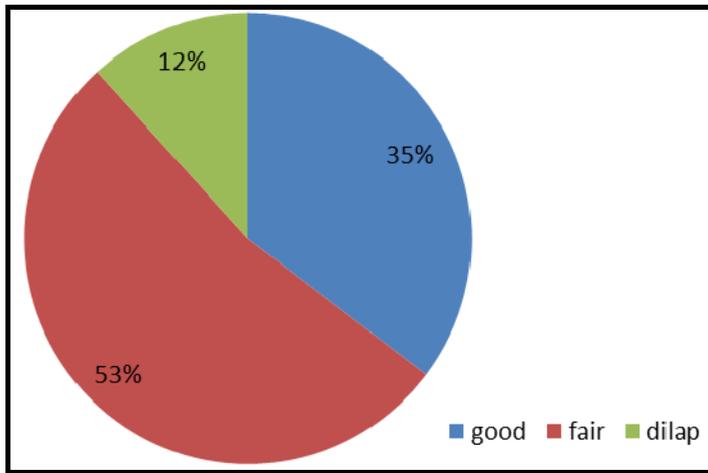
Fig 2: Historic Building Conditions in George Town, Penang.

To ensure that the objective of this study could be achieved, a pilot survey was conducted that targeted heritage buildings in George Town. The pilot survey was used to get a clear understanding of the current conditions of these historic buildings. Figure 2 presents a breakdown of building conditions in George Town, Penang based on visual observations of 85 different structures. From the

observations, it was found that 53 percent of the buildings were in fair condition, while 35 percent were in good condition and 12 percent were in a dilapidation state.

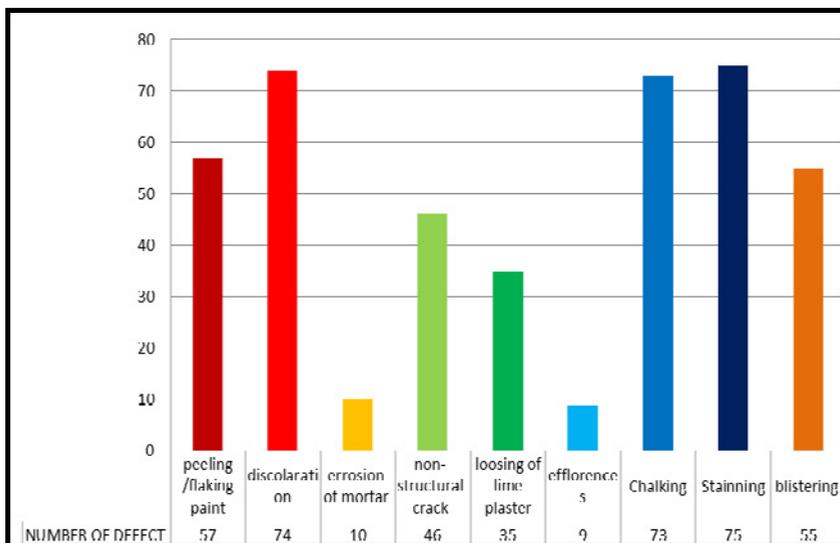
Fig 3: Number of Buildings with External Wall Defects in George Town, Penang World Heritage Site.

External walls were chosen as the focus of this evaluation because the façade of each building has an important impact on the image of such a historical district [1]. From Figure 3, nine defects on external walls were identified. Out of 85 selected historical buildings, 75 showed signs of staining, 74 buildings had discolouration, 73 buildings had chalking, 57 buildings suffered from peeling paint, 55 buildings had blistering paint, 46 suffered from non-structural cracks, 35 faced a loss of lime plaster, the mortar of 10 buildings had eroded and 9 buildings suffered from efflorescence.

Overall, it can be clearly seen from Figure 3 that the most commonly occurring building defects were staining, discolouration, and chalking. The least common defects were erosion of mortar and efflorescence. Plaster is used to protect the brick and to create surface finishes for wall paint. However the use of cement plaster on a wall will trap moisture inside the wall, and after a few years, the plaster will start to crumble and eventually fall off (Figure 4). The same thing will happen to the wall when
