Creep damage assessment of a 50 MW steam turbine shaft

Abstract. This paper reported the evaluation of a 50 MW steam turbine shaft that has exceeded the designed lifetime (30 years). The inspection of turbine is a mandatory for safety and continued reliable operation. The shaft was made of nickel-chromium-molybdenum alloy steel. The turbine operated in the range temperature of 500-600 °C, and creep was considered to be a major damage mechanism. The remaining life assessment of the turbine shaft was also conducted using replication technique. The replica samples were taken from 125 position distributed along the turbine shaft. The microstructural analysis of replicas showed that creep had occurred, which was indicated by the cavities formation at the grain boundaries. After evaluation and assessment, it can be concluded that the turbine shaft still can be used however it needs to be re-inspected within 6 months.

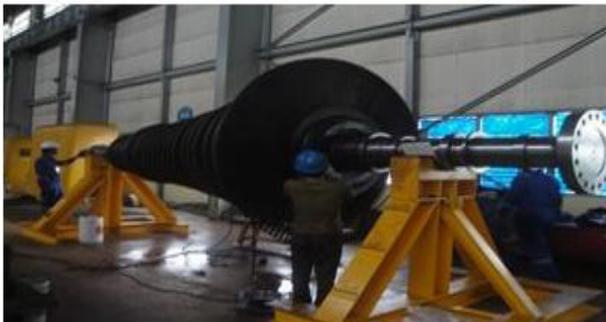
Figure 2. Inspected steam turbine shaft.

grams. The shaft has 17 stages of turbine, which is shown by D-1 until D-17 in Fig.2. The shaft turbine was inspected without its blades in all stages. The inspection methods, which were used to detect the discontinuities on the turbine shaft were dye penetrant, Eddy current and ultrasonic. Dye penetrant was utilized to detect the surface discontinuities. A NDE eddy current flow detector was carried out to find out the fine cracks, especially in the blade groove areas. Omniscan phased array ultrasonic was conducted to detect the internal defects. The replication technique for creep damage analysis was conducted by taking 125 samples, which was distributed along the turbine shaft (see Fig. 3).
