Surface Defects on Forged Nut of Stainless Steel

Abstract. Surface quality of nuts used in gas pipe joints is an important issue because the surface state affects the fatigue characteristics. Surface defects of nuts produced by warm forging from a stainless steel are observed and the cause of defect generation is discussed based on the numerical results of FEM simulation. It is revealed that there exists the lap defect on the drawn wire surface with an opened end and the surface defects on the forged nut are generated by the tensile stress during forging since there exists a moment at almost the whole area of the billet surface that a tensile stress over 200MPa is generated during nut forging.

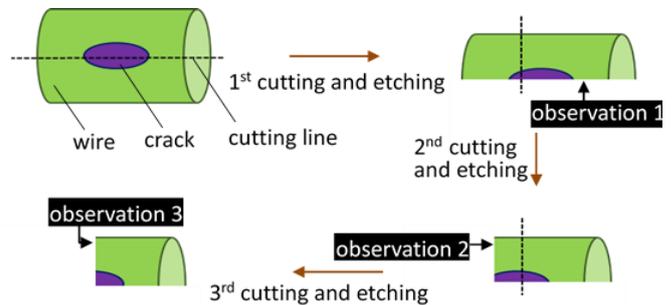
Figure 5. Process images of cross-sectional observation of defects on wire surface.

Three cross sections as shown in **Figure 4** are observed. Observation procedure is shown in **Figure 5**. First, the billet is cut parallel with the drawing direction. 1st cross section is observed (observation 1) after etching. Then the billet is cut vertically to the drawing direction and the 2nd and 3rd cross section are observed (observation 2, 3).

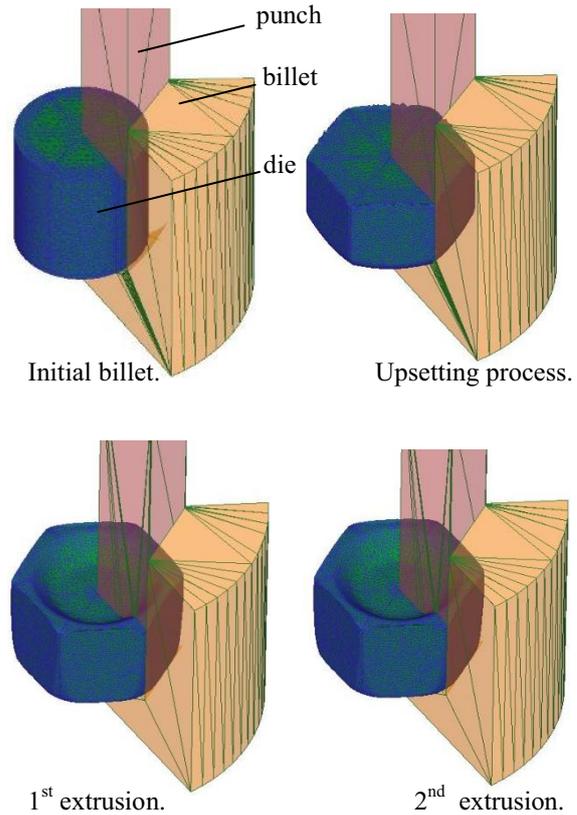
Figure 9. Forging processes of nut.

FEM simulations are carried out to clarify the stress state at the billet surface in the forging process of nut. A commercial FEM code "DEFORM-3D" is used. The simulation model is shown in **Figure 9**. The simulation is performed by using 1/6 model to reduce the time of calculation. Friction coefficient is 0.1. The strain-stress curve of SUS316 in the software is used. The billet temperature is 300 Celsius degree that is the same as the operation in forging shop.

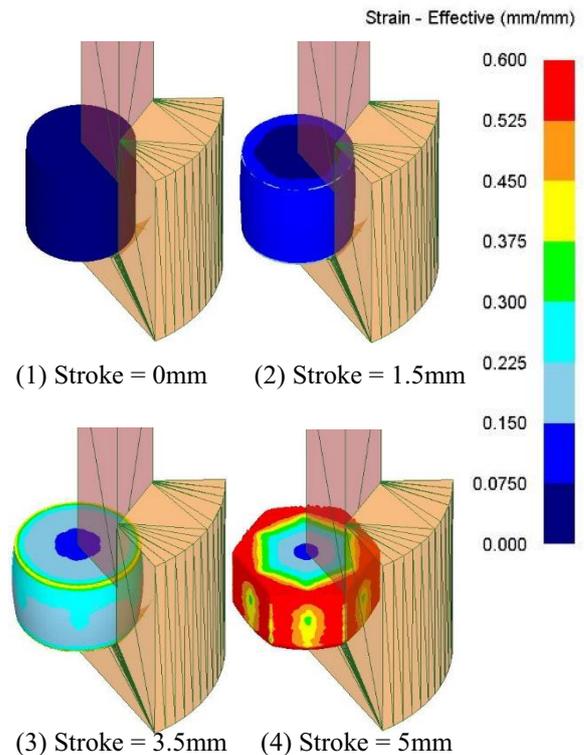
Figure 10. Change of billet shape in upsetting

Because the billet shape becomes to hexagonal at upsetting stage, the deformation state during upsetting is shown in **Figure 10**. The billet shape varies drastically to the hexagonal shape at the punch stroke of 3.5-5.0mm. The effective stain at the surface layer is about 0.6.
