# Maintenance of Heritage Building: A Case Study from Ipoh, Malaysia

**Abstract.** Heritage buildings represent the tangible cultural heritage of a community. However, many of the heritage buildings have being left neglected. Ipoh as a city rich in heritage, has many dilapidated heritage buildings which are experiencing a resurging interest. However, the problems faced by many owners are the lack of technical information of such buildings, leading to premature abandonment and demolition. Therefore, the objectives of this study are to determine the types and extent of defects present in the building studied. To achieve these objectives, a case study of a century old heritage property in Ipoh, Perak was conducted. The study aims to provide reference to owners and those responsible for the conservation of heritage buildings with similar conditions to identify and prioritize critical defects in relation to the building life span to determine its condition. The findings determined the probable causes of defects such as settlement and façade cracks, which are over 30 years old, were attributed to leaking plumbing pipes, rainwater ingress and the construction of an adjacent 20 story apar

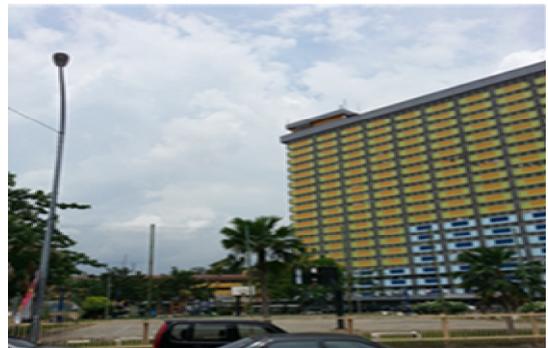
The building studied (Figure 1) is at the intersection of Patrick and Leech Street which faces the Kinta Height apartment block (Figure 2) that used to be the town market before it was relocated. The building is classifiable as Edwardian architecture as it was constructed between 1900 and 1910.

**Figure 2.** Kinta Heights apartment.
